**HEDRICK BLOCK (URS survey #18A)
211-215 South Main Street**

Recommendation and Boundaries

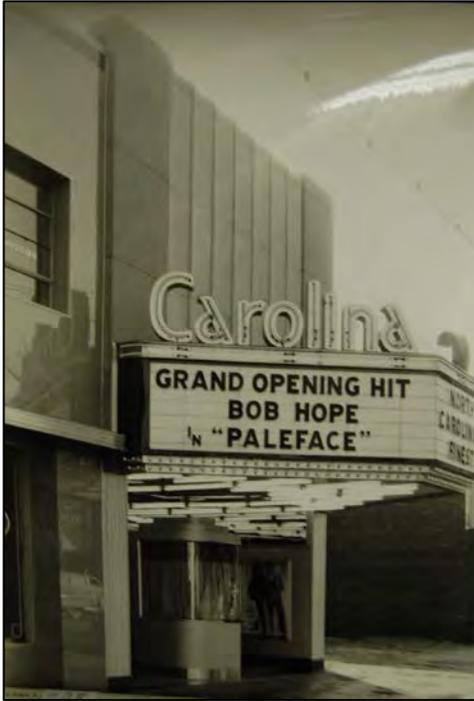
Figure 141: New Carolina Theater, at right, with portion of Hedrick Block at left in 1948 (source: Davidson County Historical Museum, H. Lee Waters collection 96.574B)

The Hedrick Block is a two-story-tall brick building. It is a straightforward functionally designed building but for its façade along Main Street, which is a late example of the Art Moderne style popular in the 1930s. This façade is original and little changed, as evidenced by a comparison of its current appearance with historic photographs from 1948 and 1950 that include views of much of it (Figure 141 and Figure 142).

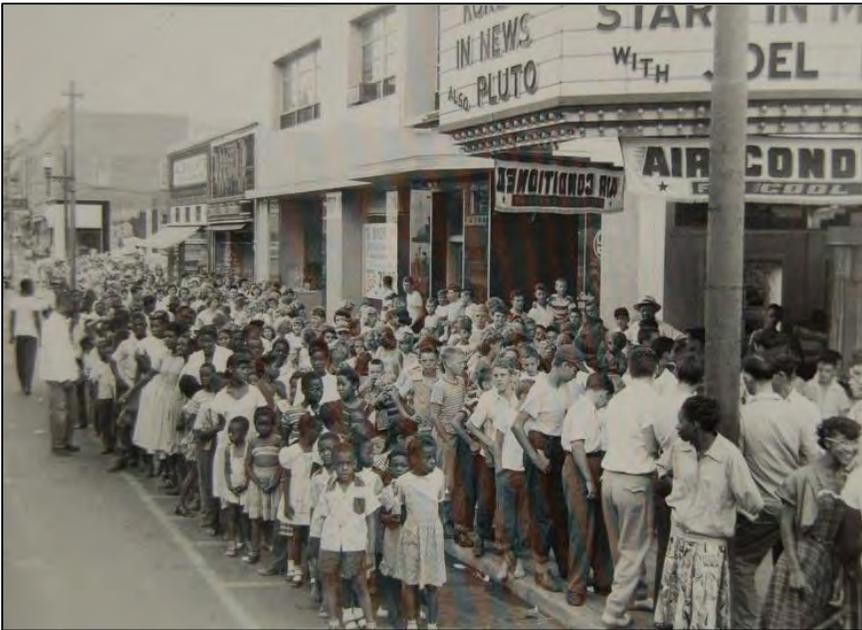
Figure 142: Hedrick Block at center with Carolina Theater at right and Family Shoe and Redwine's Grocery at left, July 1950 (source: Davidson County Sesquicentennial Association)

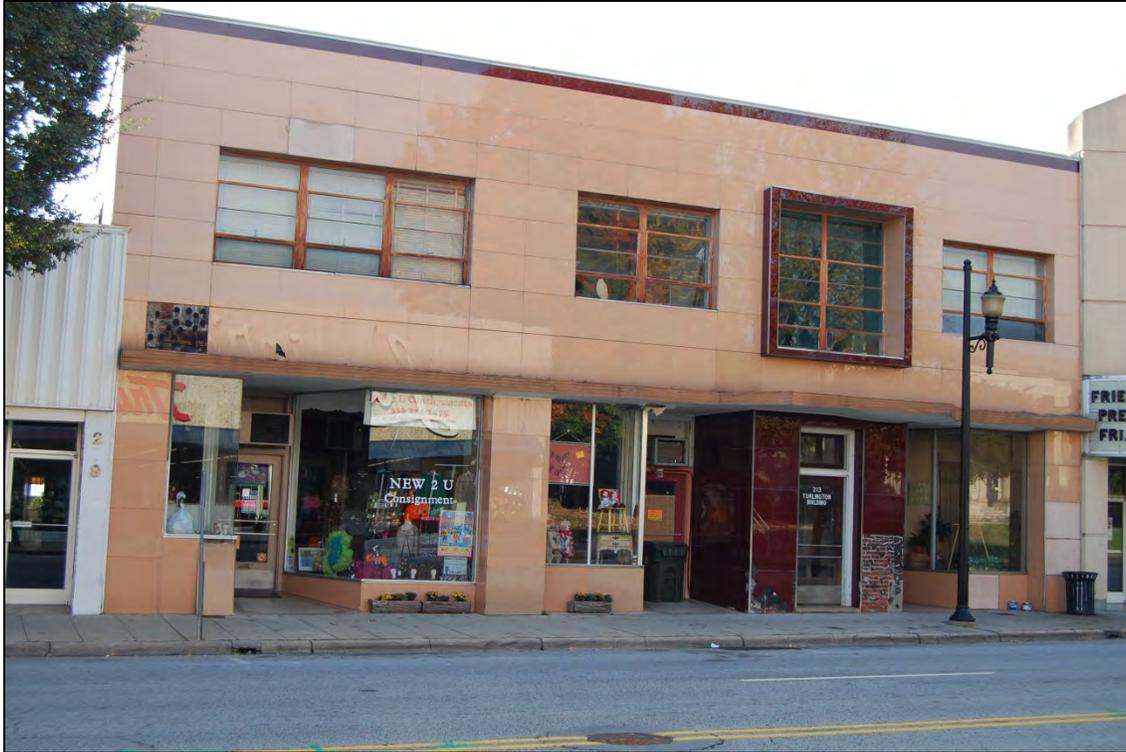
Figure 143: North front (Main Street) elevation of Hedrick Block

The façade is marked by three plate-glass store fronts and a central entry, which opens to a stair to the second floor (Figure 143 - Figure 147). Sheathing the façade are distinctive panels of thick, structural, peach-pigmented, mirror-finish glass. Further accenting the elevation are similar panels in maroon that flank the entry, outline one of the second-story windows, and limn the cornice. These are thicker than the beige panels, measuring about one-third of an inch deep. The panels are Carrara Structural Glass, a trade name of the Pittsburgh Plate Glass Company. The building also includes at least a few thinner maroon panels of a plastic or plastic-like material. These are likely later replacements, for as panels have pulled away from the brick walls, chipped, or broken, they have been replaced with jerry-rigged materials, including wooden boards painted beige.

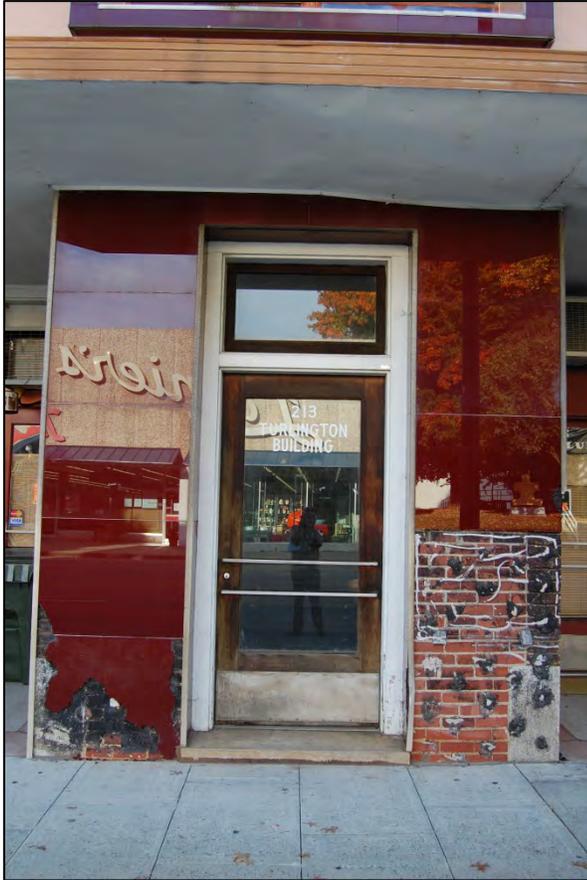
Figure 147: Front elevation detail of Hedrick Block entry; note reflectivity of glass and damage to panels

Where not broken, the glass has indeed maintained its appearance. The approximately one-third-inch-thick maroon glass conforms with the company's suggestion to utilize a thickness of 11/32-inch for store fronts. A thinner glass was chosen for the beige panels.

The Hedrick Block is an unusual, if belated, local example of the Art Moderne style. Some of its Carrara structural glass panels have broken or fallen, but it is otherwise little altered and, in terms of the seven elements of National Register integrity, intact. The building is eligible under Criterion C as a good, local, representative example of the Art Moderne style. The recommended National Register boundary is all of the resource's lot—Parcel Number 11083000A0004B / Pin ID 6725-02-86-0509—which covers less than one-quarter of an acre (Figure 148). As noted above, the building is also recommended as contributing to an expanded Uptown Lexington Historic District.

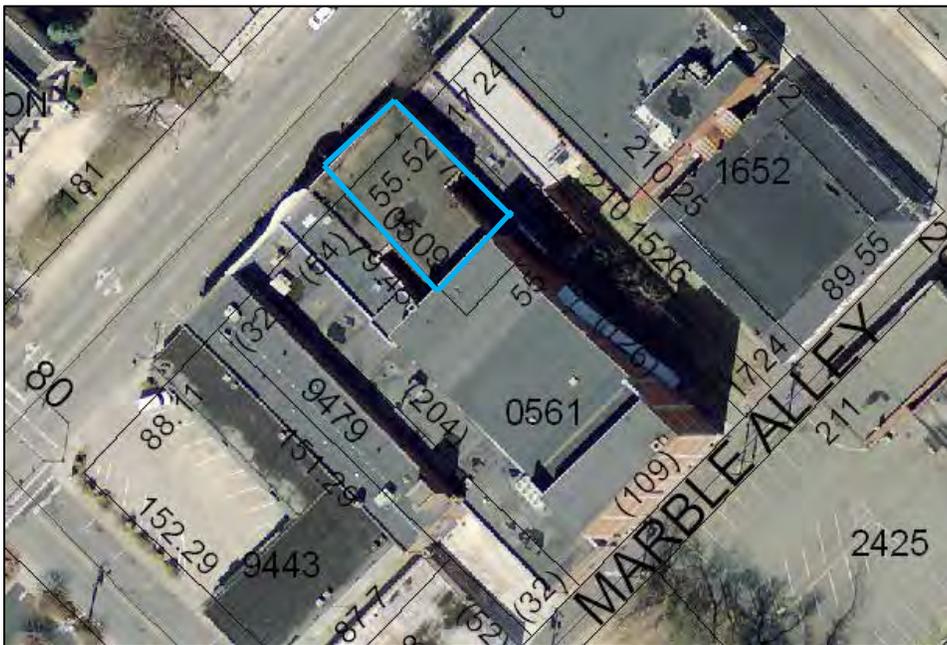
Figure 148: Proposed National Register boundaries of Hedrick Block, encompassing entire parcel, marked in blue (source: Davidson County with blue lines shifted to correct off-center overlay of parcel lines)

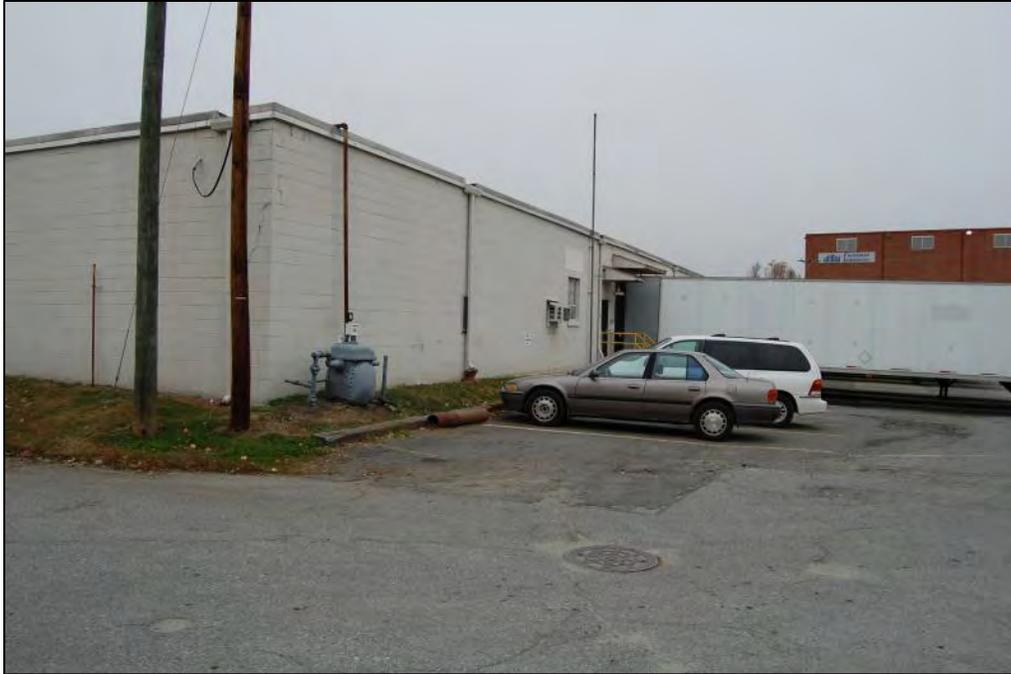
Figure 149: United Furniture Industries, west and south elevations of concrete-block building (1964) at left and west elevation of brick-veneered masonry building (1974) at right

The United Furniture Industries complex consists of two large principal buildings (Figure 149 - Figure 152). The earliest is a long, relatively low, rectangular building (1964) at the northeast portion of the complex that is constructed of exposed concrete blocks. A later-constructed, metal-clad, long rectangular building is affixed to its east. Attached to the south of these connected buildings is a taller, brick-veneered, masonry building (1974) that is also long and rectangular. The buildings appear to be used exclusively or almost exclusively as warehouses: they are windowless, they have numerous truck loading bays, and scores of tractor trailer bodies stand on the grounds or at the bays at any one time.

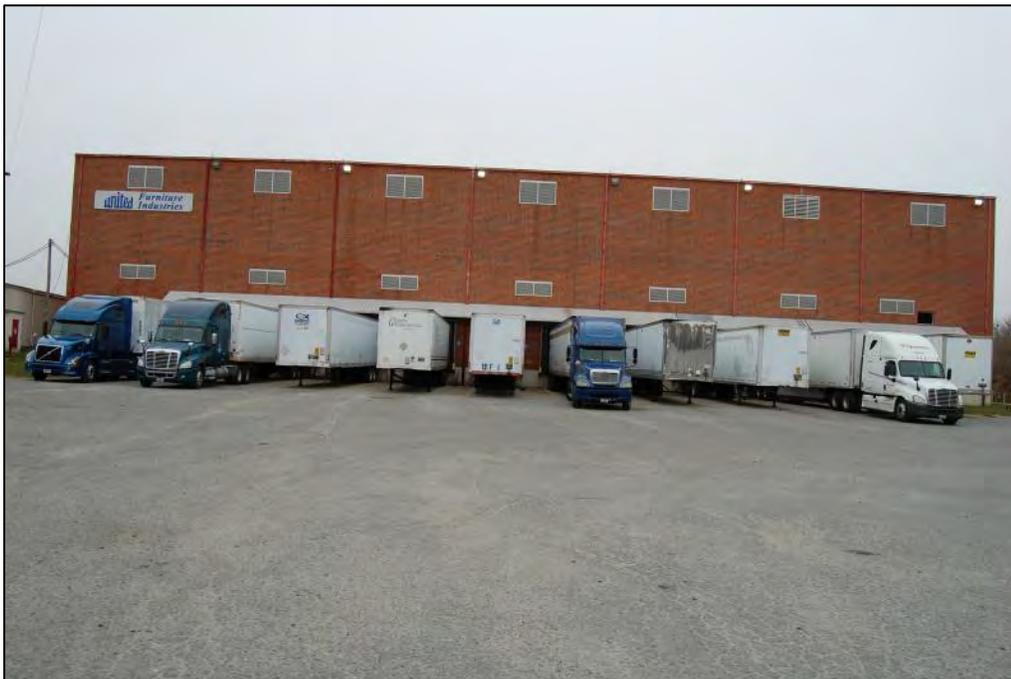
Figure 150: United Furniture Industries, west elevation of brick-veneered masonry building (1974) with edge of concrete-block building (1964) at far left

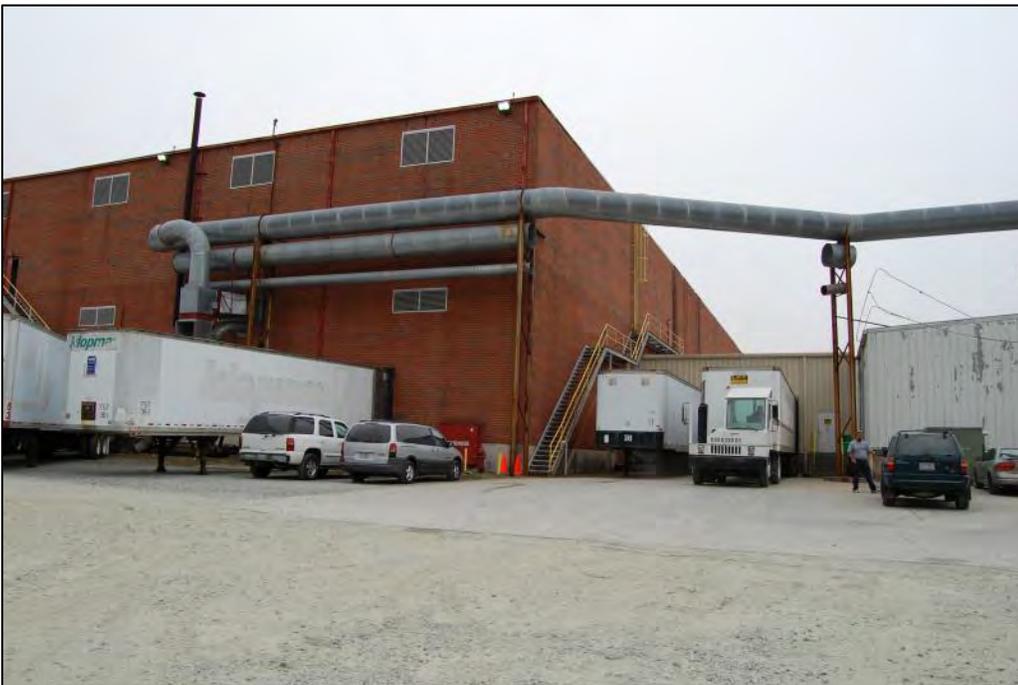
Figure 152: United Furniture Industries, west and north elevations of brick-veneered masonry building (1974) at left with metal-clad extension of concrete-block building at right

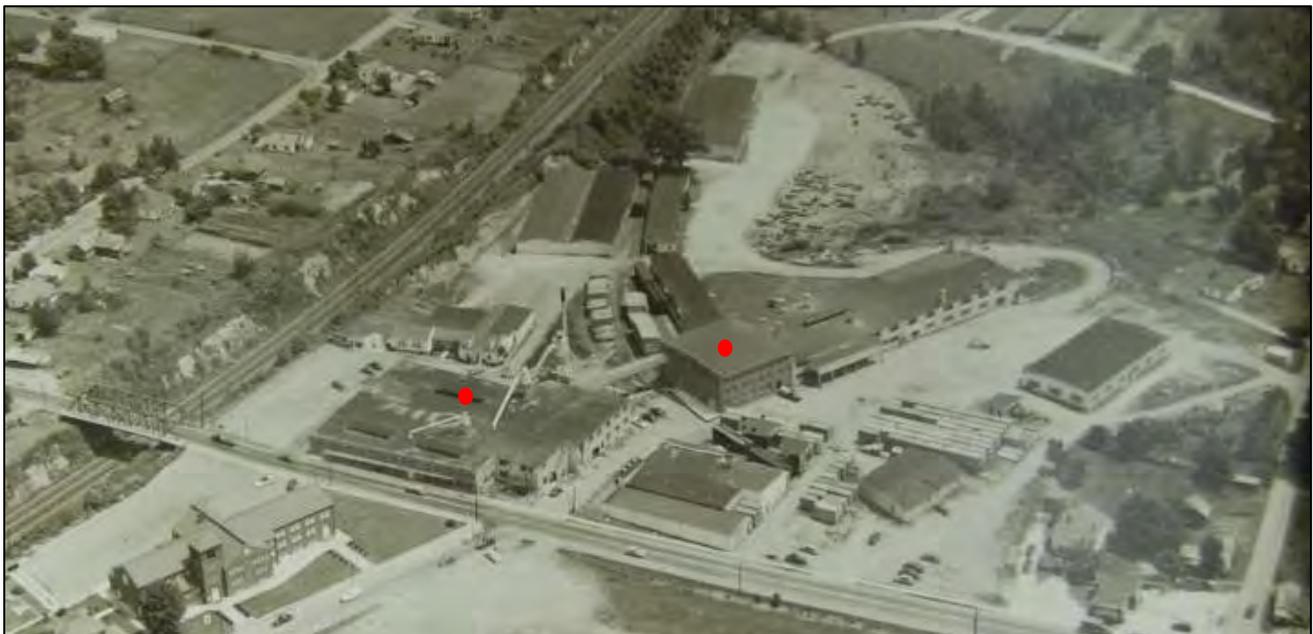
Figure 154: Lexington Chair Company, 1950s; only extant buildings are two marked by red dots (source: Davidson County Historical Museum, H. Lee Waters collection 96.11569)

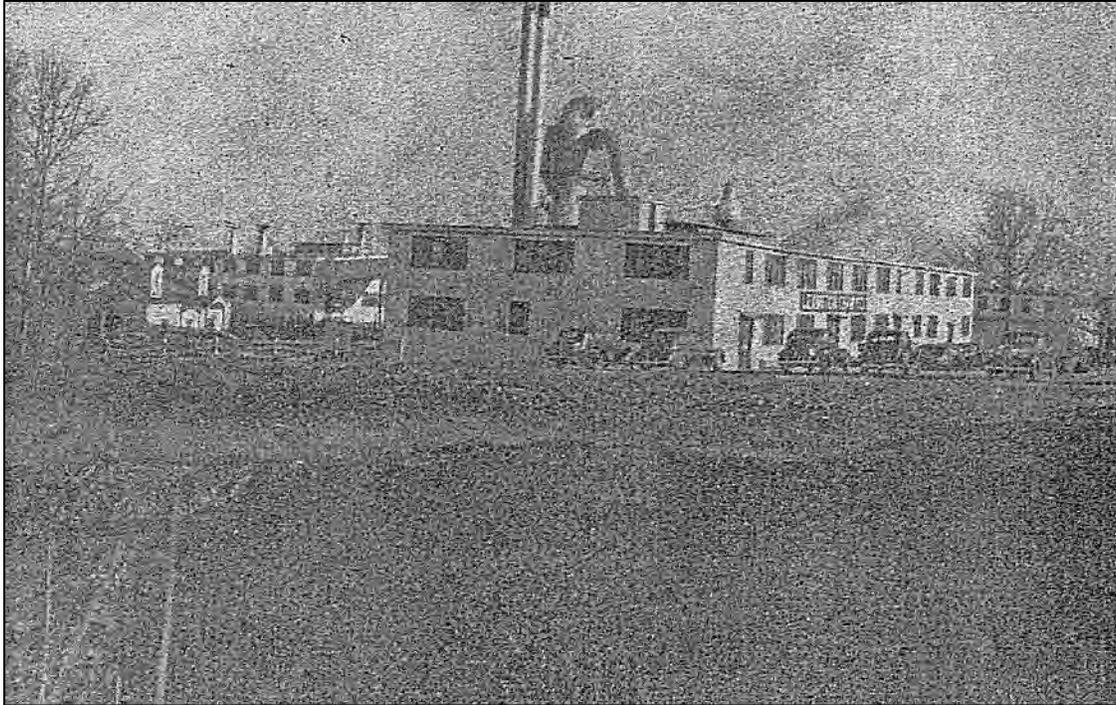
Figure 155: Lexington Chair Company, ca.1947; only Raleigh Road factory building [A] at center survives (source: *The State*, February 22, 1947)

The former Lexington Chair Company complex consists of four buildings. Extending along Raleigh Road is a long, functional, brick, **two-story factory building** that is depicted on the 1948 Sanborn map and appears to date from the 1940s [A on Figure 153]. It retains large metal casement windows on its south and west elevations, but these have largely been bricked over at the other two elevations. Projecting to its rear (east) are the walls of a small early power plant that may date to as early as the original complex's construction in 1905. Appended to its south elevation is an extension likely dating to the 1950s that has metal casement windows at its second story. A **three-story factory building** [B] to the east is also functionally designed. Its brick walls are plainly finished and pierced by large metal casement windows. Its rear (east) elevation is metal clad, reflecting the former presence of an earlier factory building it once abutted. It was in all likelihood erected in the early or mid-1950s. Immediately to its east is a low, metal-clad, frame wood-storage **shed** [C] that may date from the 1980s. A large, modern, metal-sided storage or **warehouse building** [D] at the south stands on the site of a former steam-drying kiln.

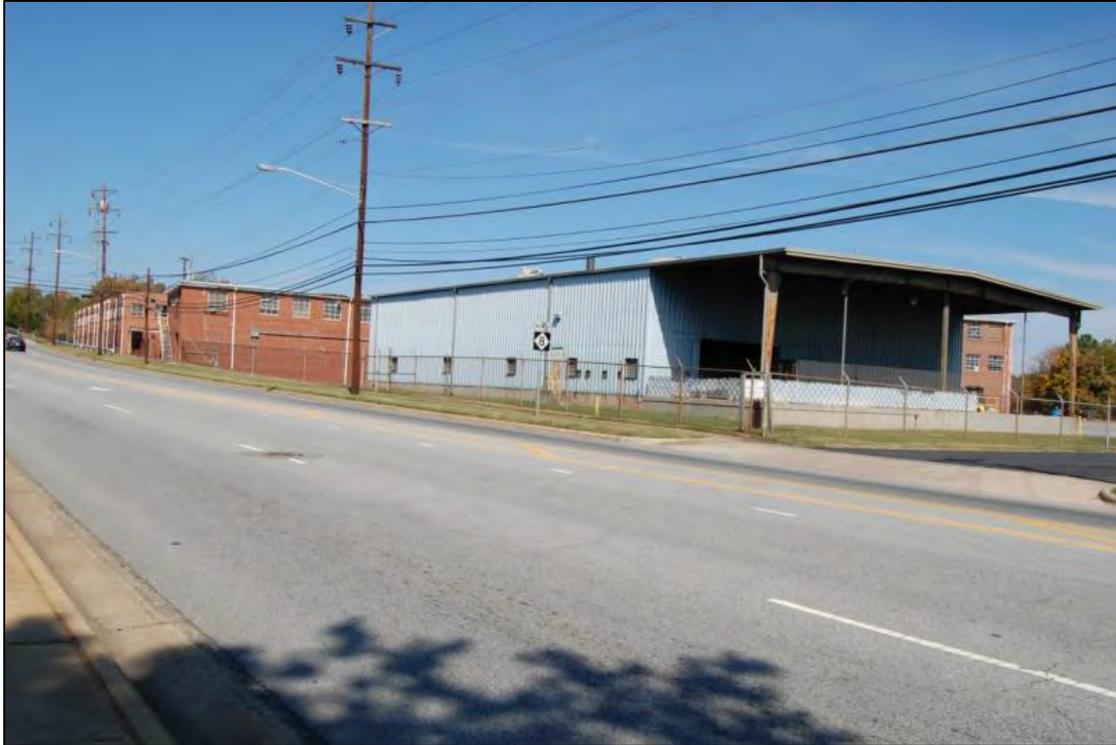
Figure 157: Lexington Chair Company from Raleigh Road, edge of three-story factory brick building [B] at far right, metal-clad storage building [D] at center, and, at left, later factory wing and, beyond, factory [A]

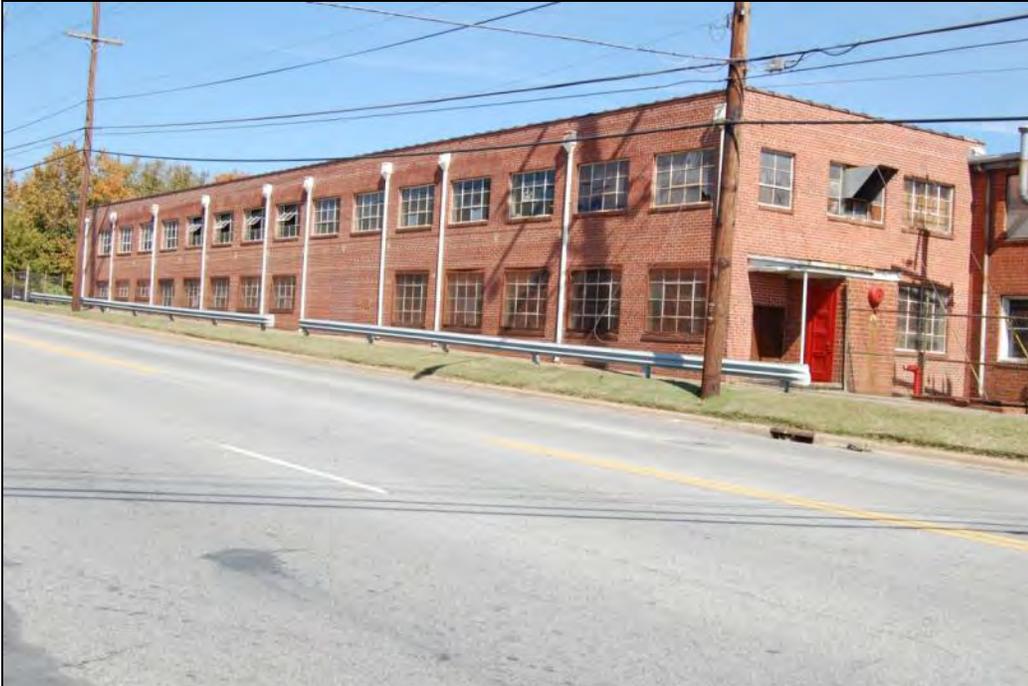
Figure 159: Lexington Chair Company factory building [A] on Raleigh Road

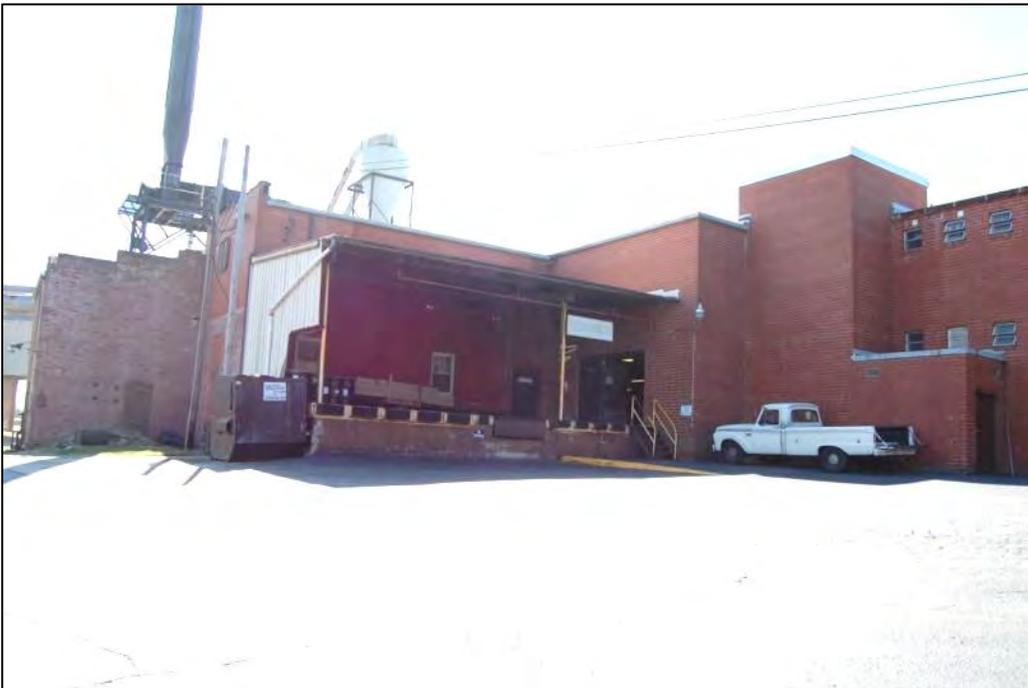
Figure 160: Lexington Chair Company, rear of factory building [A] with walls of early power plant at far left

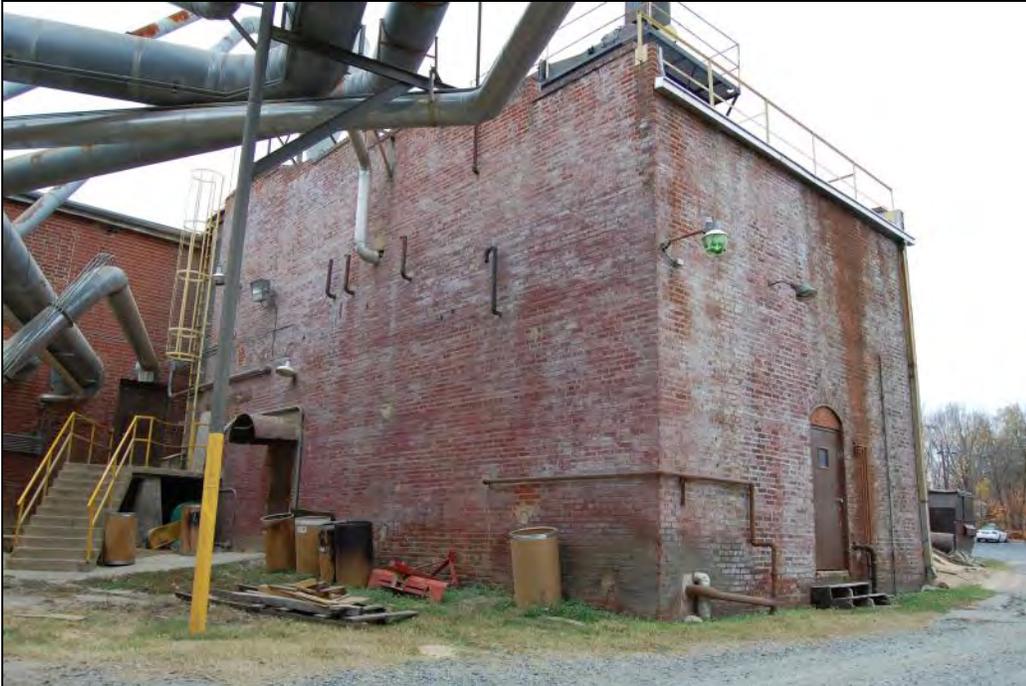
Figure 161: Lexington Chair Company, early power plant walls at rear of factory building [A]

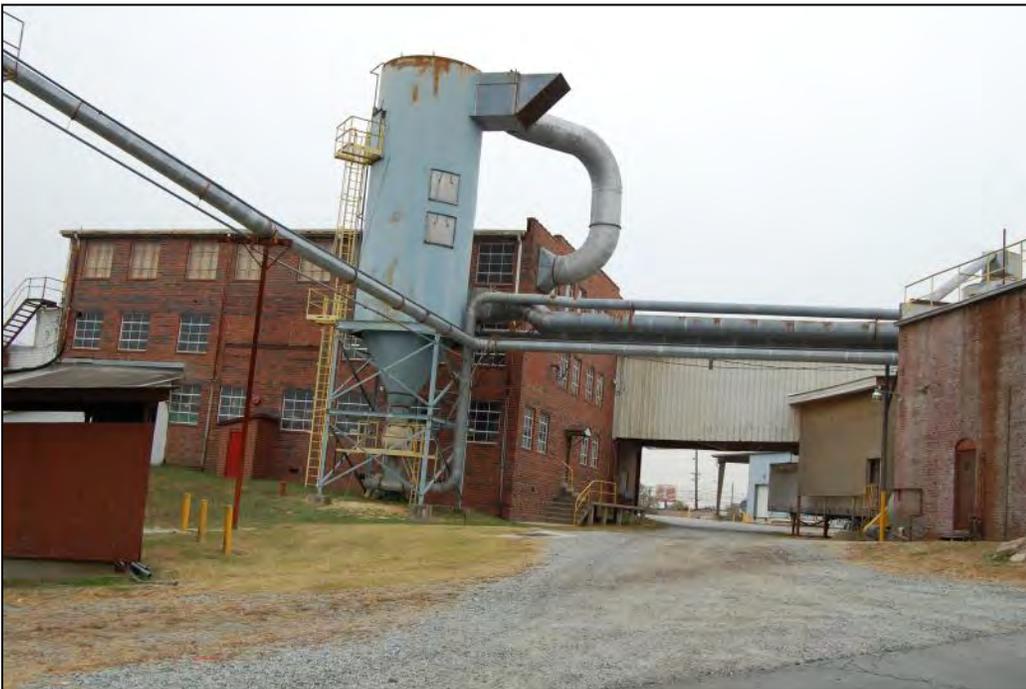
Figure 162: Lexington Chair Company, three-story factory building [B] at left and early power plant wall at far right

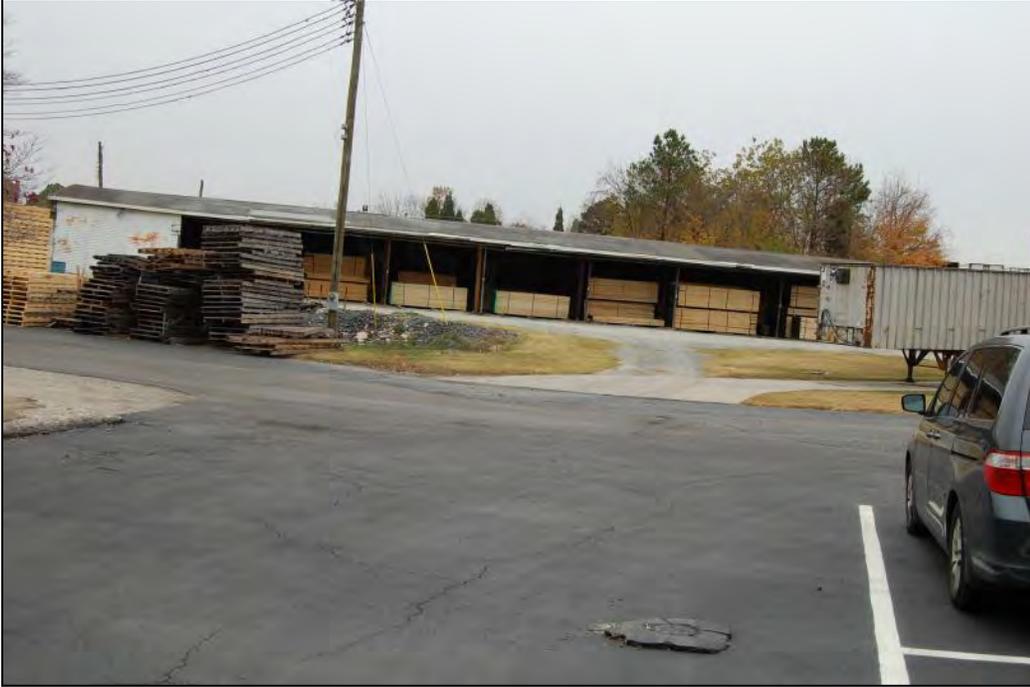
Figure 163: Lexington Chair Company, wood shed [C] extended to east of three-story factory building

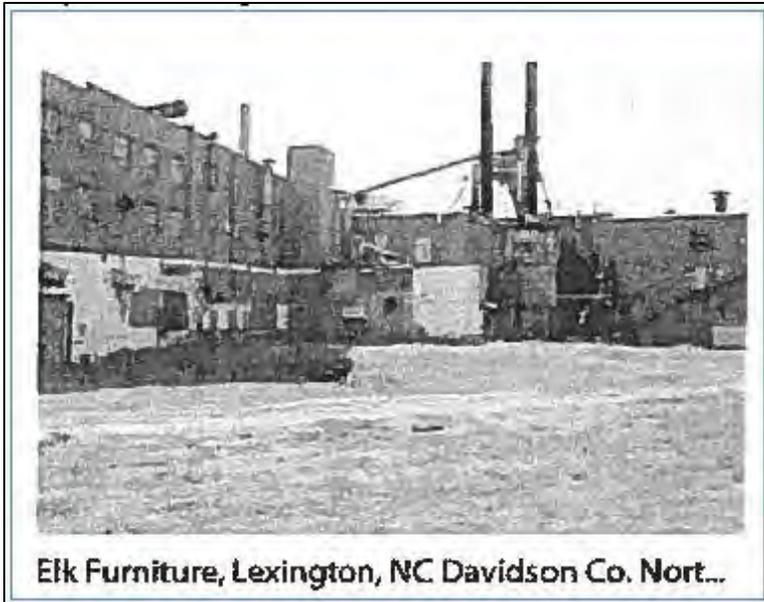
Figure 166: Elk Furniture Company/United Furniture Company, image of Block A at left and Block B at right, from 2007 Study List Application (Susannah V. Franklin)

The only portion of the factory that survives is Block A and the later additions that frame its north and west sides (Figure 165 - Figure 175). Block A, built ca.1923, is a functional, three-story, flat-roofed, brick factory building marked by metal casement windows and a square, flat-roofed stair tower. To its south is a similarly fashioned three-story extension built in two phases between 1929 and 1948, and in ca.1952. A two-story concrete-block addition on the west side of the block, at the corner of Elk Street and West 5th Avenue Extension, was erected between 1948 and 1952. To that addition's rear, along 5th Avenue, are two brick-veneered, masonry, two-story blocks likely added in the 1960s.

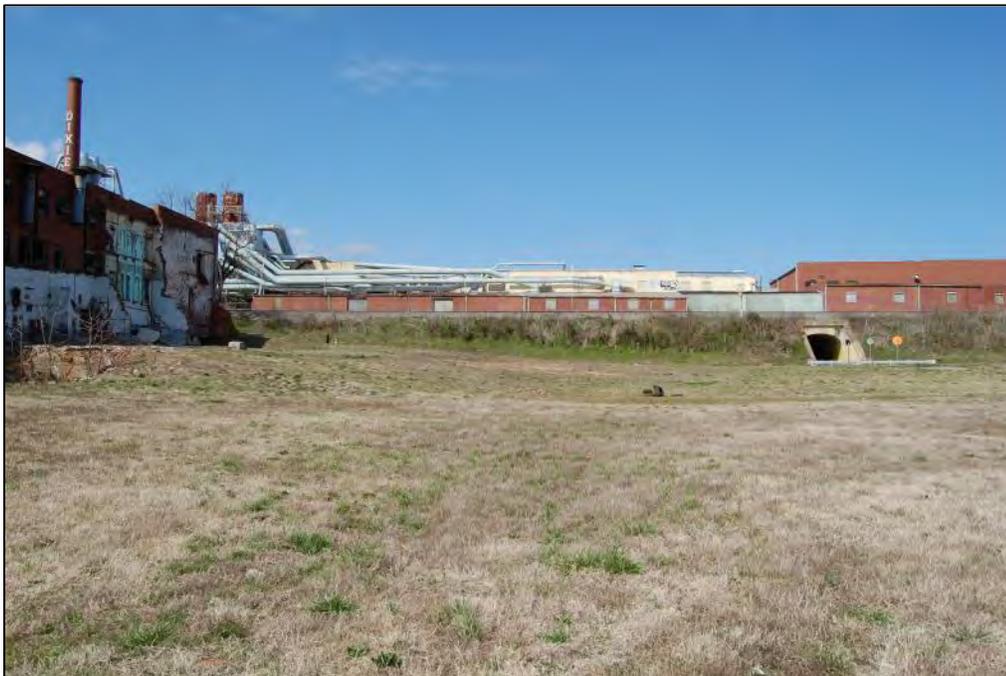
Figure 167: Elk Furniture Company/United Furniture Company, 2012 photograph from same location as Figure 166 showing damage to Block A and removal of Block B (Dixie Furniture Company across tracks in background)

In the few years since the drawing of the map, however, about half of the factory has burned. The string of buildings along Elk Street beyond Block A, which were centered on the 1923-1929 Block B portion of the factory, have all been leveled. Their former location is now a graded lot.

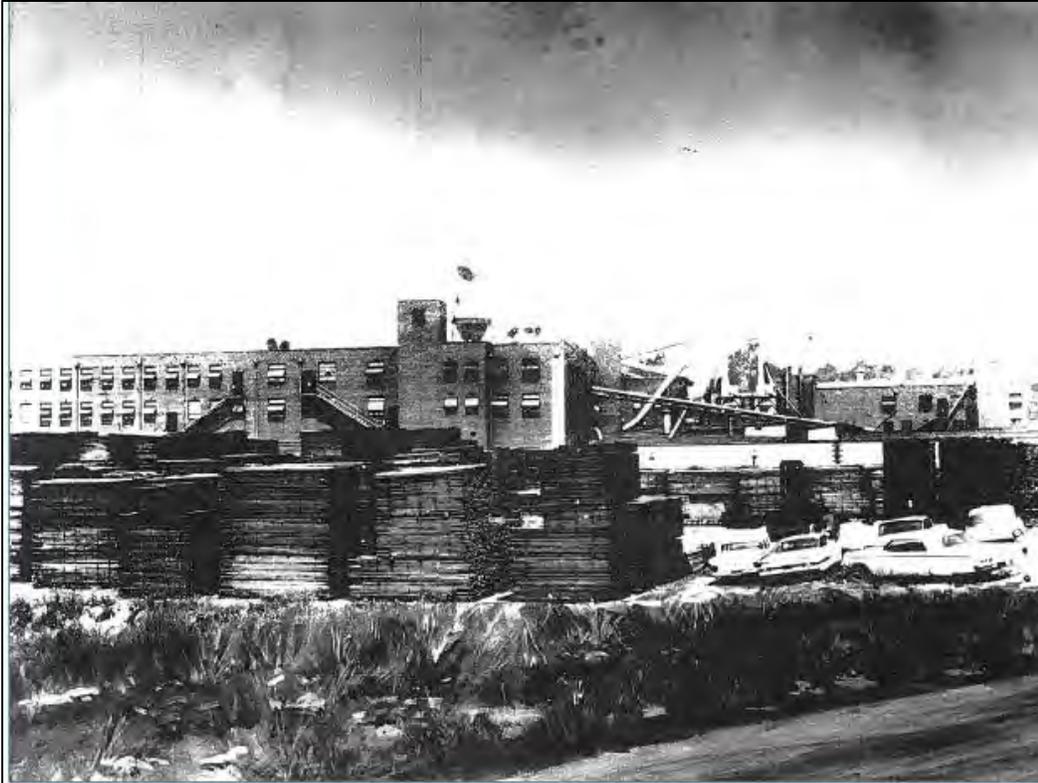
Davidson County Historical Society (HLW96.747a), early 1950s

Figure 170: Elk Furniture Company/United Furniture Company, historic view showing Block A at left and Block B at right (source: Davidson County Historical Museum, H. Lee Waters collection 96.747a)

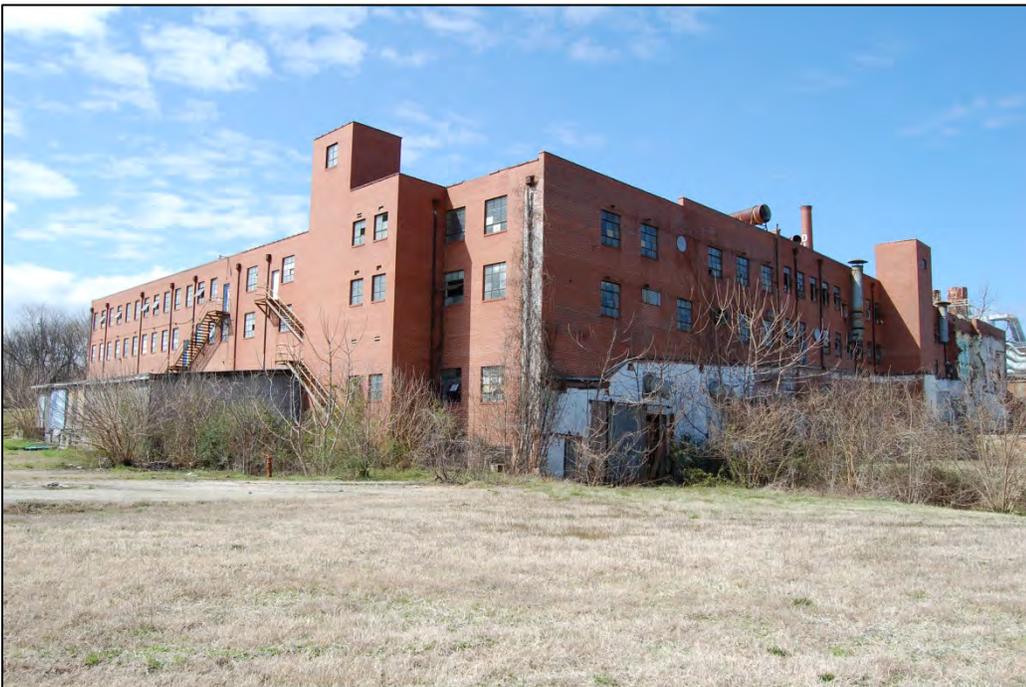
Figure 171: Elk Furniture Company/United Furniture Company, view similar to Figure 170 above showing Block A; Block B would have extended to right

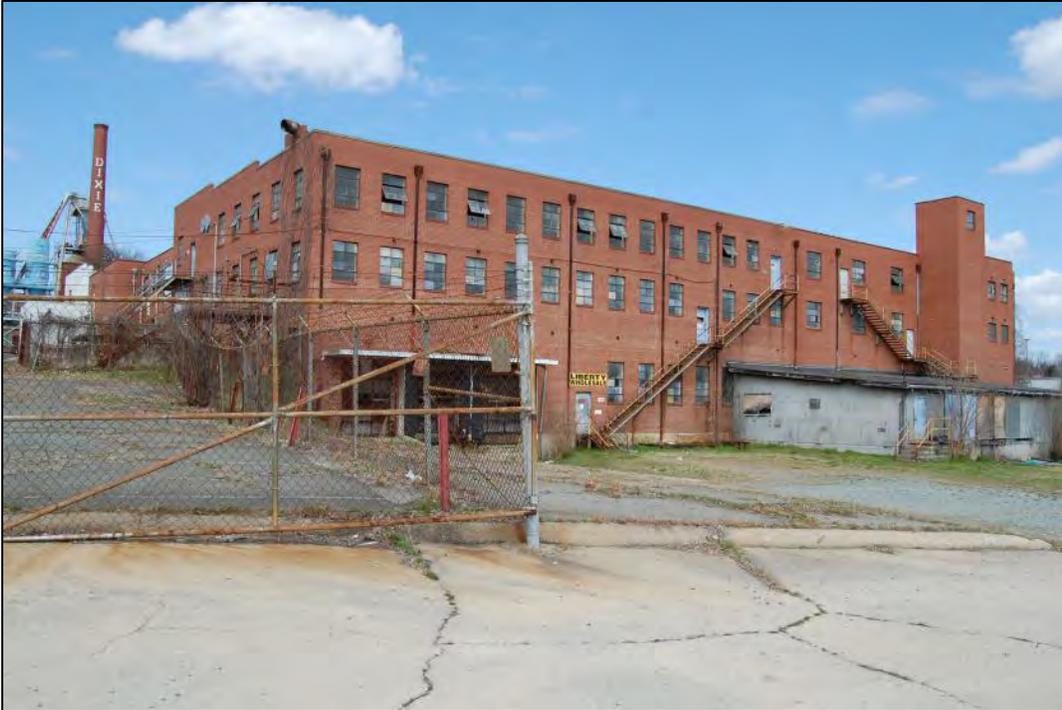
Figure 172: Elk Furniture Company/United Furniture Company, south and west elevations of Block A

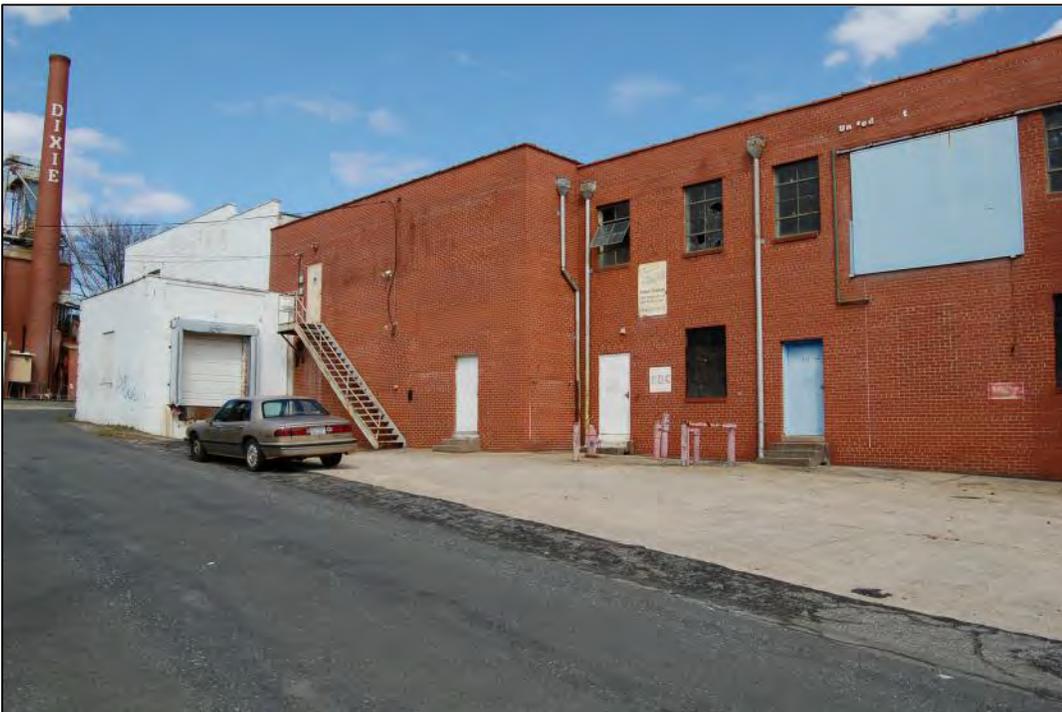
Figure 173: Elk Furniture Company/United Furniture Company, west elevation of block A along West 5th Street Extension

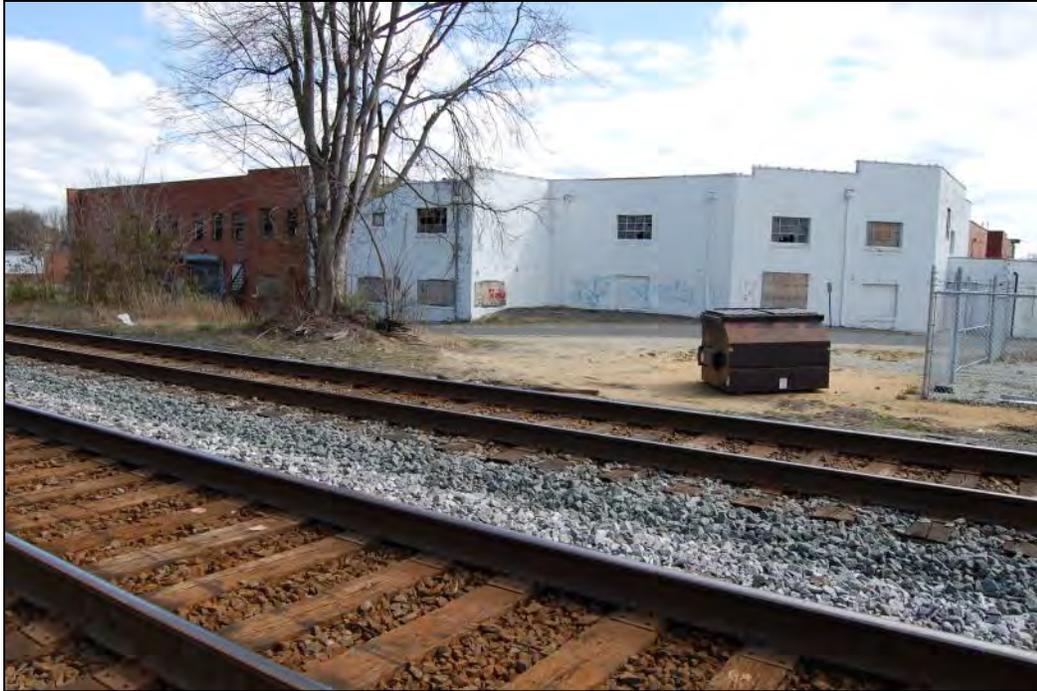
Figure 174: Elk Furniture Company/United Furniture Company, north elevation of Block A along Elk Street

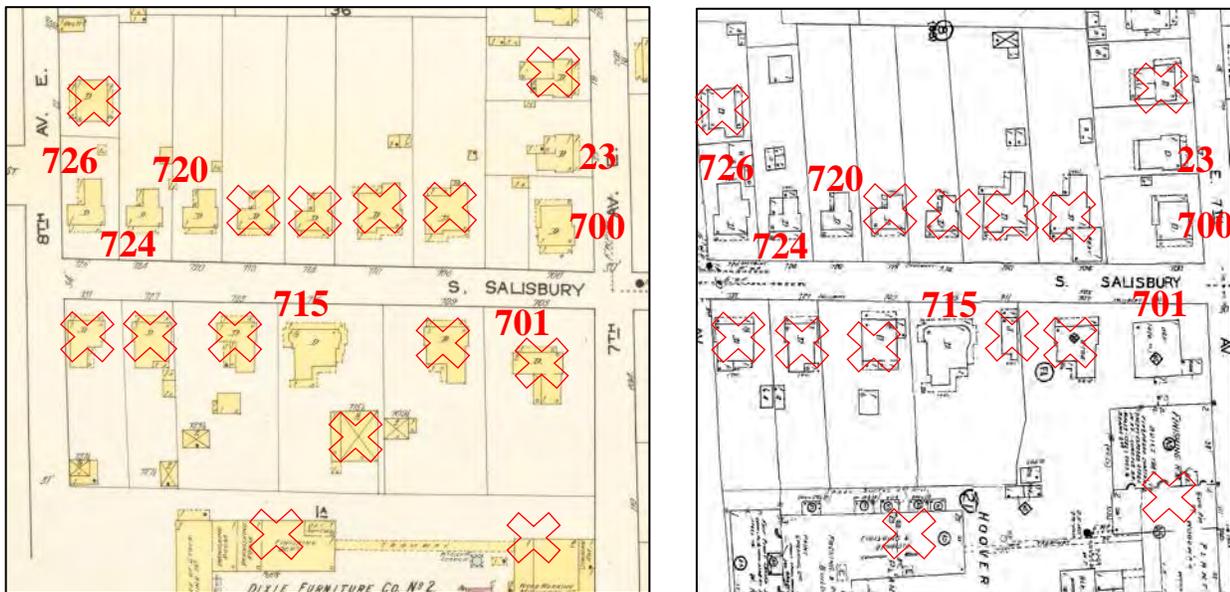
Figure 177: 1913 Sanborn map at left and updated 1948 Sanborn at right with addresses of extant houses identified in red and lost houses and industrial buildings marked over with red crosses

The deed record for these houses as well as the Sanborn maps indicate that they were not erected as part of any mill village, but were always private dwellings. They are first briefly described with thumbnail histories and then the group is addressed. Below are a modern aerial photograph (Figure 176) and historic Sanborn maps (Figure 177).

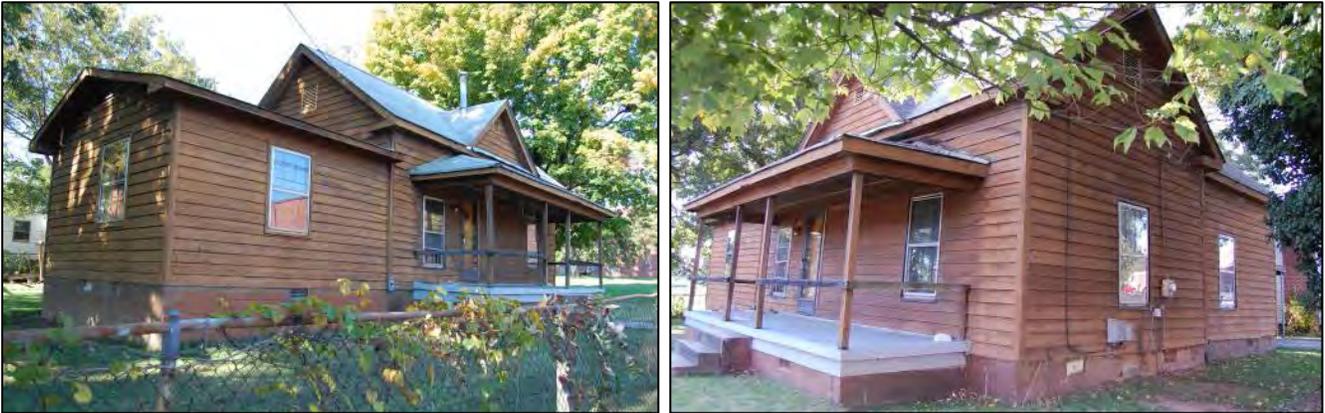
Figure 178: 700 South Salisbury Street—south front and west side elevations at left and south front and east side elevations at right

This one-story, single-pile, frame dwelling has a gable-end roof and façade gable (Figure 178). Three asymmetrically placed bays shaded by a hip-roofed porch cross its front (south) elevation. An original ell extends to its rear. The ell affixed to its west gable end postdates the 1948 Sanborn map. The house's weatherboards have been replaced, as has its sash and the posts and floor of its porch. The house appears to date from the late nineteenth/early twentieth century. It is depicted on the 1913 Sanborn map, the first to cover this block of Salisbury Street. Its parcel was private property in 1941 according to a transaction between members of the Swink family that year (Davidson County Deed Book 149/Page 210). Earlier deeds were not identified.

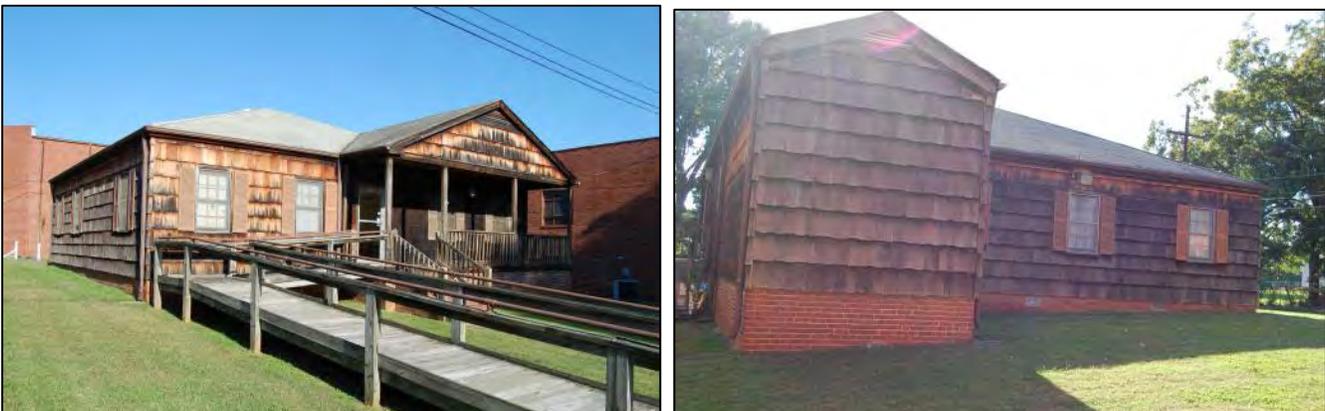
Figure 179: 701 South Salisbury Street—west front and north side elevations at left and east rear and south side elevations at right

This parcel was private property in 1917, when it was tract 3 of a three-parcel property transferred by Caroline Sink to Thomas M. Swink (Book 110/Page 123). A house was on this lot by 1913 according to the Sanborn map of that year. However, the estate of Thomas M. Swink sold the property to the Hoover Chair Company in 1936 (Davidson County Deed Book 126/Page 21), which by the drawing of the updated 1948 map had erected the current building as its offices in place of that dwelling. (Tax records date the building to 1939.) The boxy, one-story, frame, wood-shingled building rests on a brick foundation and is topped by a hipped roof (Figure 179). A porch extends from part of its front (west) elevation and an ell from its east rear. Snap-in faux muntins give the sash windows a six-over-six appearance.

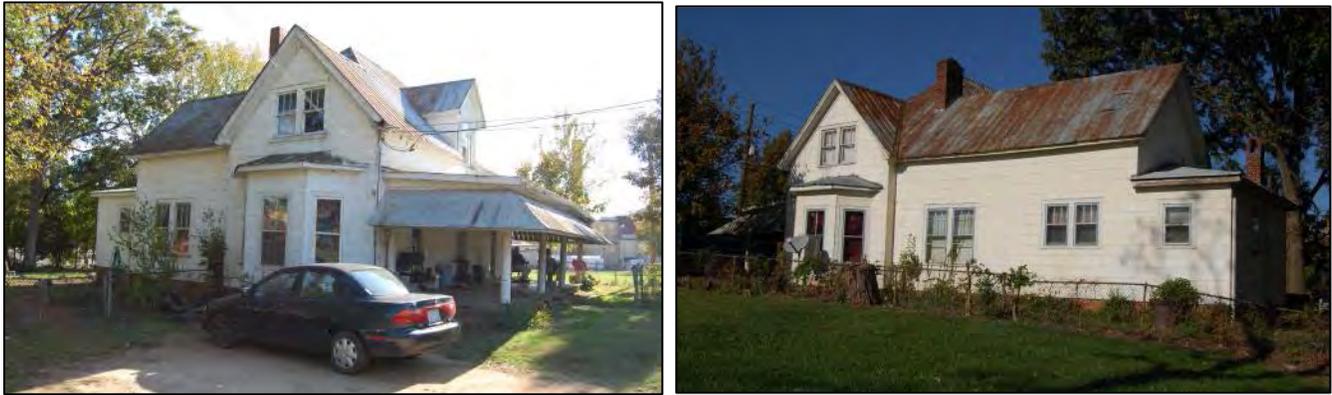
Figure 180: 715 South Salisbury Street—east side and north front elevations at left and west side and south rear elevations at right

According to a transaction between members of the Robbins family, this parcel was private property in 1900 (Davidson County Deed Book 52/Page 175). The house, which appears to date from the late nineteenth/early twentieth century, is depicted on the 1913 Sanborn map. It is a boxy, frame, one-and-a-half-story dwelling that is larger and more ornately finished than the other houses on the street (Figure 180). Its three-bay, gable-end, front (north) block is extended to the sides by bay windows, at the top by a gabled wall dormer, and to the rear by a large gabled ell that essentially gives the house a square footprint. A smaller ell extends further to the rear. The house retains the front portion of a porch, with altered columns and roof, that once wrapped around its east gable. A rear porch has been removed. The dwelling retains much of its original three-over-one and two-over-two sash. Asbestos siding, however, appears to be a later addition.

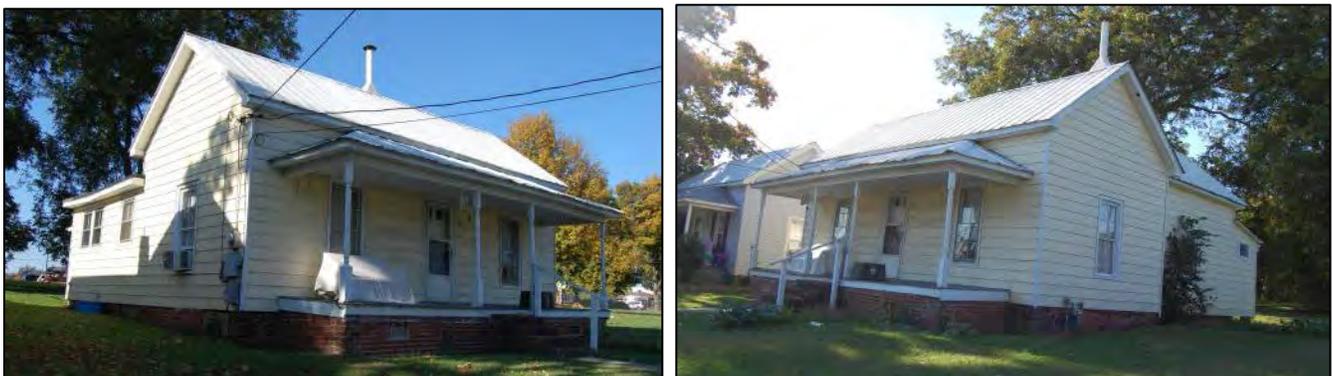
Figure 181: 720 South Salisbury Street—south front and west side elevations at left and south front and east side elevations at right

This parcel was private property in 1901 when J.L. Bowers acquired it from F.C. Robbins (Davidson County Deed Book 53/Page 440). In 1903 Bowers, who also owned the parcel at 724 Salisbury, sold it to Flora A. Gallimore (Davidson County Deed Book 149/Page 595). Later deeds associated with property state that Salisbury Street here was once known as Bowers Row or Road. The dwelling, which appears to date from the late nineteenth/early twentieth century, may have been erected by Bowers between 1901 and 1903. It is depicted on the 1913 Sanborn map. It is a one-story, single-pile, frame, gable-end house with a porch with turned posts across its three-bay front (south) elevation and an original ell to its rear (Figure 181). Its four-over-four sash may be original. Its vinyl siding is not.
