**HEDRICK BLOCK (URS survey #18A)
211-215 South Main Street**

Recommendation and Boundaries

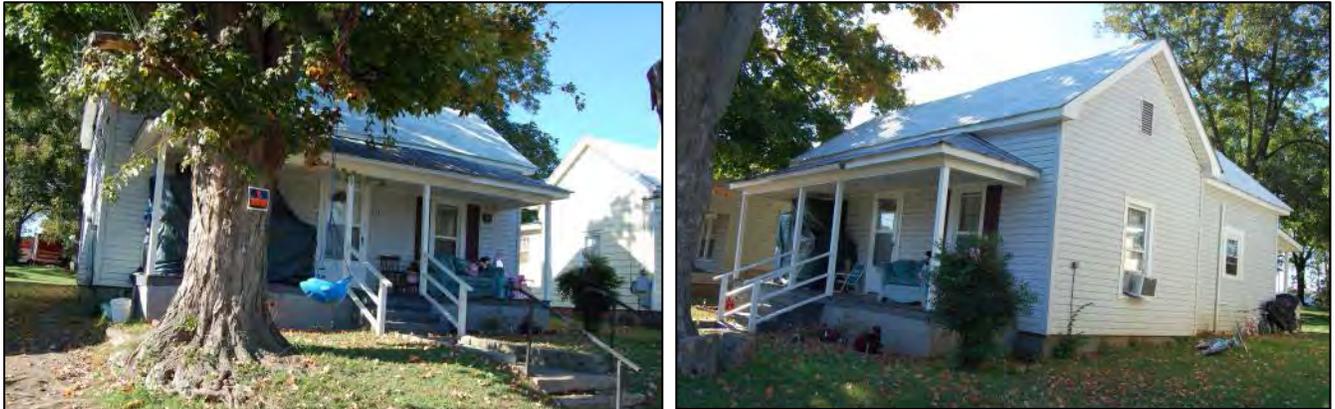
Figure 182: 724 South Salisbury Street—south front and west side elevations at left and south front and east side elevations at right

This parcel was private property in 1901 when J.L. Bowers acquired it with the lot for 720 Salisbury from F.C. Robbins (Davidson County Deed Book 53/Page 440). In 1903 Bowers sold it to James Adderton (Davidson County Deed Book 55/Page 594). The house, which appears to date from the late nineteenth/early twentieth century, may have been erected by Bowers between 1901 and 1903. It is depicted on the 1913 Sanborn map. The house is essentially identical to 720 Salisbury: it is one-story-tall, one-room-deep, frame, and gable-ended with an altered porch shading its three-bay front (south) elevation and an original ell to its rear (Figure 182). Its one-over-one sash and vinyl siding are not original.

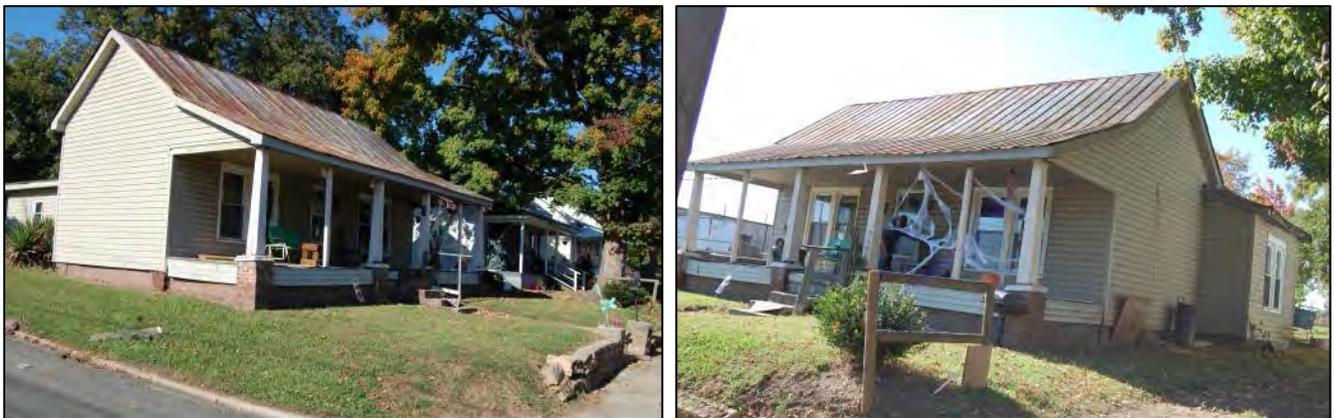
Figure 183: 726 South Salisbury Street—south front and west side elevations at left and south front and east side elevations at right

This parcel was private property in 1920 when local developers J.E. Foy and Dermot Shemwell sold it to Nanie and Bettie Crouse for \$950.00 (Davidson County Deed Book 86/Page 509; for information on Foy and Shemwell see Fearnbach 2006). The house, which appears to date from the late nineteenth/early twentieth century, is pictured on the 1913 Sanborn map. It is one-story tall, three bays wide, and one-room deep with a seam-metal gabled roof (Figure 183). An engaged porch crossing its three-bay front (south) elevation is supported by tapered posts on brick piers. Its front bays and sash have been altered and it is sided in vinyl. A one-story ell to its rear is likely original.

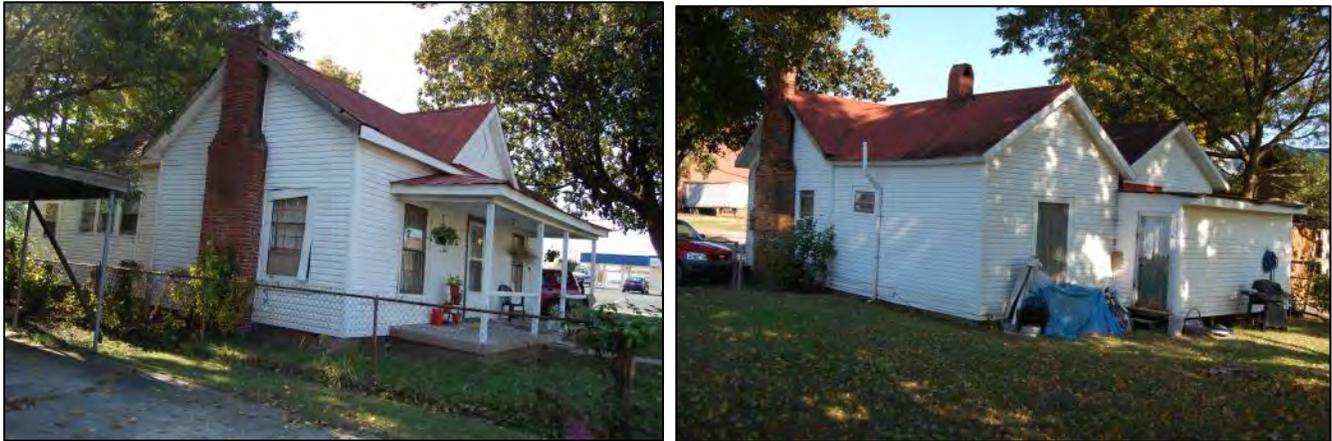
Figure 184: 23 East 7th Avenue—east front and south side elevations at left and north side and west rear elevations at right

This property was acquired through a quitclaim deed by a financial company from a bank in 2012 (Davidson County Deed Book 2048/Page 1759) and its deed history could not be determined. It appears to date from the late nineteenth/early twentieth century and is included on the 1913 Sanborn map, the first to cover its section of 7th Avenue. It is one-story tall, one-room deep, and frame with a metal-seam gable-end roof supplemented at its front (east) elevation by a façade gable (Figure 184). An altered porch shields its three-bay front façade and an original ell extends to its rear. It retains what appears to be original six-over-six sash and shallow exterior-end chimneys. It is now clad in vinyl siding.

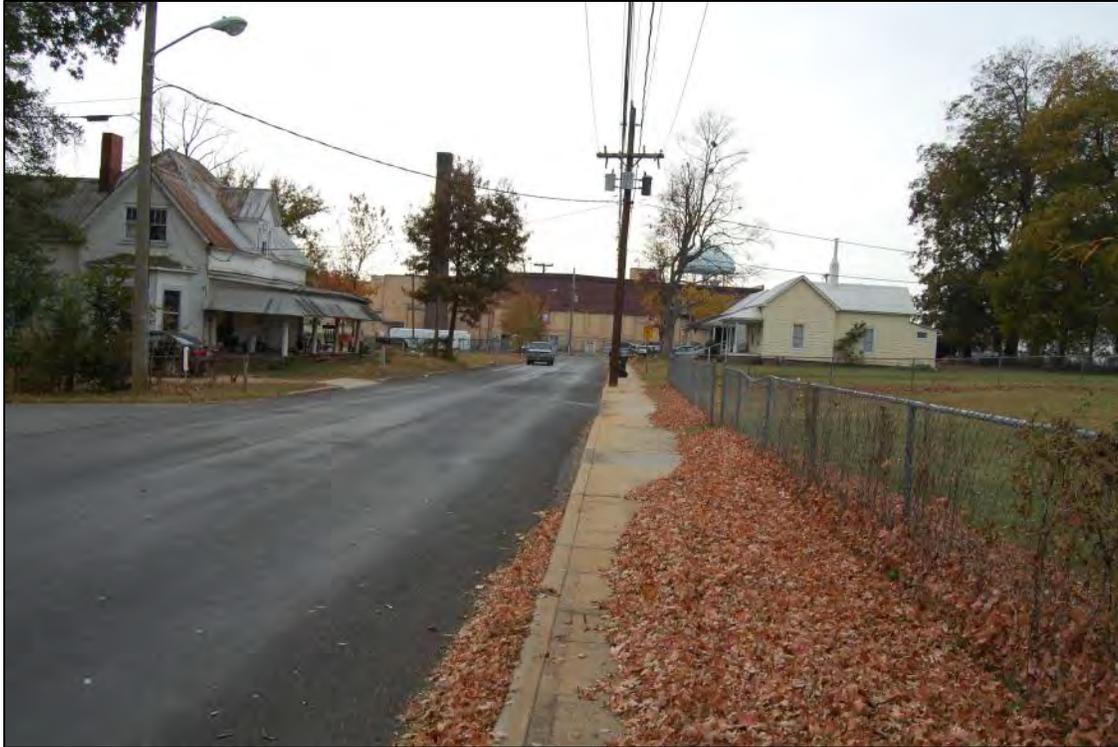
Figure 187: Looking west with 715 South Salisbury Street at left and 720 South Salisbury Street at right; note empty lots in foreground at right and Wenonah Mills complex at end of street at center

These houses are what remain on (and just off) a block of South Salisbury Street that was once full of houses (Figure 185 - Figure 188). Only one of the six houses depicted on the 1913 Sanborn map on the south side of the street—715 Salisbury—survives. (About 1939, 701 Salisbury was replaced by the current building, which was erected as an office.) This side of the street is now defined by its empty lots, where houses and the former Dixie Furniture Company No. 2 mill and its successor, the Hoover Chair Company, once stood. The north side of the street retains four houses, but a gaping space that once held an additional four houses now extends between 700 Salisbury and 720 Salisbury. Houses to the north on East 7th and East 8th Avenue have also been demolished, although 23 East 7th Avenue still survives.

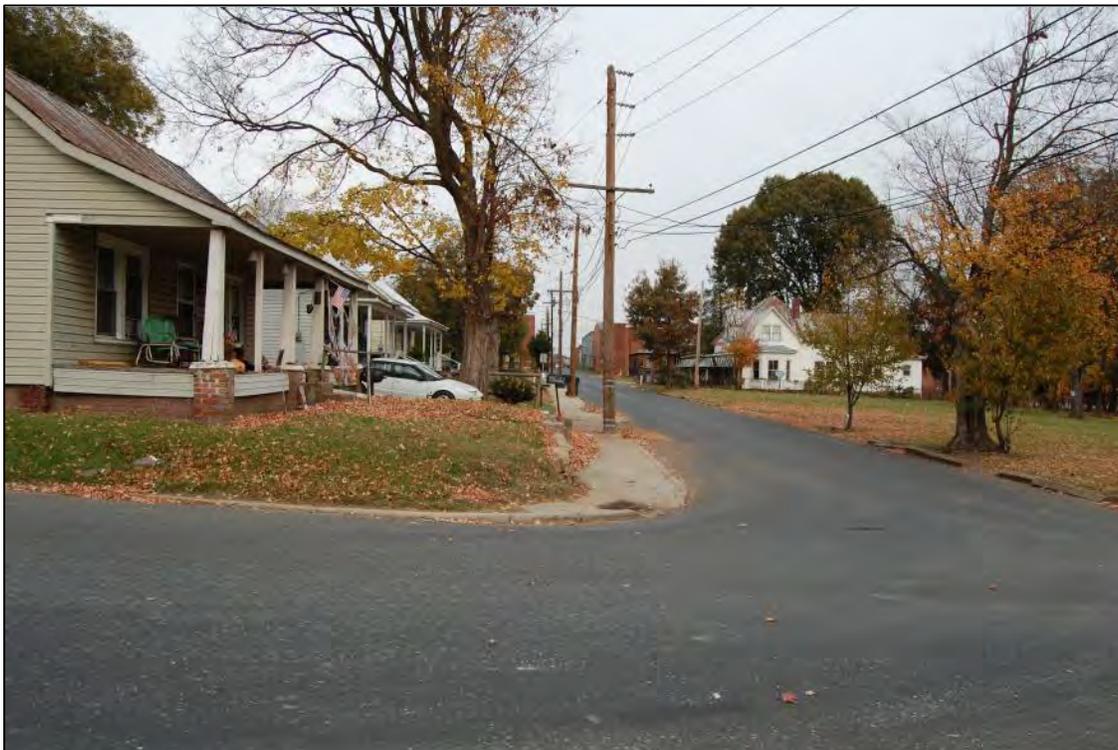
Figure 188: Looking east with 726 South Salisbury Street at left and 715 South Salisbury Street at center right; note empty lots at right

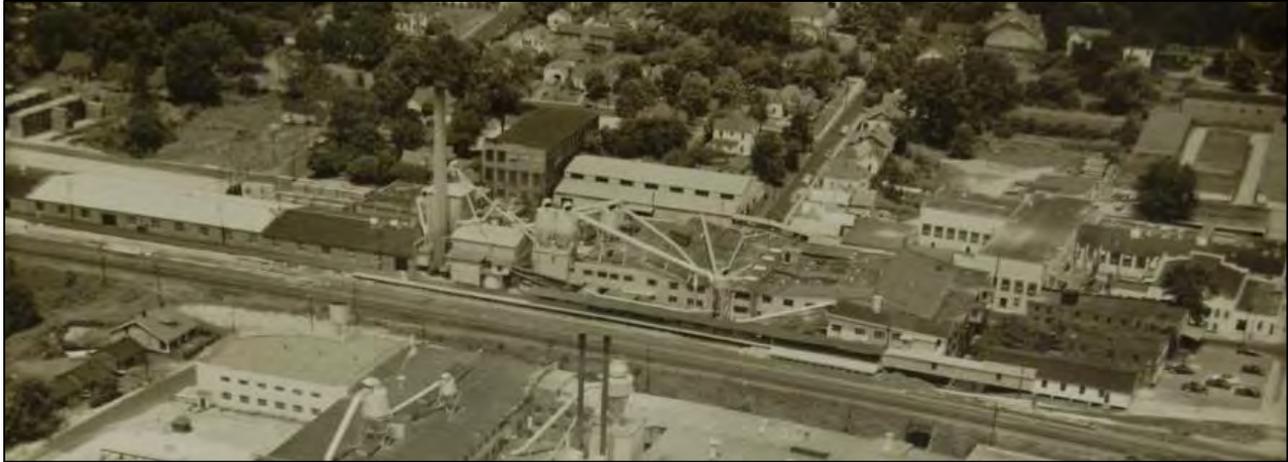
Figure 193: Dixie Furniture Company at top and Elk/United Furniture Company to south of tracks at bottom, mid-1950s (source: Davidson County Historical Museum, H. Lee Waters collection 96.11566)

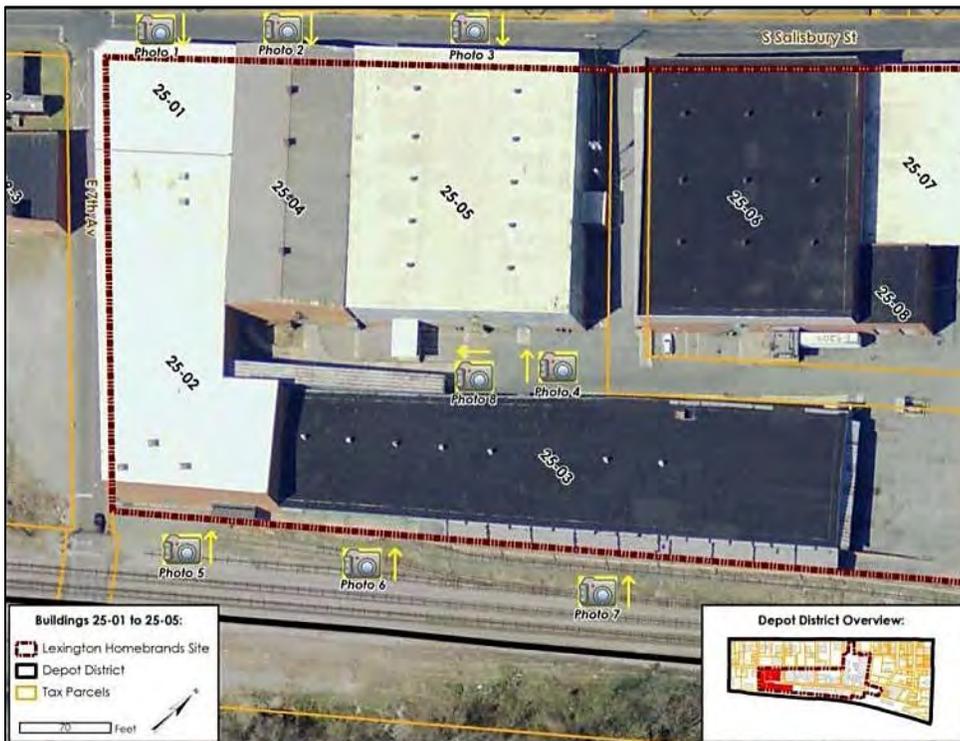
Figure 195: Dixie Furniture Company, Buildings 25-01 to 25-05 (source: Lexington Redevelopment Commission 2010)

According to tax records, this building was erected in 1972. The Sanborn maps updated though 1948 indicate that a house previously occupied its site. A one-story, almost square building with a masonry structural frame, brick veneer, and a flat roof, it was used for storage by Lexington Home Brands. It occupies the southeast corner of the intersection of South Salisbury Street and East 7th Avenue and is attached to the slightly earlier Building 25-02 at its south (Figure 195, Figure 196 and Figure 199).

The site of this L-shaped one-story building, which has a masonry structural frame, brick veneer, and a flat roof, was occupied by two houses and the buildings of the Myers & Carver Cotton Gin company in 1948. According to tax records, it supplanted these buildings in 1967. Its long leg extends along East 7th Avenue; its shorter leg parallels the railroad tracks. Lexington Home Brands used it for storage (Figure 195, Figure 196 and Figure 198).

been built without windows—and, along the tracks, sided with vertical boards pierced by wide sliding doors. It was used by Lexington Home Brands for storage (Figure 195 - Figure 197).

The updated 1948 Sanborn maps depict a house on the site of this two-story building, which was erected, according to tax records, in 1958. Brick-veneer covers all of its masonry structural frame—it appears to never have had windows—and a shallow-peaked, gable-front roof tops it. Lexington Home Brands utilized it for storage (Figure 195, Figure 196 and Figure 200).

The updated 1948 Sanborn maps picture a single house on the site of this building which, according to tax records, was built in 1960. Corrugated metal sides its masonry structural frame, which is two stories tall, shielded by a flat roof, and appears to have always been windowless (Figure 195 - Figure 196 and Figure 201 - Figure 202).

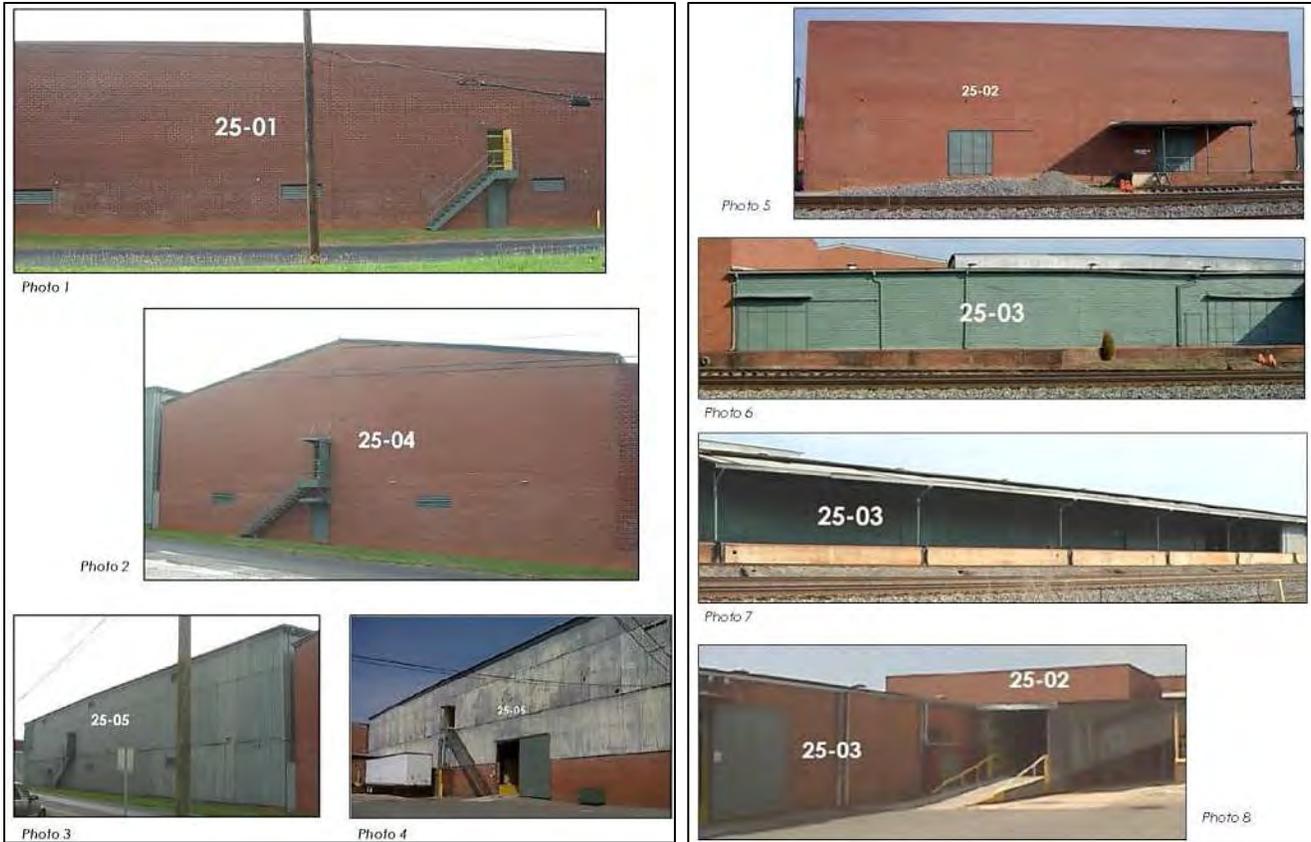
Figure 196: Dixie Furniture Company, Buildings 25-01 to 25-05 (source: Lexington Redevelopment Commission 2010)

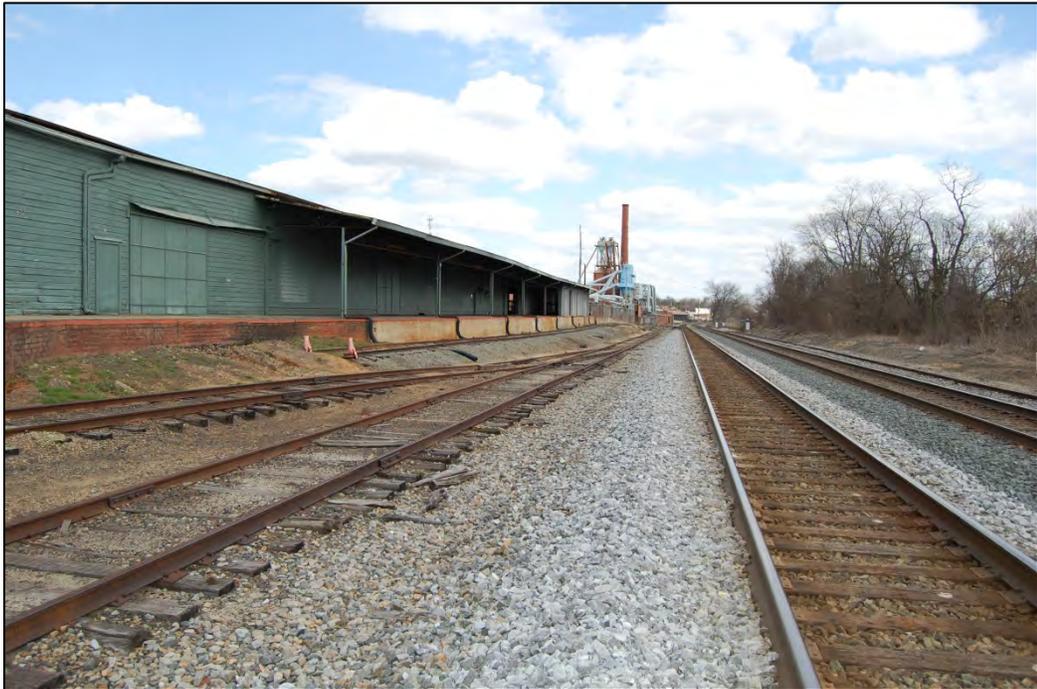
Figure 197: Dixie Furniture Company, railroad (south) elevation of Building 25-03

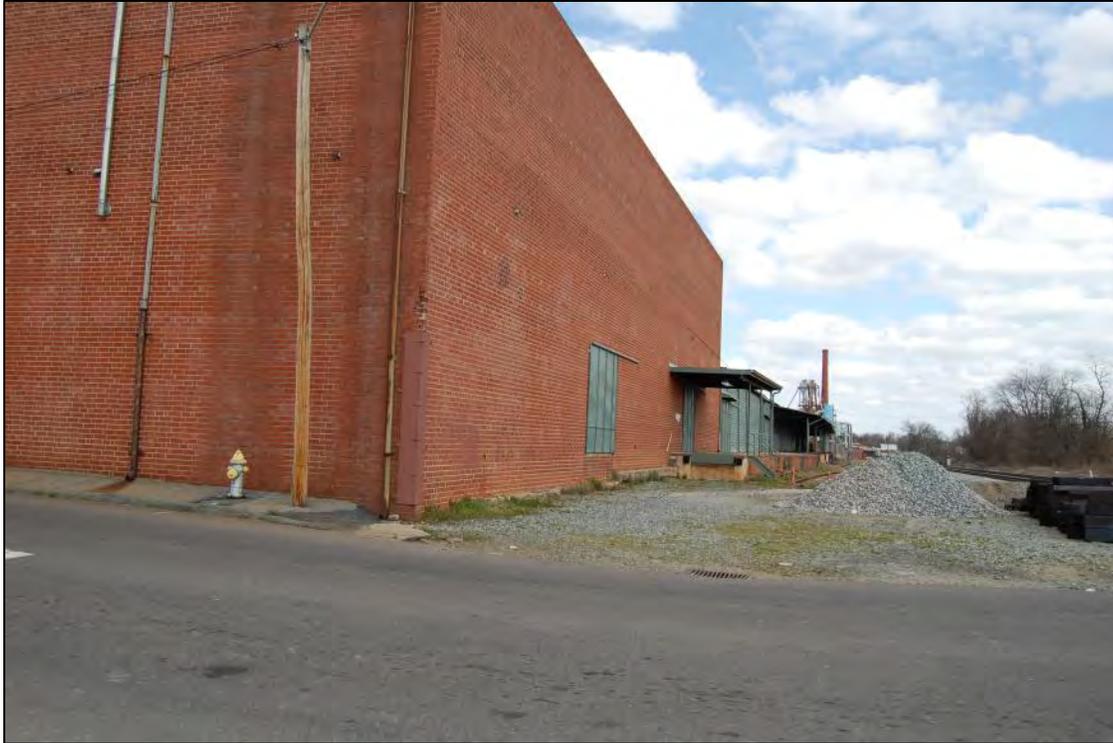
Figure 198: Dixie Furniture Company, East 7th Avenue (west) and railroad track (south) elevations of Building 25-02; lower Building 25-03 extends into distance along tracks

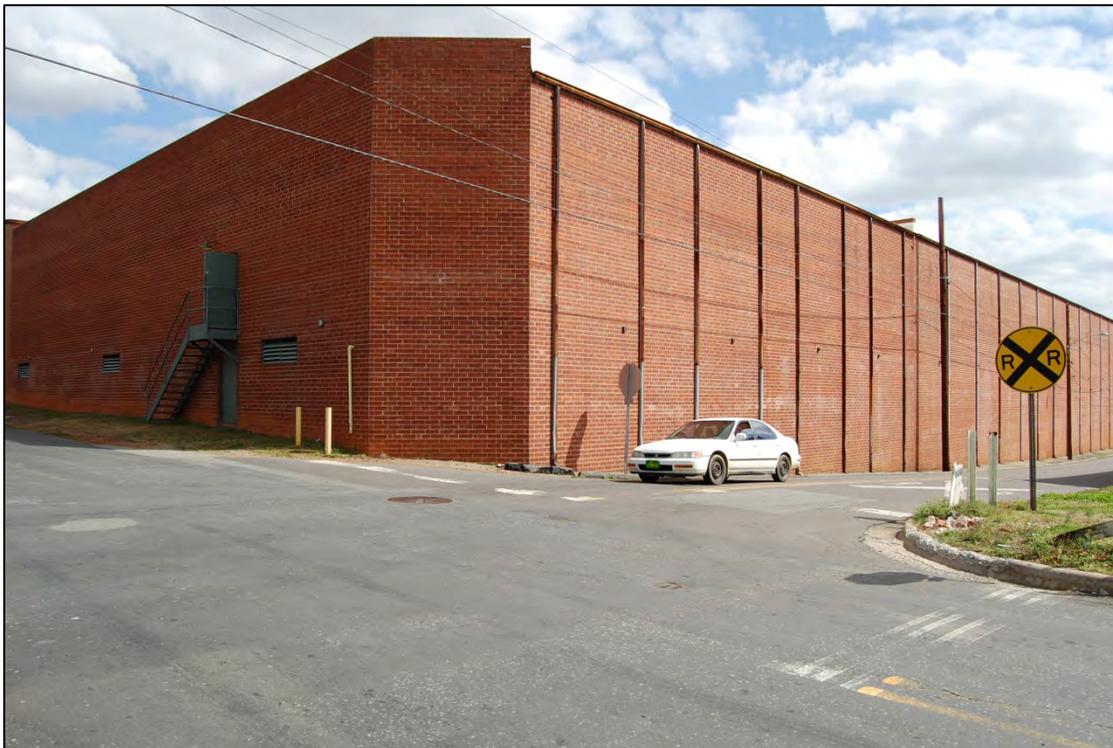
Figure 199: Dixie Furniture Company, South Salisbury Street (north) and East 7th Avenue (west) elevations of Building 25-01 at left and center; 7th Avenue elevation of Building 25-02 at right behind railroad crossing sign

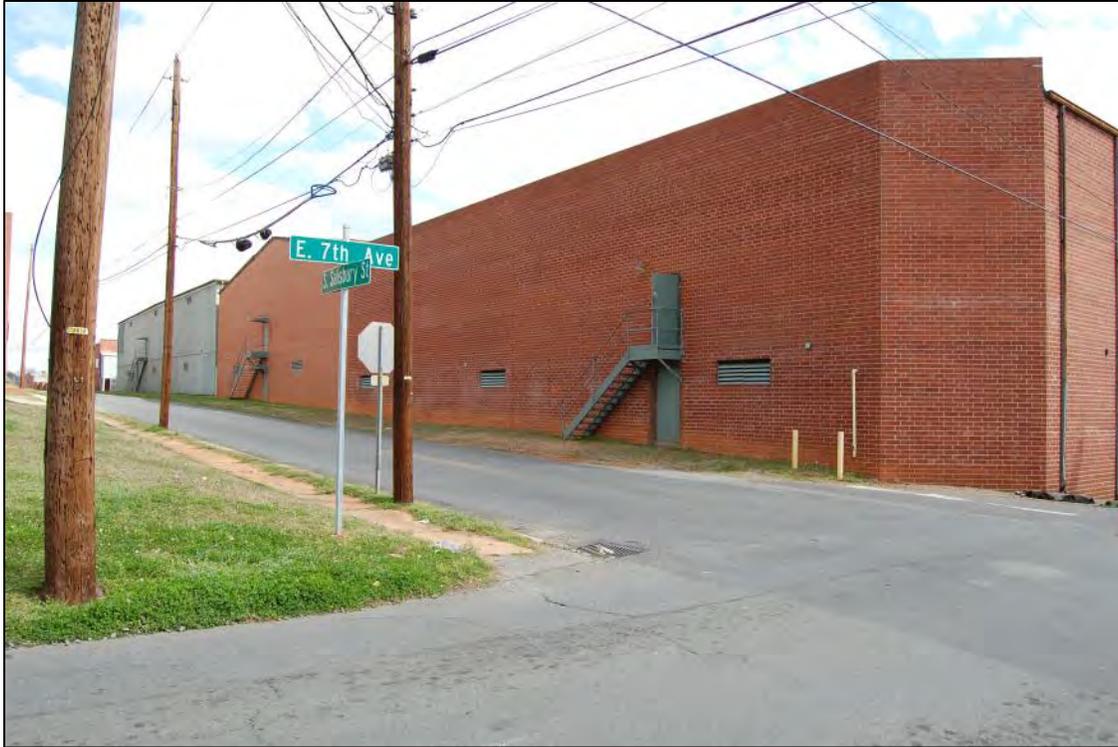
Figure 200: Dixie Furniture Company, south side of South Salisbury Street between East 7th Avenue and East 6th Avenue with Building 25-01 at right, Building 25-04 at left center behind street sign, and Building 25-05 at far left

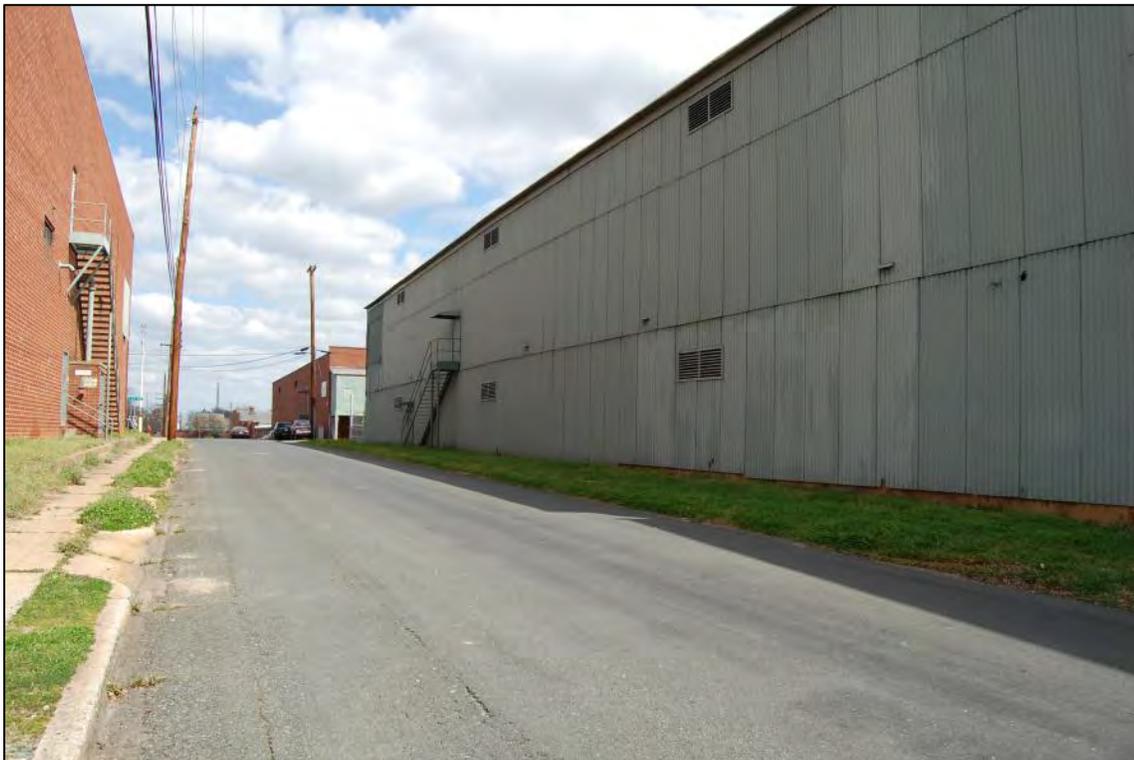
Figure 201: Dixie Furniture Company, South Salisbury Street elevation of Building 25-05 at right with Building 25-06 beyond at center left

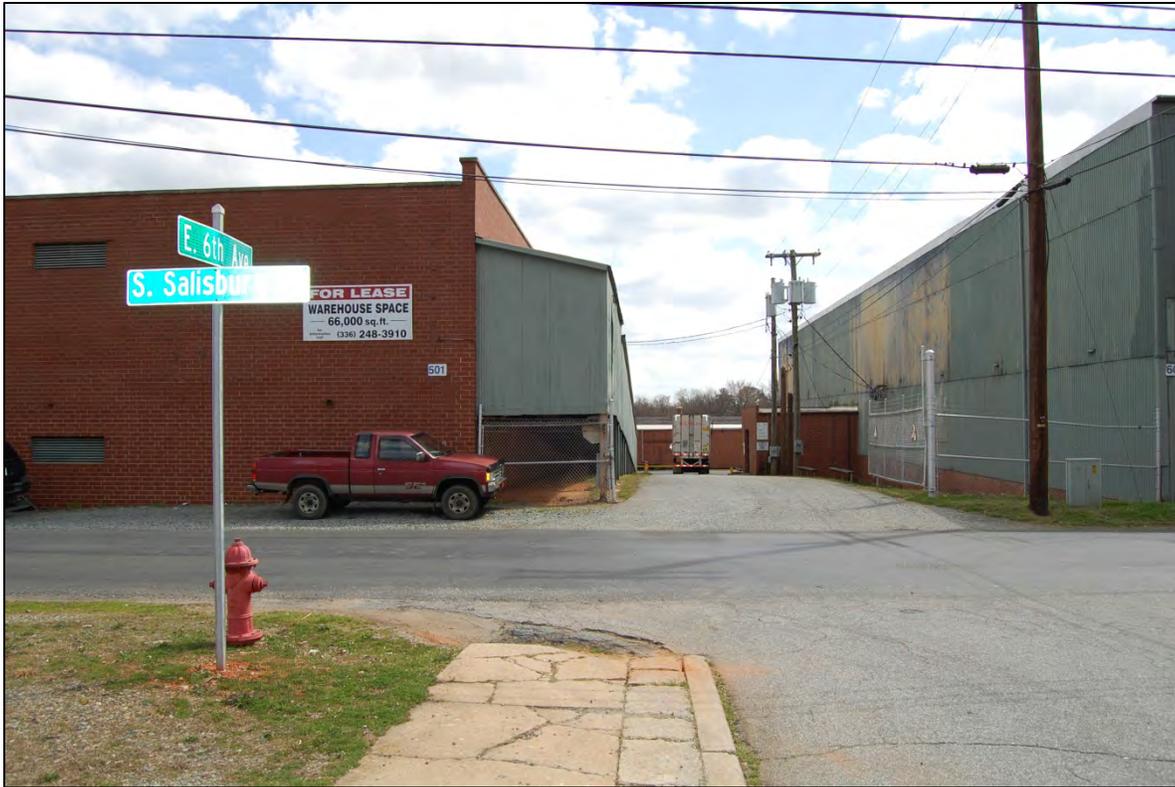
Figure 202: Dixie Furniture Company, East 6th Avenue elevation of Building 25-05 at right; East 6th Avenue and South Salisbury Street elevations of Building 25-06 at left

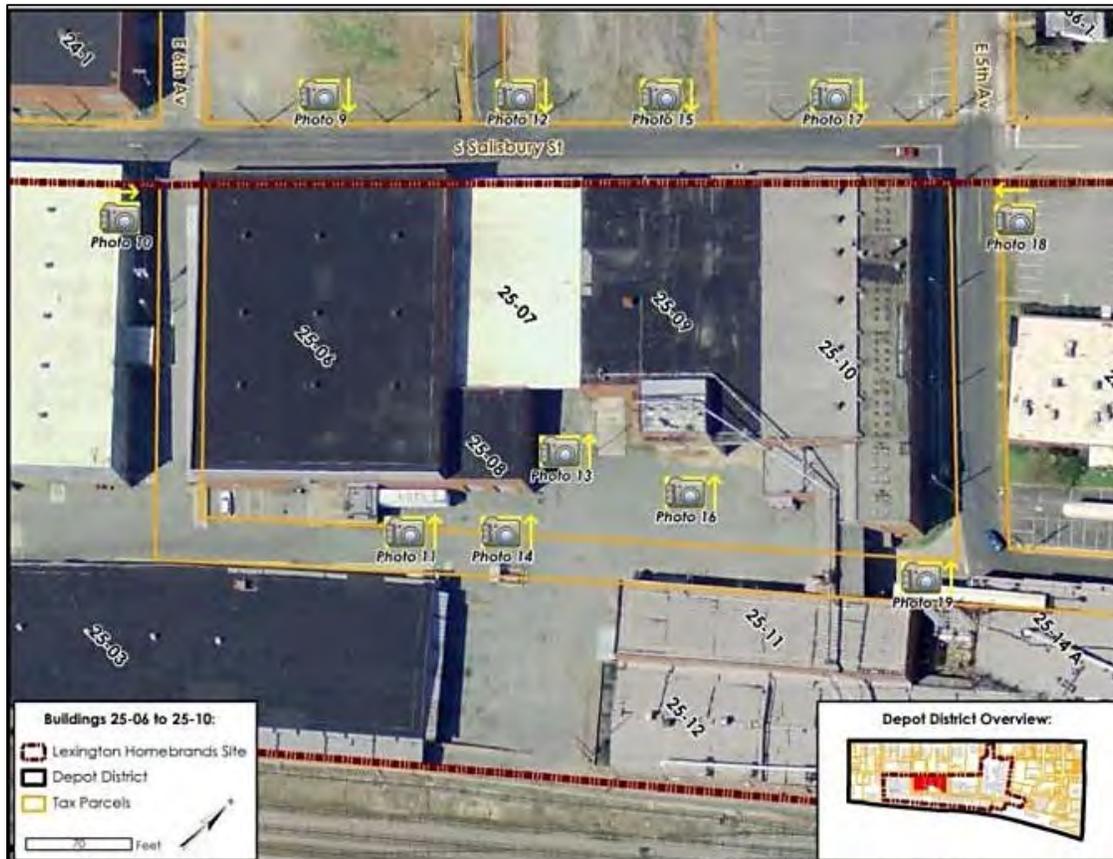
Figure 203: Dixie Furniture Company, Buildings 25-06 to 25-10 (source: Lexington Redevelopment Commission 2010)

This two-story, masonry-structural-frame, brick-veneered building, which appears to never have had windows, rose in 1962, according to tax records, upon a site that was occupied by a single house in 1948. A nearly square building almost identical in size to Building 25-05 to its west, it was used by Lexington Home Brands to store finished furniture products (Figure 203 - Figure 205).

This relatively small building, which has a masonry structural frame, bricked-veneered walls without windows, and a flat roof, was erected, according to tax records, in 1980. In 1948 a house stood on its site. Lexington Home Brands used it for vehicle and equipment storage (Figure 203 and Figure 204).

This small building, which was erected in 1969 according to tax records, occupies the 1948 site of the backyard of a house. A one-story building with a masonry structural frame, brick-veneered windowless walls, and a flat roof, it was used by Lexington Home Brands for vehicle storage, matching the use of Building 25-07 to which it is attached on the north (Figure 203 and Figure 204).

erected in 1966. The building, topped by a flat roof, was used for processing wood by Lexington Home Brands (Figure 203 and Figure 204).

The site of this building was occupied by four houses in 1948. It is one and two stories tall and was used by Lexington Home Brands as a warehouse and a wood kiln. This suggests two different building periods which, according to tax records, both took place in 1962. It has a masonry structural frame, brick veneer never pierced by windows, and a flat roof (Figure 203, Figure 204 and Figure 206).

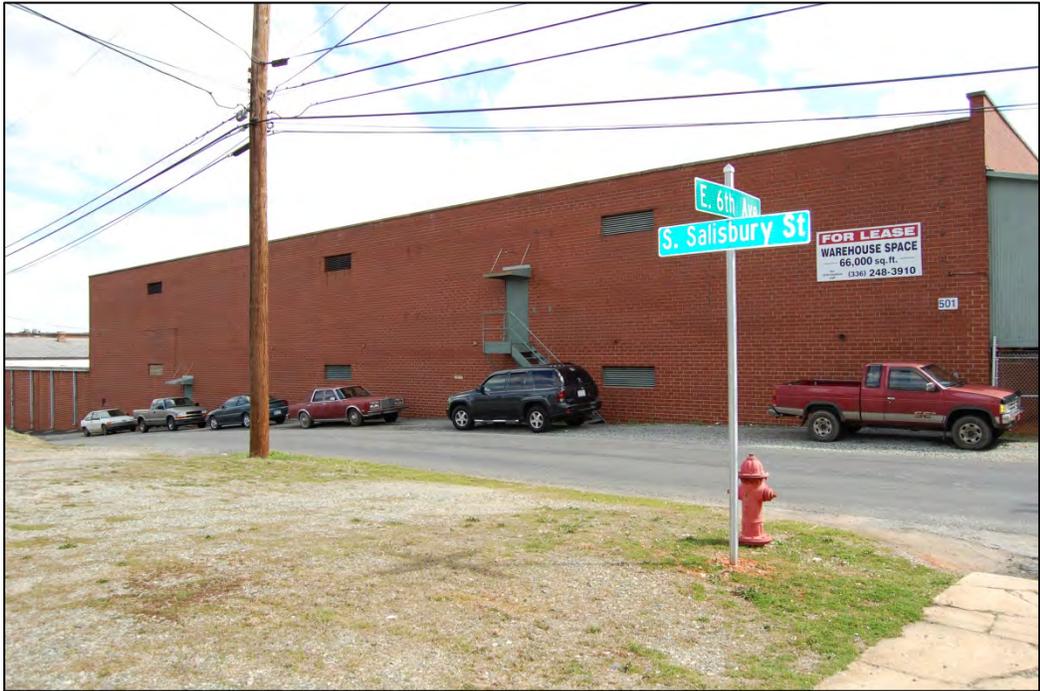
Figure 205: Dixie Furniture Company, East 6th Avenue elevation of Building 25-06

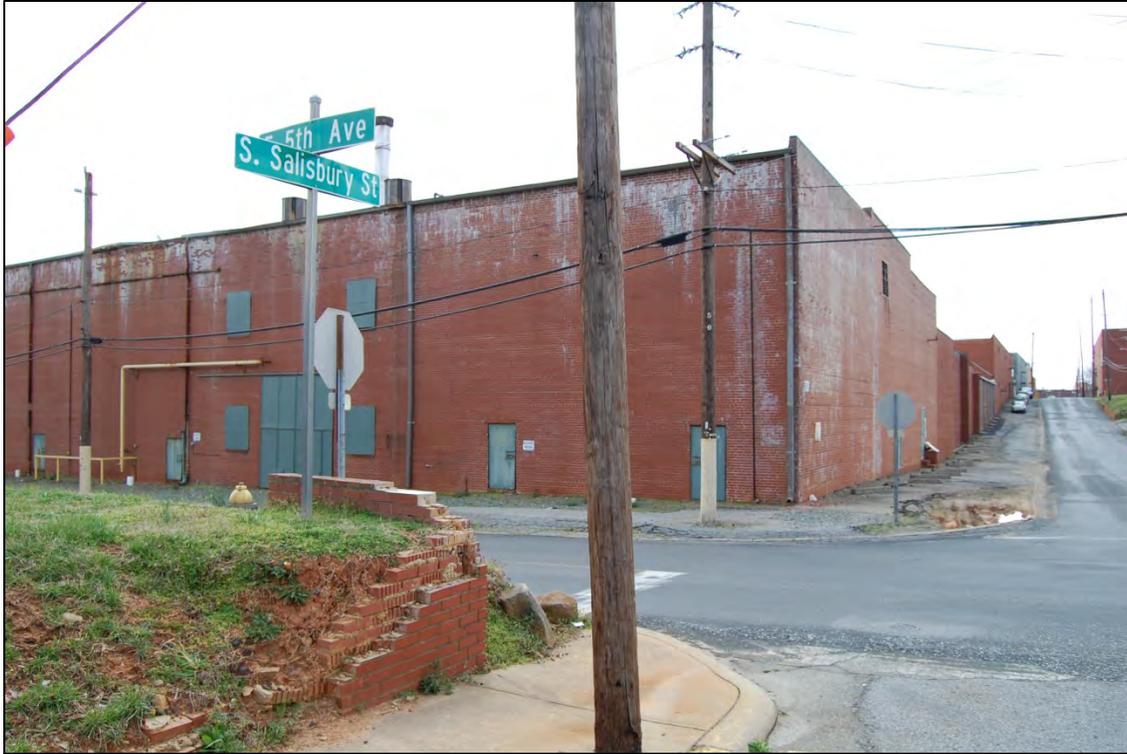
Figure 206: Dixie Furniture Company, East 5th Avenue and South Salisbury Street elevations of Building 25-10 at left; shorter Building 25-09 stands immediately to right of 25-10 and, just beyond, are the projecting metal garage doors of Building 29-07

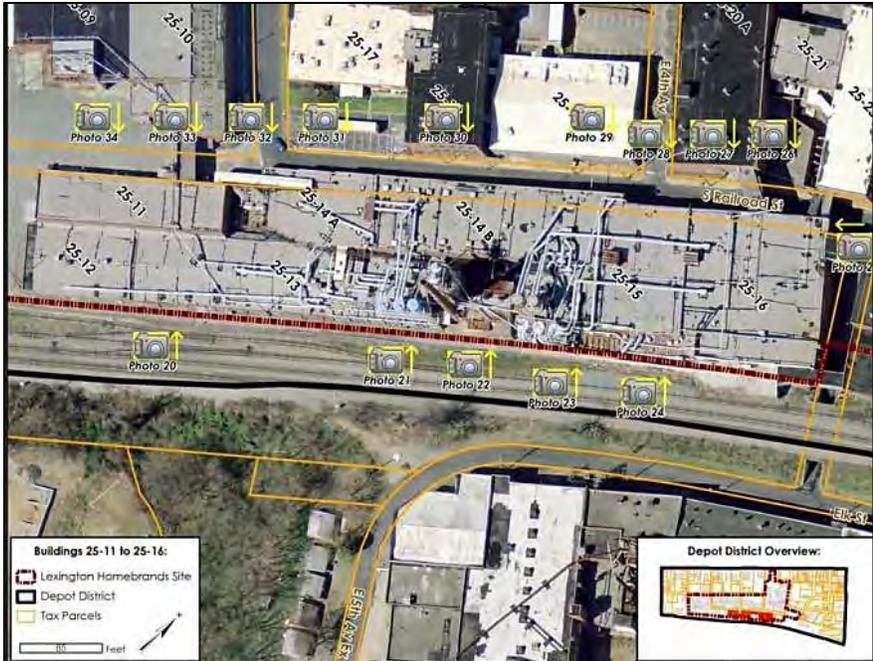
Figure 207: Dixie Furniture Company, Buildings 25-11 to 25-16 (source: Lexington Redevelopment Commission 2010)

This two-story building, which has a masonry structural frame, brick-veneered walls that still retain long casement windows, and a flat roof, was erected in 1953, according to tax records. Its site was an empty lot in 1948. Lexington Home Brands stored wood parts in it (Figure 207 - Figure 210).

This one-story building, which has a masonry structural frame, brick-veneered walls and, at its south elevation facing the tracks, large door or window bays, was erected in 1952 according to tax records. In 1948 its site was an empty lot. Lexington Home Brands used it for woodworking (Figure 207 - Figure 209).

According to tax records, this one-story building was constructed in 1950. It has a masonry structural frame, a flat roof and, facing the tracks, brick veneering and large door or window bays. Its site in 1948 was an empty lot. Lexington Home Brands used it for wood sanding (Figure 207 - Figure 209 and Figure 211).

of a one-story, frame kiln built by the drawing of the 1902 Sanborn. This likely burned in a 1904 fire and was replaced, by 1907 Sanborn by a one-story kiln built of brick, which also appears on the 1913 Sanborn. By 1923 a second kiln of equal size but uncertain material was added to the front (north) of the kiln along Railroad Street. These paired buildings are also marked as kilns on the 1948 Sanborn updated map. They were likely supplanted about 1950—the date assigned by tax records—by the current two-story, masonry-structural-framed, flat-roofed building that Lexington Home Brands used for woodworking. Its brick-veneered walls are pierced by regular rows of ventilated openings. At the rear (south) of this woodworking building is a one-story ell that Lexington Home Brands used as an engine house. This ell was erected between the drawing of the 1929 Sanborn map and its 1948 updating. A freestanding, concrete-block, partially brick-veneered building immediately to its west, also added between 1929 and 1948, held the boilers. Immediately to its west, also likely built between 1929 and 1948, is a soaring brick chimney stack bearing the words “Dixie” in large capital letters. The stack is the most visible feature of the entire complex. The complex’s second most visible feature—aside, perhaps, from its sheer extent and bulk—is the dust collection system on the roof. To the east of the stack are three cyclone separators served by an extensive system of outsized ductwork. To the west are three additional cyclone separators connected to less monumental ductwork. A cyclone separator uses centrifugal force to remove particulate matter—such as wood dust at furniture factories or cotton fibers at textile mills—from industrial facilities. They date back to at least the turn of the century (Hexamer 1905:216; Turner 1926:730). An earlier dust removal system is visible on aerial photographs from the 1950s (Figure 193, which also depicts cyclone separators atop the buildings of the United Furniture Company). The current system probably dates from the 1960s or 1970s (Figure 207 - Figure 209 and Figure 212).

This building stands on the site of earlier buildings, but was likely erected in only one or at most two construction episodes. The portion adjacent to Building 25-14 partially occupies the site of a two-story, frame building erected in part by 1902. This likely burned in the 1904 fire and was replaced by 1907 Sanborn by a metal-clad, frame building on the same footprint. This building in turn was expanded to the east between 1923 and 1929. By 1948 that entire building had likely been replaced and greatly enlarged to the east where it connects with Building 25-16. It is a masonry-structural-framed, flat-roofed building with brick-veneered walls pierced by regular rows of ventilated openings. The building was used for woodworking, bench work, and gluing in 1948. Lexington Home Brands utilized it for woodworking, gluing, and cutting (Figure 207 - Figure 209 and Figure 213).

This building was erected in two or three sections. The portion adjacent to Building 25-15 stands on the site of a building erected by 1902 and likely replaced after the fire of 1904. Tax records assign it a construction date of 1905, but that building is no longer extant. This western portion of the building likely dates between 1913 and 1923; its many changes make it difficult to pinpoint its date of construction through the Sanborn maps. It was further expanded by additions to the east and south between 1923 and 1929. In 1929 it housed Dixie’s packing and finishing and the spray painting departments and by 1948 it was additionally used for storage. It is a two-story building with a masonry structural frame and a flat roof. Its brick-veneered walls are pierced by regular rows of ventilated openings (Figure 207 - Figure 209 and Figure 214 - Figure 215).

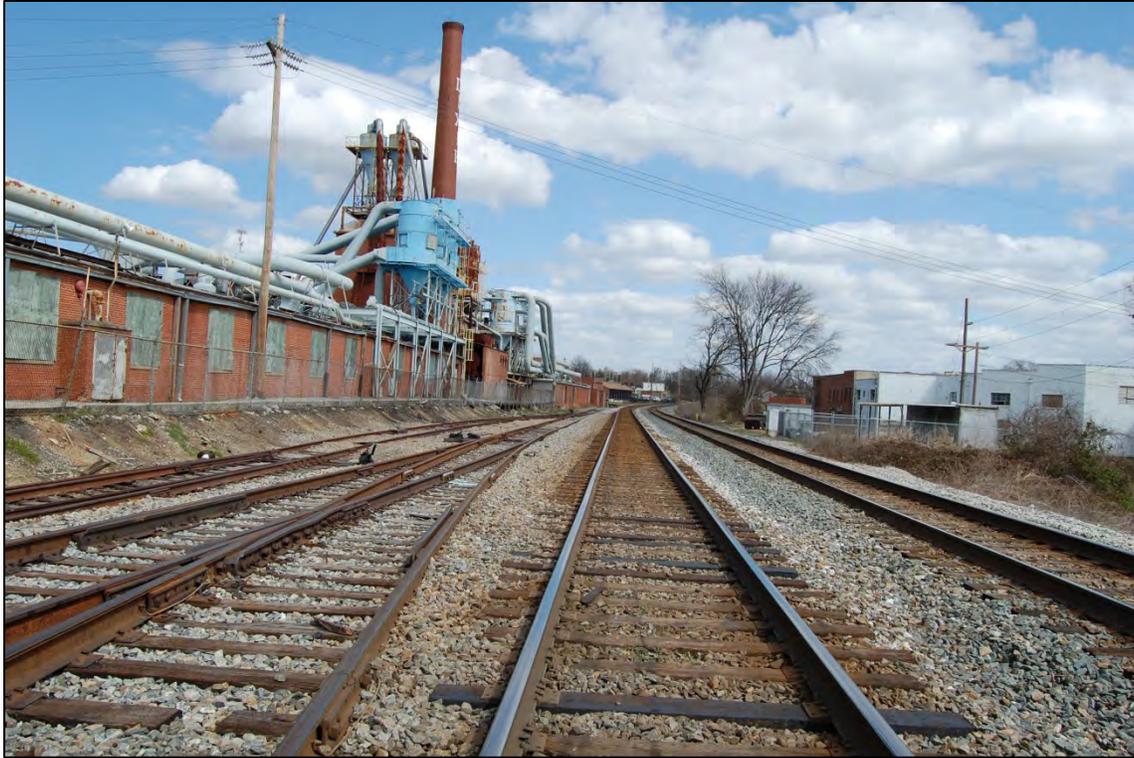
Figure 211: Dixie Furniture Company, railroad (south) elevation of Building 25-13 at left

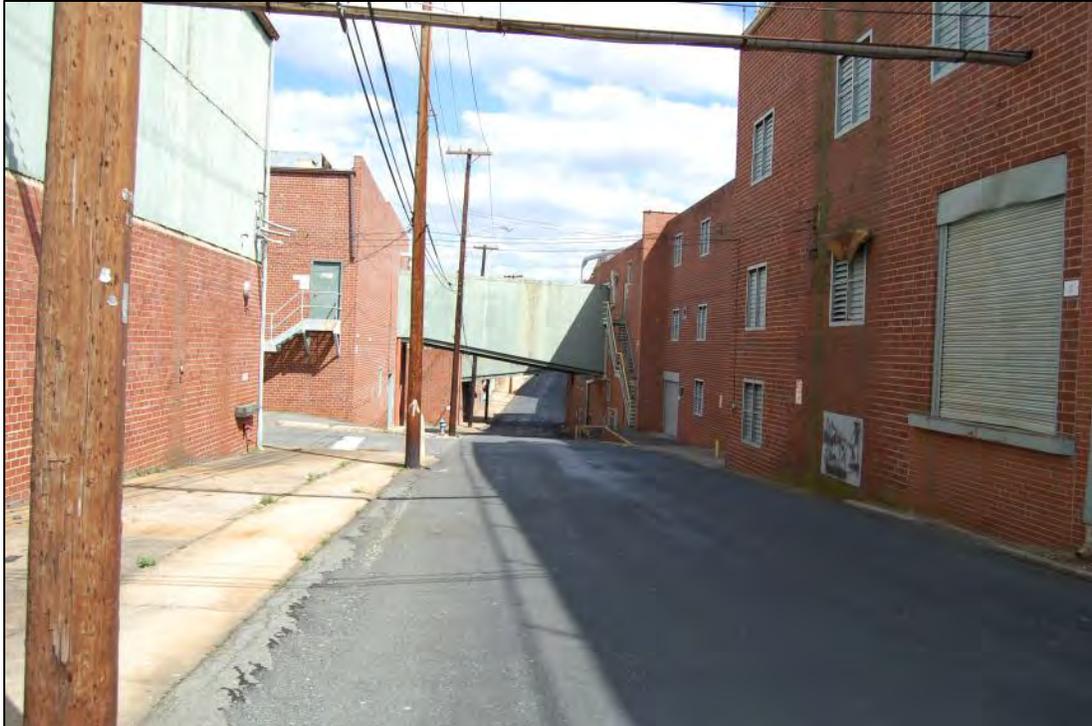
Figure 213: Dixie Furniture Company, looking east on Railroad Street at north elevation of Building 25-15 at right and south elevation of Building 25-19 at left; beyond, connected by an overhead passage, are Building 25-16 on right and Building 25-20 at left

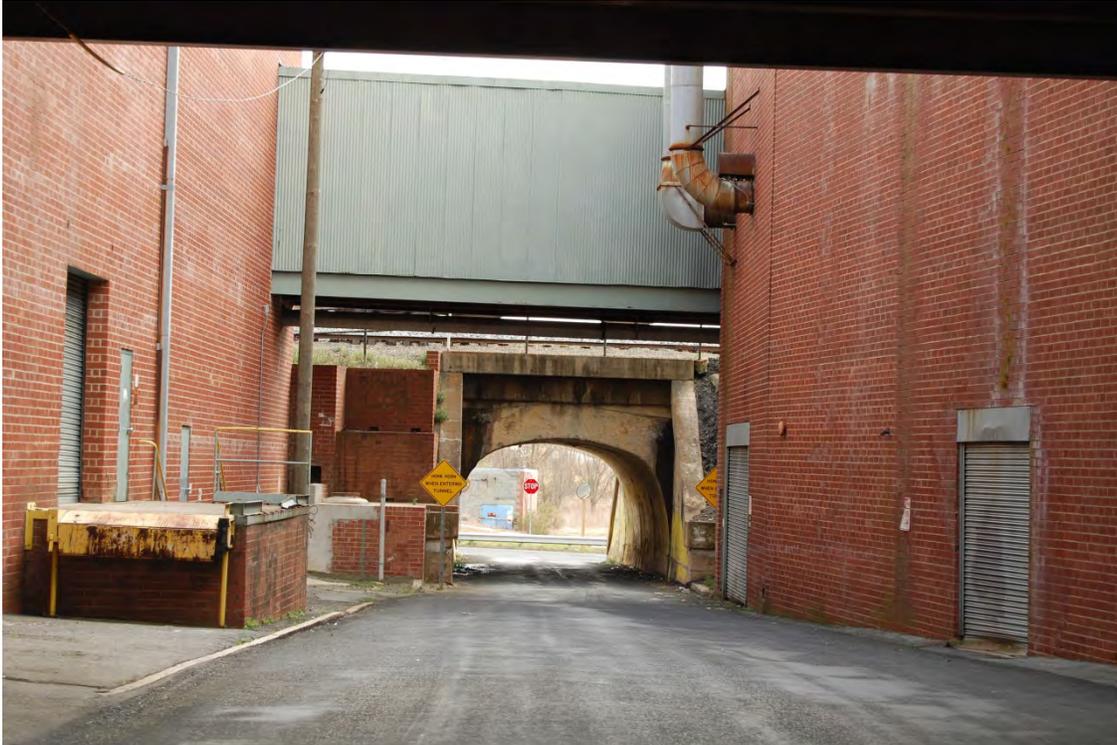
Figure 215: Dixie Furniture Company, looking south down Elk Street connector from Railroad Street toward concrete railroad underpass with Building 25-16 at the right and Building 25-28A at the left

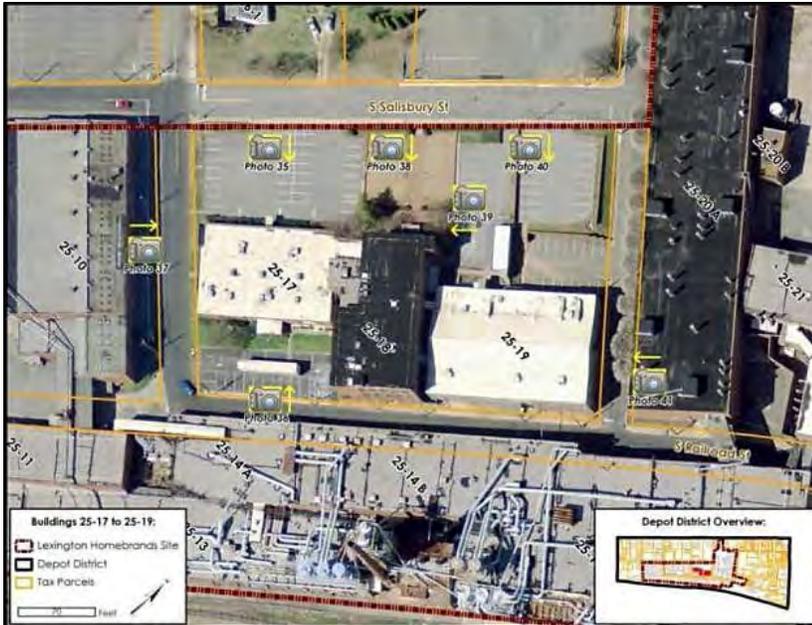
Figure 216: Dixie Furniture Company, Buildings 25-17 to 25-19 (source: Lexington Redevelopment Commission 2010)

In 1948 two houses stood on the site of this building which, according to tax records, was constructed in 1962. It is a one-story, masonry structural framed, flat-roofed building that was used by Lexington Home Brands as an office and showrooms. Its brick-veneered walls appear to have always been broken by only a few entries and bays (Figure 216 - Figure 218).

The Mountcastle Knitting Company factory was opened in late 1928. In the early or mid-1950s, the Dixie Furniture Company acquired the former factory building, as part of its rapid post-war expansion in the area, and converted it into offices and showrooms. The company hired the High Point architecture firm of Voorhees and Everhart to add a Modernist, curtain-wall façade to the building's north-facing elevation. The building is recommended as individually eligible for National Register listing. More information on it and additional images can be found above at its individual entry (URS survey #7A) (Figure 216 - Figure 217 and Figure 219 - Figure 220).

This building was erected—in 1950 according to tax records—on a lot that in 1948 held a house and outbuildings. A two-story, masonry-structural-frame building topped by a slightly peaked gabled roof, it is sided with corrugated asbestos and brick veneer. The veneer once had more openings, which were subsequently bricked in. It held office space for Lexington Home Brands (Figure 216, Figure 217 and Figure 220).
