**HEDRICK BLOCK (URS survey #18A)
211-215 South Main Street**

Recommendation and Boundaries

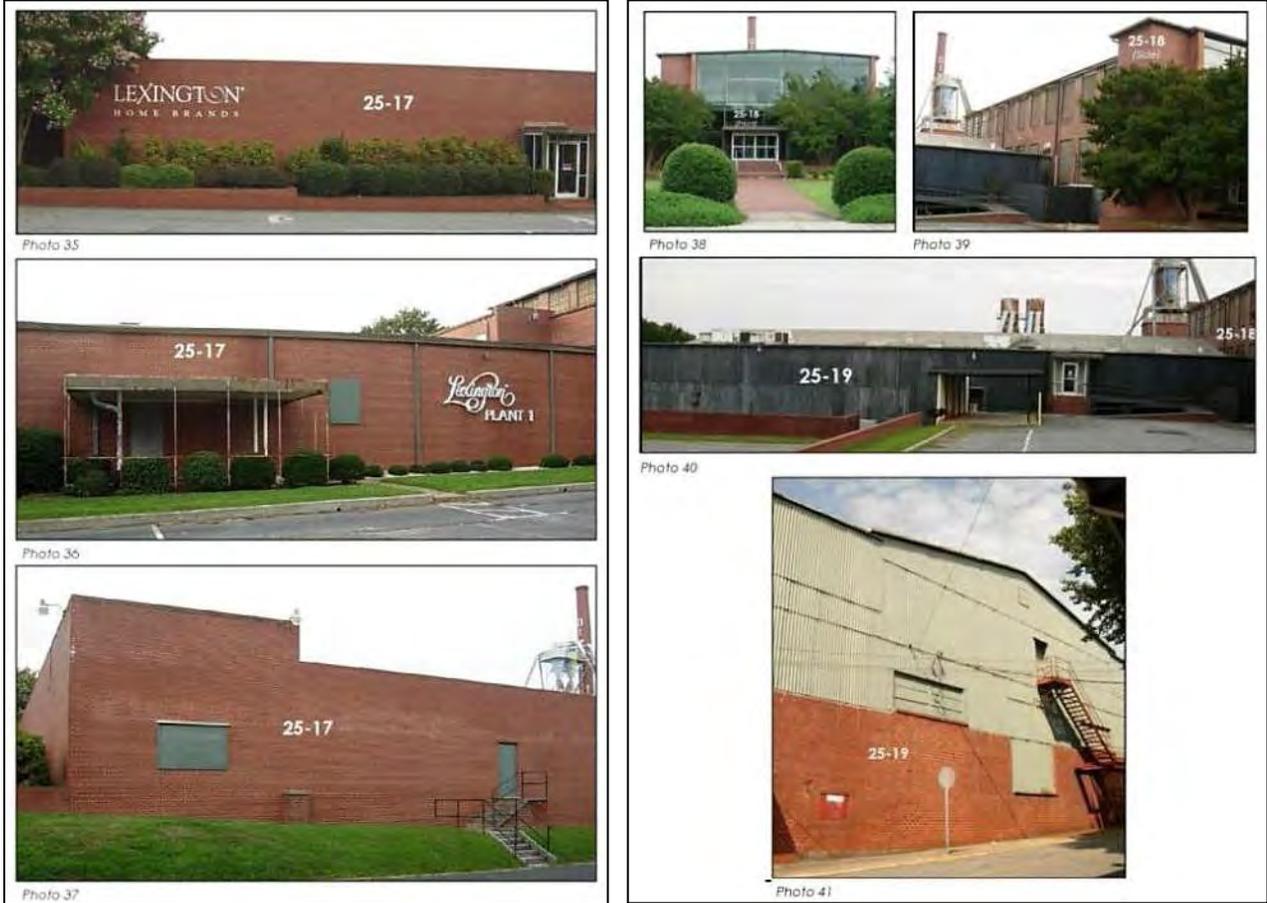
Figure 217: Dixie Furniture Company, Buildings 25-17 to 25-19 (source: Lexington Redevelopment Commission 2010)

In 1948 two houses stood on the site of this building which, according to tax records, was constructed in 1962. It is a one-story, masonry structural framed, flat-roofed building that was used by Lexington Home Brands as an office and showrooms. Its brick-veneered walls appear to have always been broken by only a few entries and bays (Figure 216 - Figure 218).

The Mountcastle Knitting Company factory was opened in late 1928. In the early or mid-1950s, the Dixie Furniture Company acquired the former factory building, as part of its rapid post-war expansion in the area, and converted it into offices and showrooms. The company hired the High Point architecture firm of Voorhees and Everhart to add a Modernist, curtain-wall façade to the building's north-facing elevation. The building is recommended as individually eligible for National Register listing. More information on it and additional images can be found above at its individual entry (URS survey #7A) (Figure 216 - Figure 217 and Figure 219 - Figure 220).

This building was erected—in 1950 according to tax records—on a lot that in 1948 held a house and outbuildings. A two-story, masonry-structural-frame building topped by a slightly peaked gabled roof, it is sided with corrugated asbestos and brick veneer. The veneer once had more openings, which were subsequently bricked in. It held office space for Lexington Home Brands (Figure 216, Figure 217 and Figure 220).

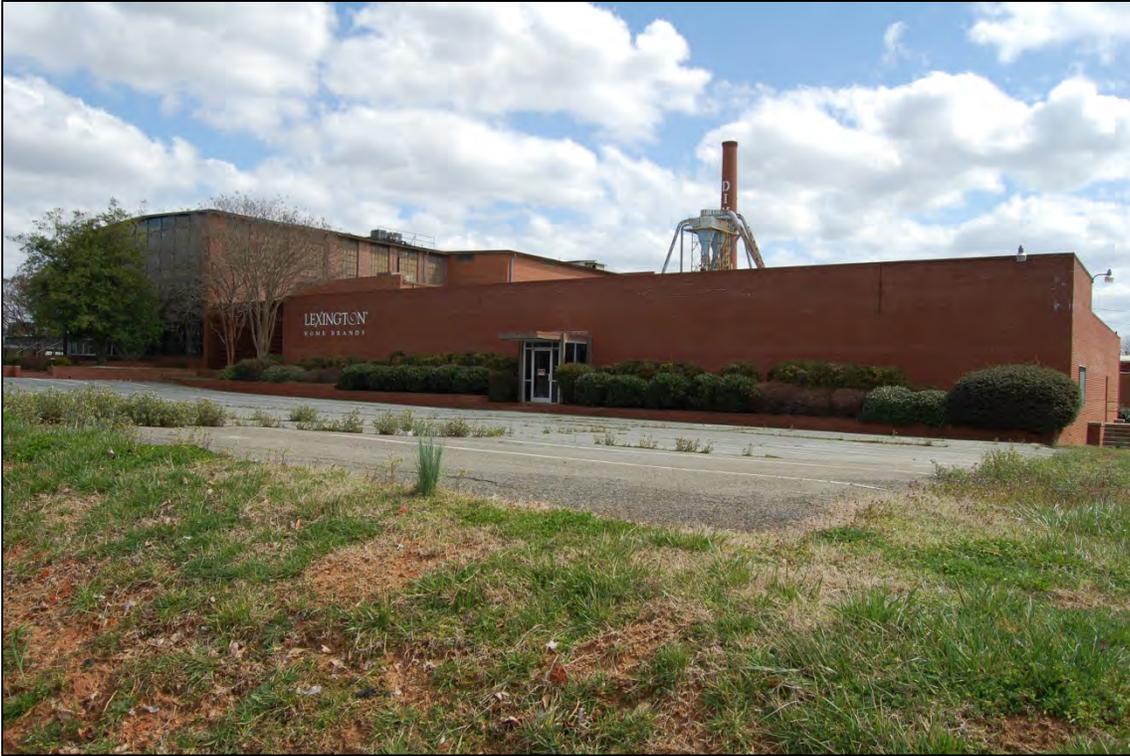
Figure 218: Dixie Furniture Company, South Salisbury Street elevations of Building 25-17 at right and Building 25-18 at left

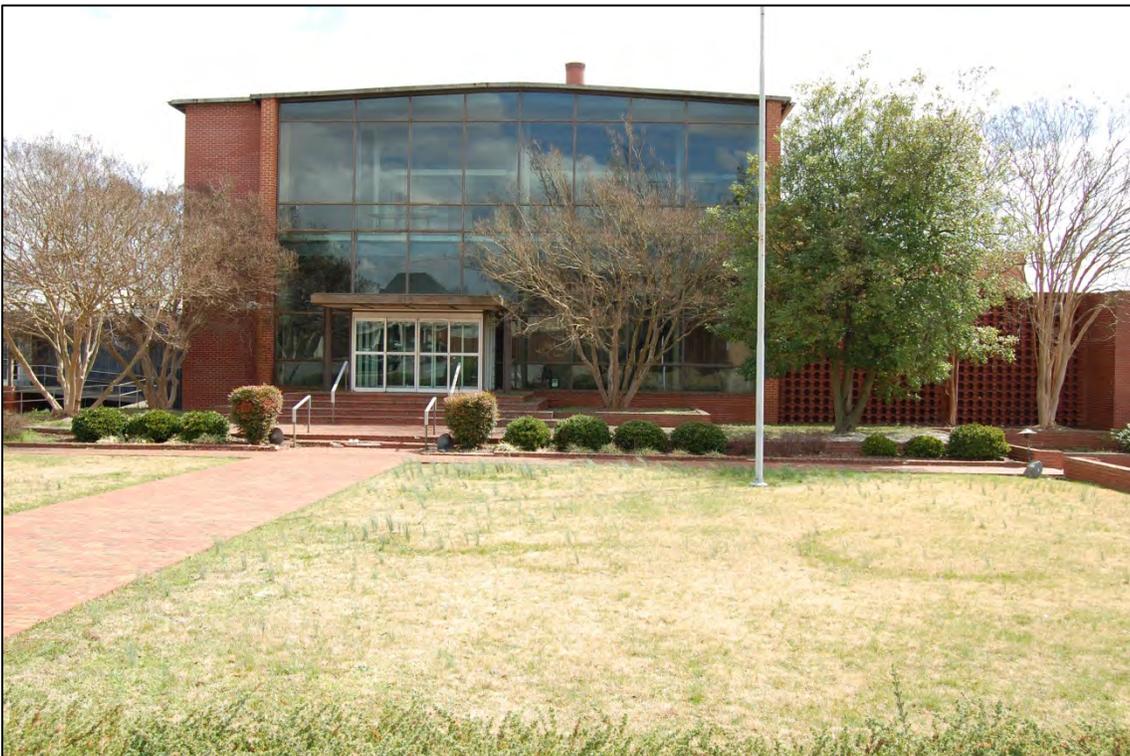
Figure 219: Dixie Furniture Company, Building 25-18 façade at South Salisbury Street

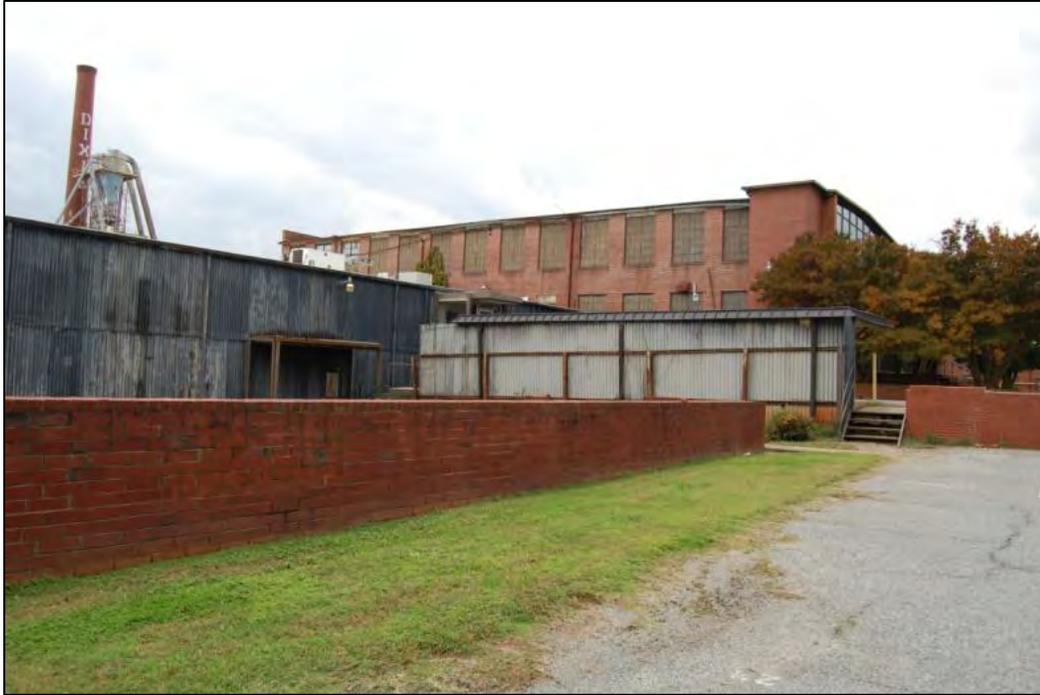
Figure 220: Dixie Furniture Company, east side elevation of Building 25-18 at right and north elevation of Building 25-19 at left

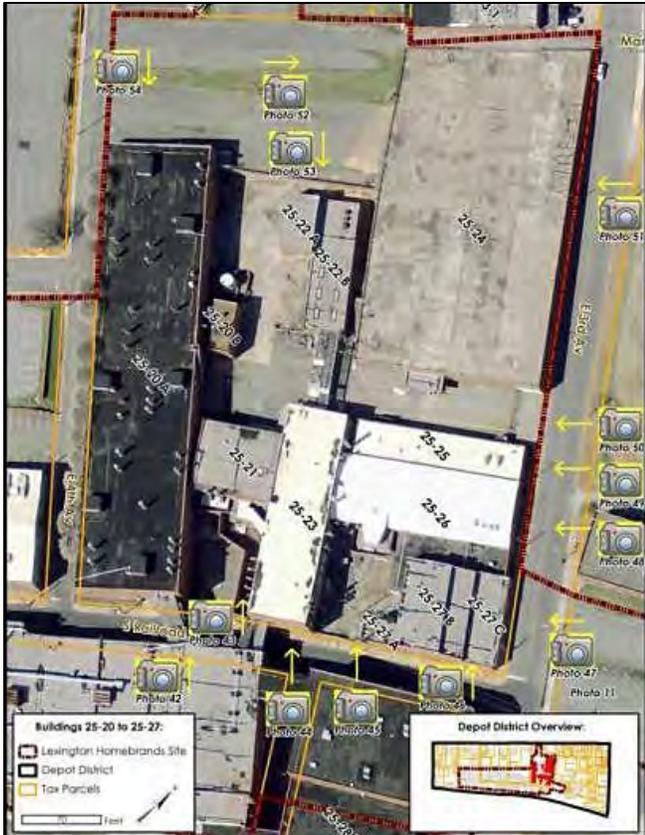
Figure 221: Dixie Furniture Company, Buildings 25-20 to 25-27 (source: Lexington Redevelopment Commission 2010)

Between 1913 and 1923, on a vacant tract of land, the Shoaf-Sink Hosiery Mill Company erected this building. It housed their entire operation—a large knitting room and a small office, a dye room, and a “boarding room”. By 1929 Shoaf-Sink had added Building 25-21 to the west side of this building and a separate boiler room, which was removed and replaced by 1949 by Dixie Furniture and now provides part of the site for Building 25-22. Dixie added a second story to the southern end of the knitting factory building and clerestory windows, perhaps in 1935, the date of construction assigned by tax records. It subsequently added a third story. Dixie utilized the space in 1948 for paint spraying. Lexington Home Brands used it as a finishing plant. The building has a masonry structural frame, flat roof, and brick-veneer cladding. The second-story windows at its east side elevation remain largely in place. Those at its south elevation on Railroad Street have been bricked. The various colors of brick veneer and infill on this elevation reflect the building’s various building periods (Figure 221 - Figure 225 and Figure 227).

This building was erected—in 1969, according to tax records—on the 1948 site of three large sheds of unspecified use. The largest single building in the complex, it is one-story tall and has a masonry structural frame clad in brick veneer that is broken only by a few scattered bays. Its pre-stressed concrete roof was built strong enough to support a parking deck. It was used by Lexington Home Brands as a storage building and for parking (Figure 221 - Figure 225).

The North Carolina Candy Company erected a factory on this site between 1919, when the company was founded, and 1923. That building burned and was replaced in 1929 by the current building, which likely retains much of the first building’s walls. The Dixie Furniture Company acquired it after 1948 and utilized it as a finishing plant. The main central block of the brick building is two-stories tall with segmental-arched windows. One-story sections flank it to east and west. The building is recommended as individually eligible for National Register listing. More information on it and additional images can be found above at its individual entry (URS survey #7B). (Figure 221 - Figure 225 and Figure 230).

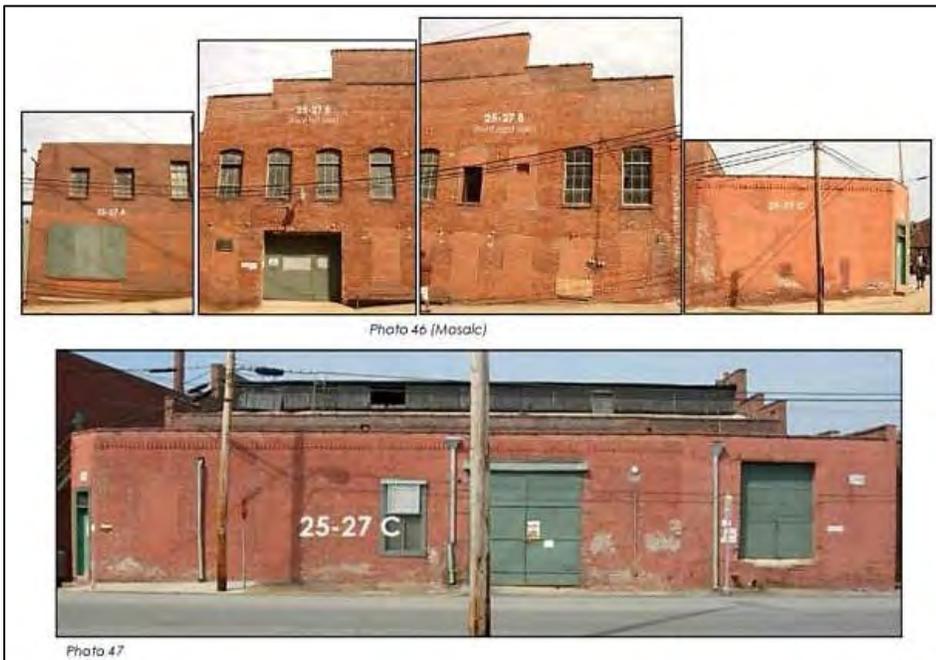
Figure 222: Dixie Furniture Company, Buildings 25-20 to 25-27 (source: Lexington Redevelopment Commission 2010)

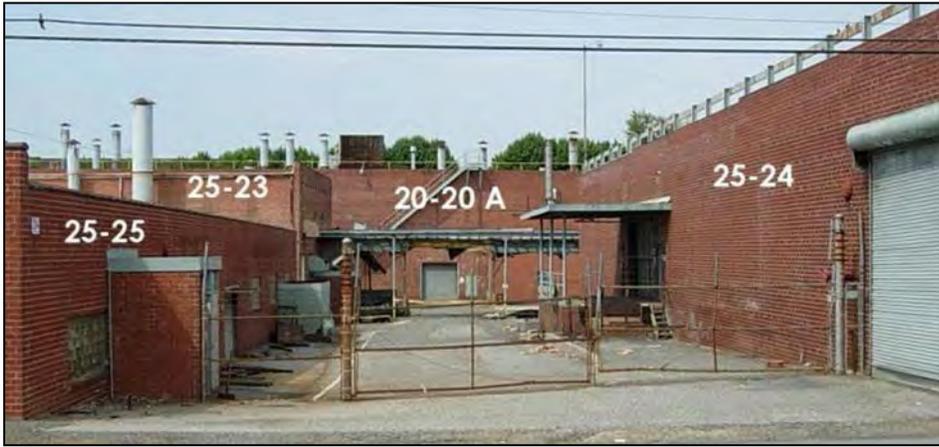
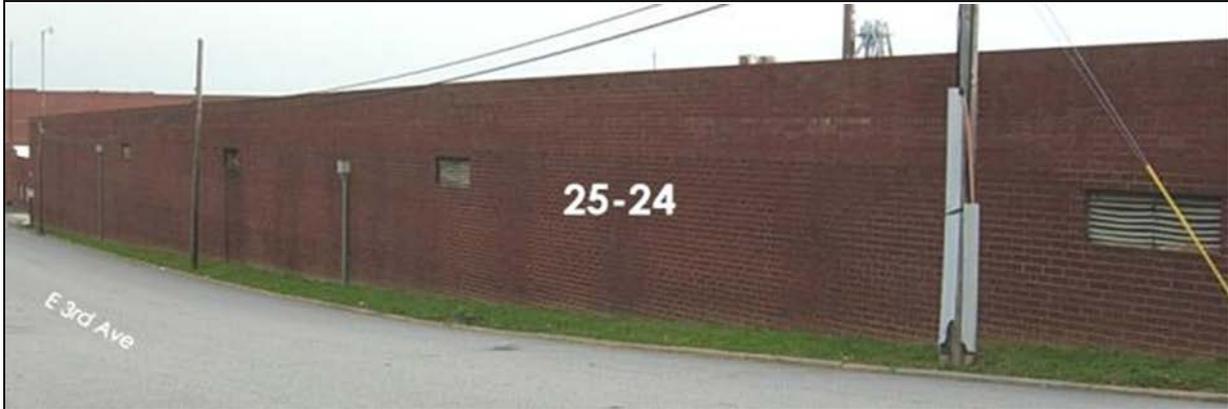
Figure 224: Dixie Furniture Company, Buildings 25-20 to 25-27 (source: Lexington Redevelopment Commission 2010)

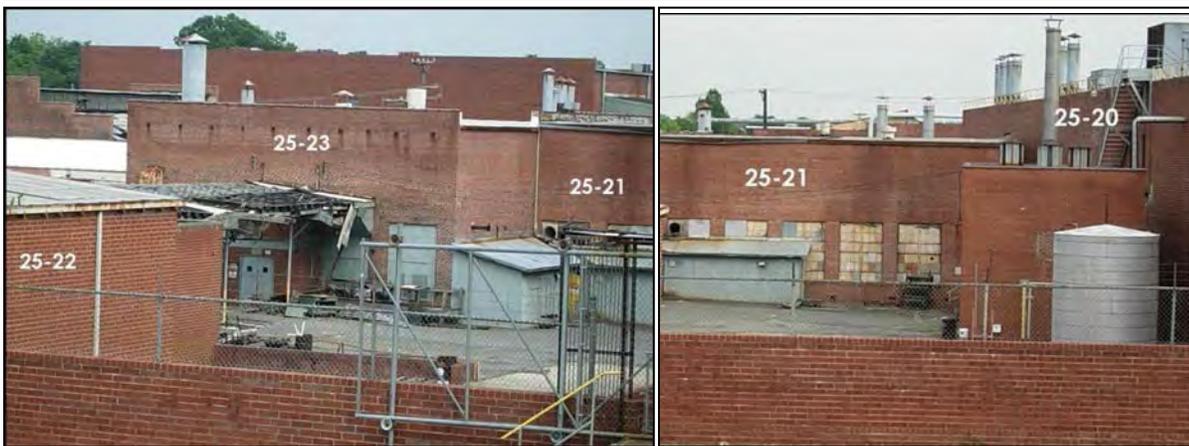
Photo 53 (Mosaic)

Figure 225: Dixie Furniture Company, Buildings 25-20 to 25-27 (source: Lexington Redevelopment Commission 2010)

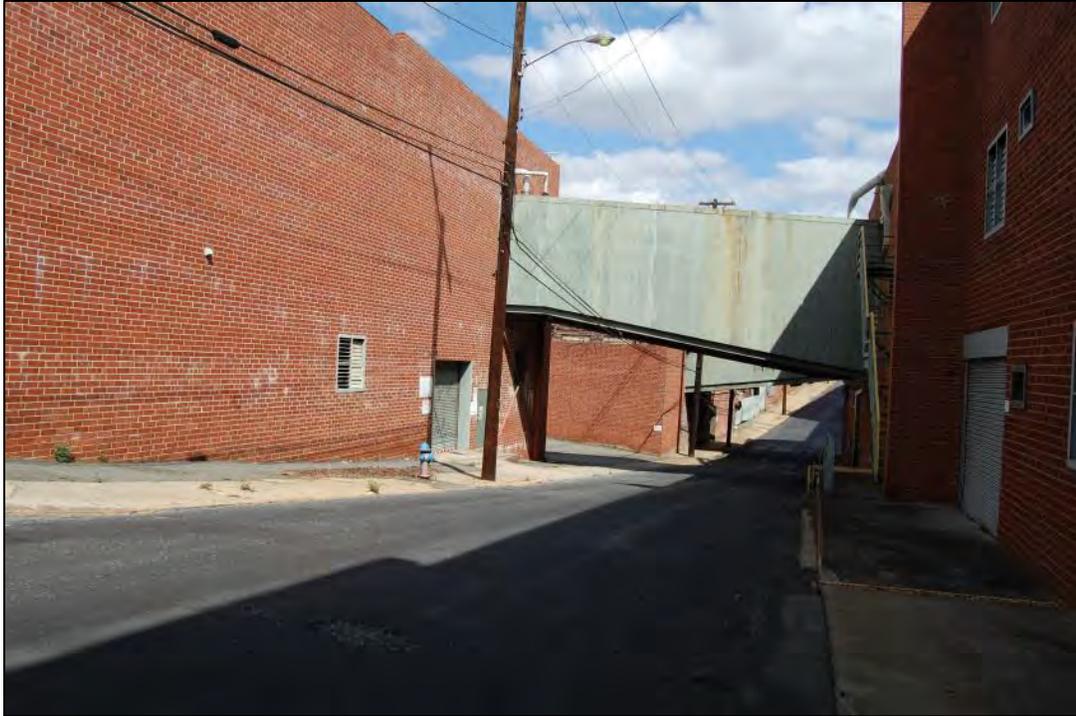
Figure 226: Dixie Furniture Company, Railroad Street (south) elevation Building 25-20 at left; Building 25-15 at right

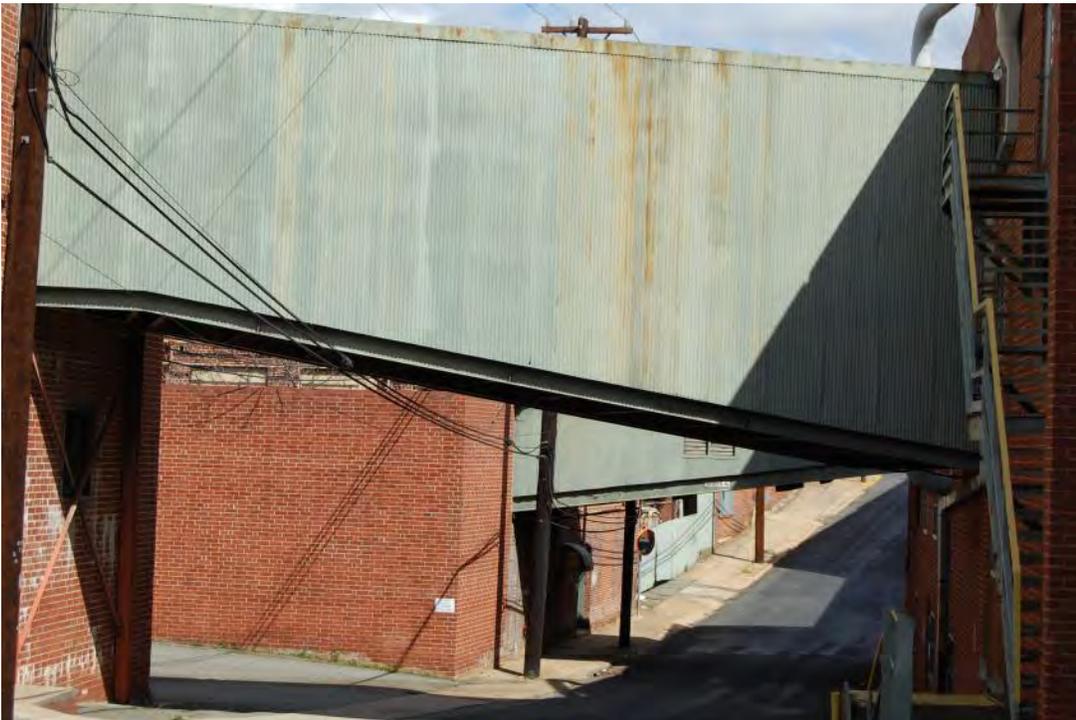
Figure 227: Dixie Furniture Company, looking east on Railroad Avenue at Building 25-23

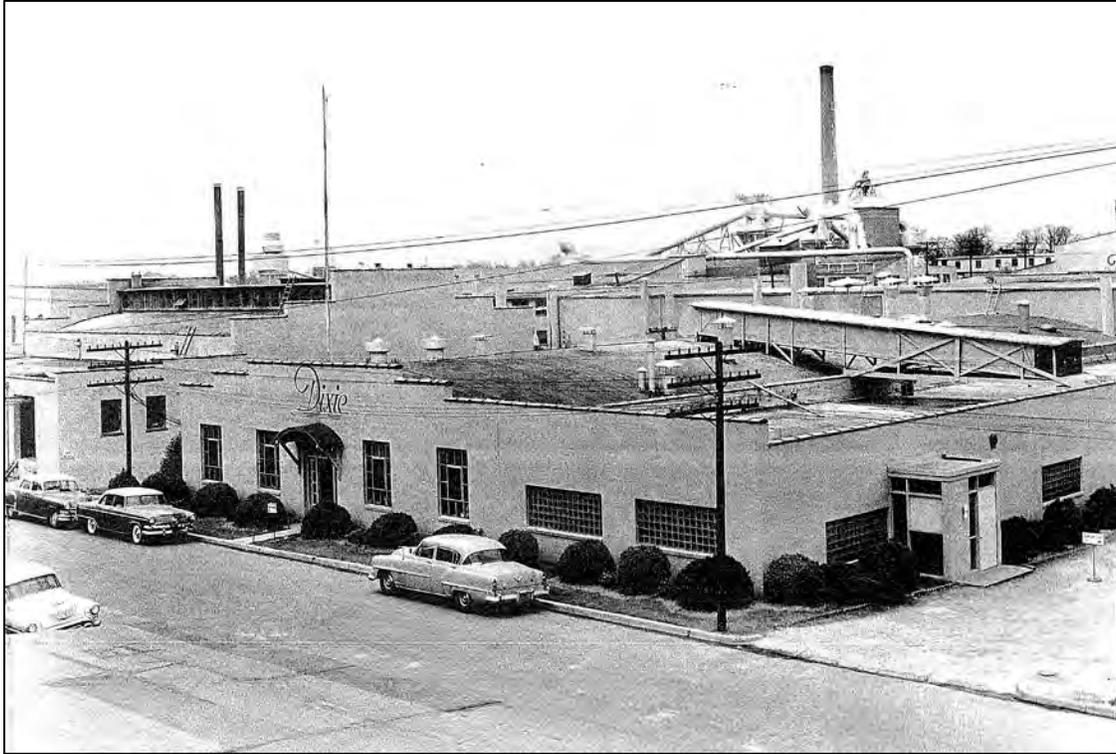
Figure 228: Dixie Furniture Company, 3rd Avenue (east) elevations of Building 25-26 at left with “Dixie” over door and Building 25-25 at right with long glass-block windows, ca.mid-1950s (source: Davidson County Historical Museum, image P 01.58.3a)

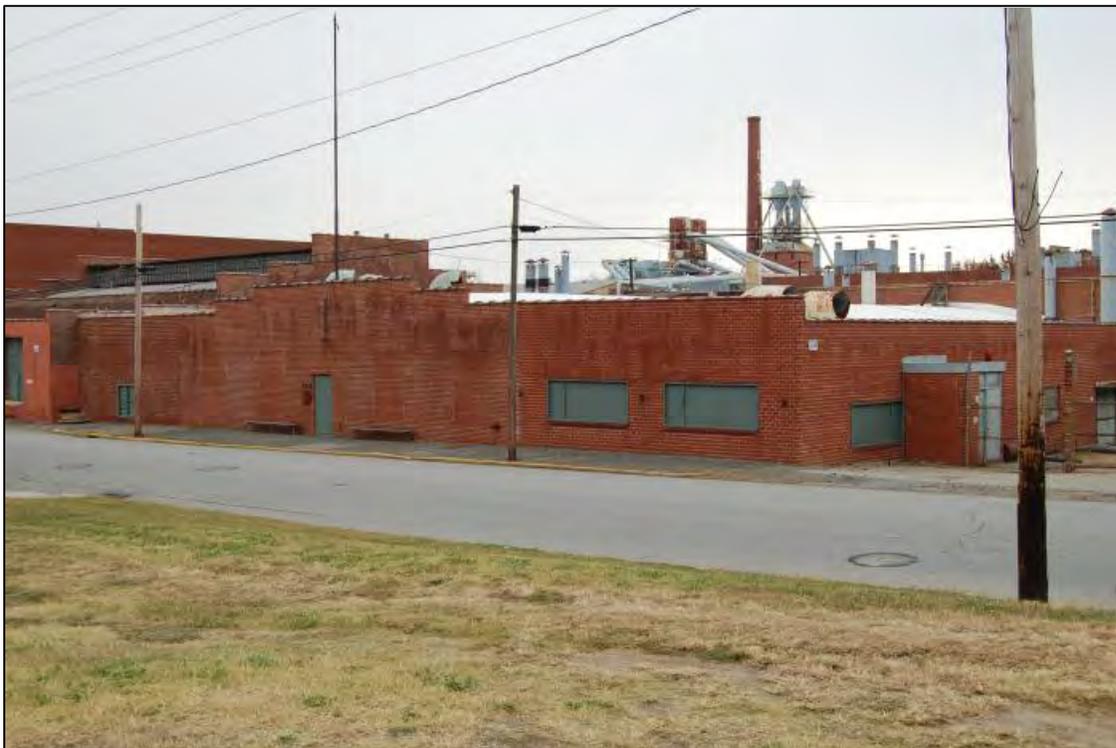
Figure 229: Dixie Furniture Company, modern view of Figure 228 above

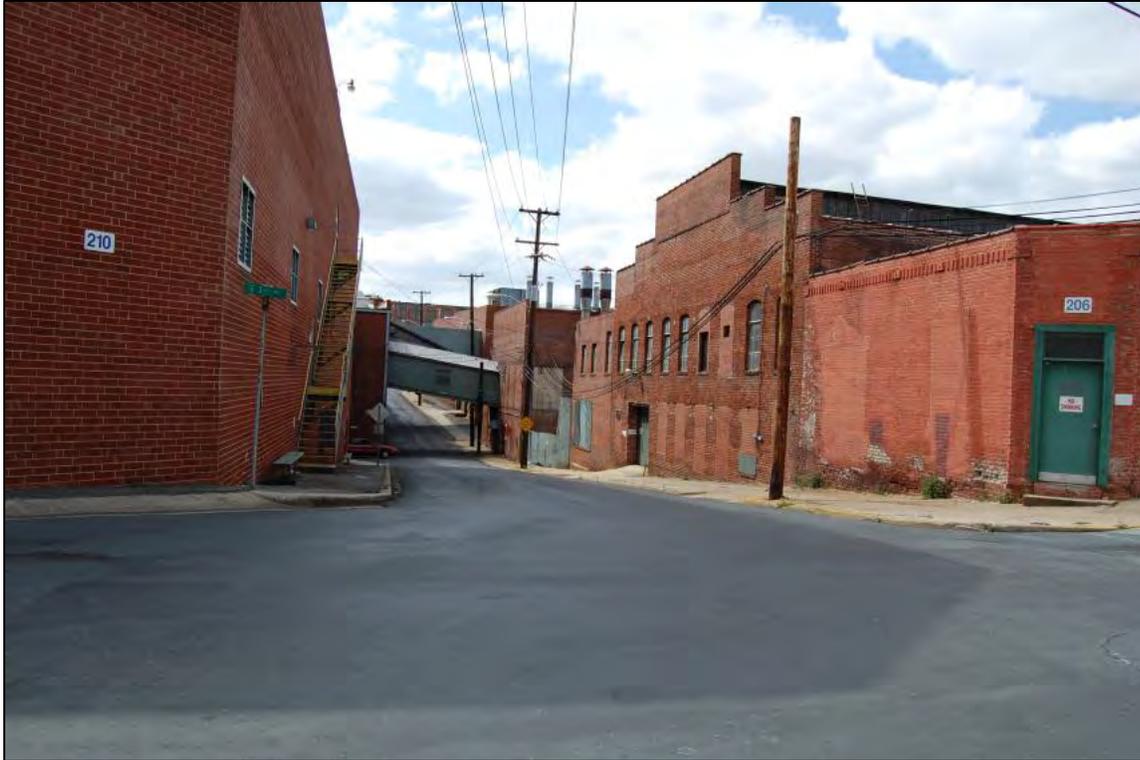
Figure 230: Dixie Furniture Company, looking west on Railroad Street with Building 25-27 on right and Building 25-28A at left

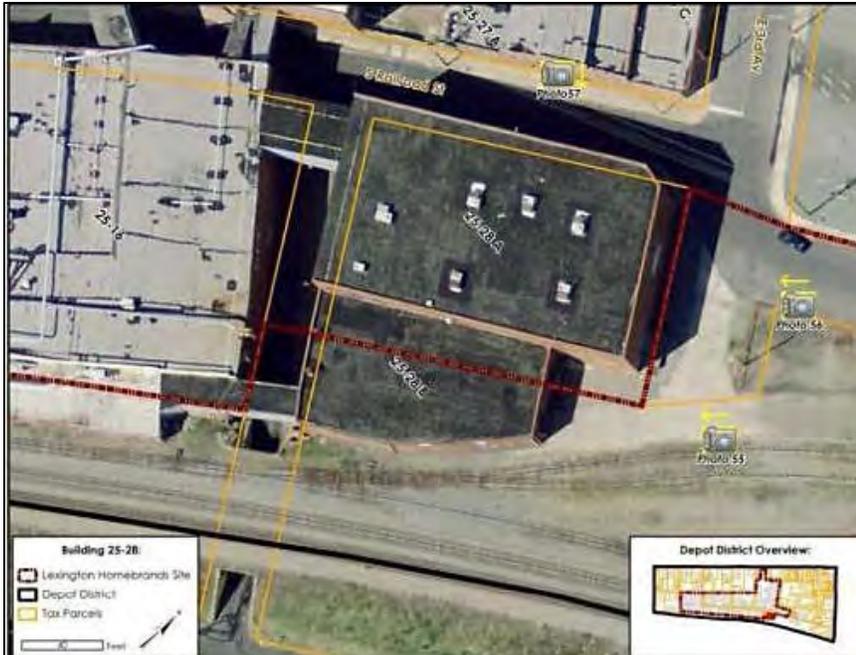
Figure 231: Dixie Furniture Company, Buildings 25-28A and 25-28B (source: Lexington Redevelopment Commission 2010)

Two separate buildings previously stood on the sites of the attached components of this resource, Building 25-28A and Building 25-28B. A wholesale grocery warehouse occupied part of the northern portion of the site by 1907, and between 1913 and 1923 that warehouse was replaced by a larger warehouse. On the southern portion of the site, a furniture storage building was erected between 1913 and 1923. About 1980, according to tax records, Building 25-28A was erected on the sites of the warehouse, much of the storage building, and land in between the two and to their east. At the same time, Dixie erected Building 25-28B on part of the site of the storage building and additional property to the south. Like the other buildings constructed by Dixie from the 1950s into the early 1980s, the two buildings are flat-roofed, brick-veneered, and have very few openings. Some square bays fitted with vents pierce their brick veneer and, at their east-facing elevations, there are three loading-bays with roll-up doors. Both buildings have structural steel frames (Figure 231 - Figure 234).

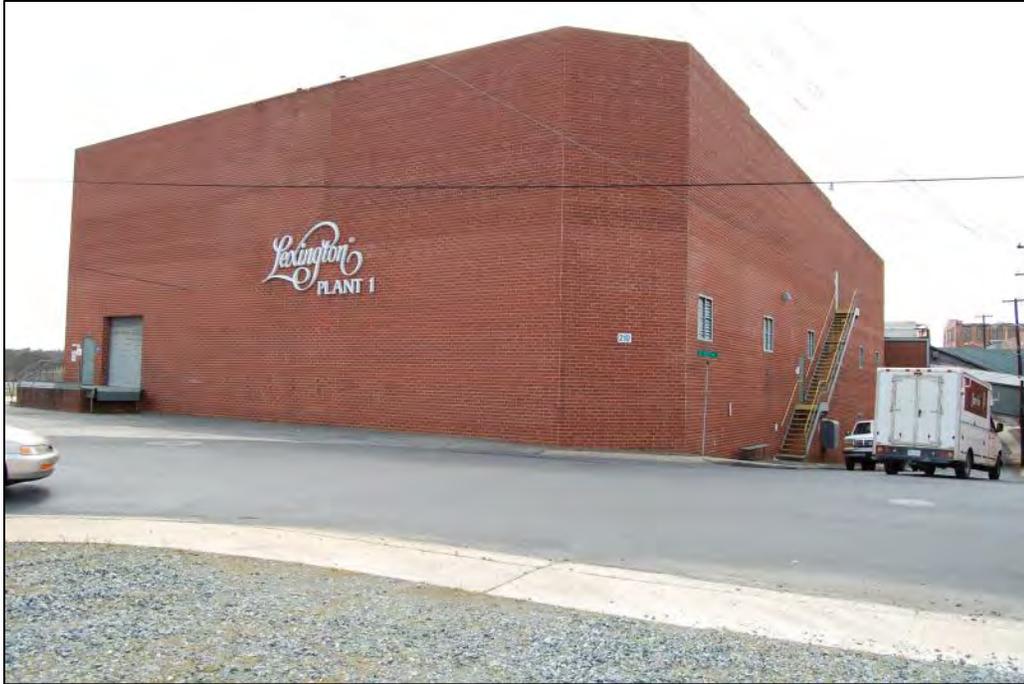
Figure 233: Dixie Furniture Company, Railroad Street (north) elevation of Building 25-28A at right and east elevation at left

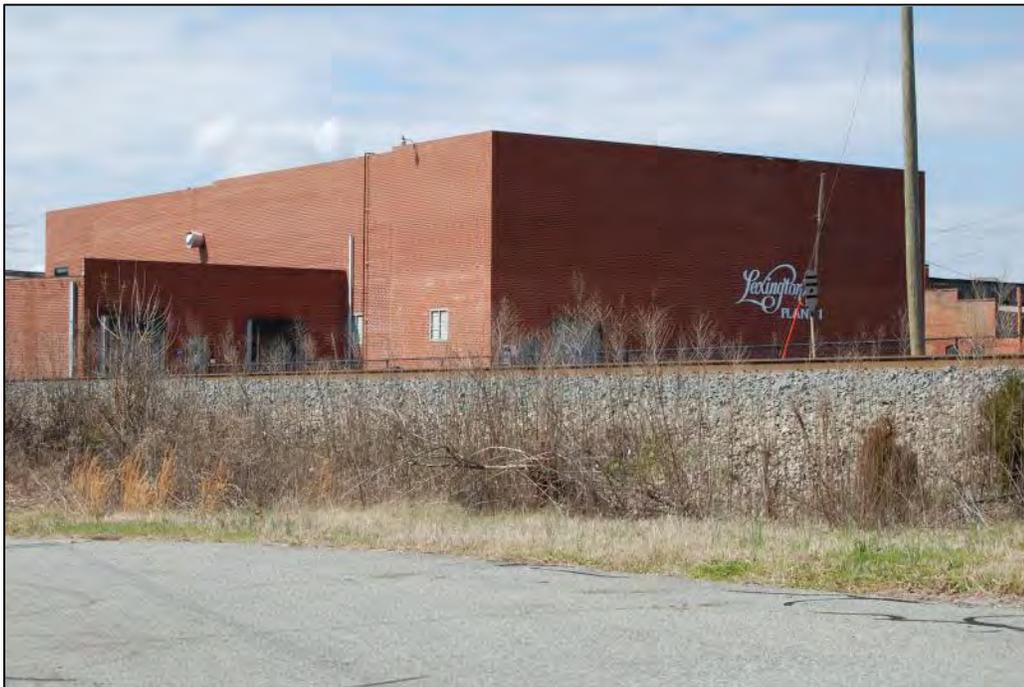
Figure 234: Dixie Furniture Company, Building 25-28A at right and 25-28B at left, from south side of tracks

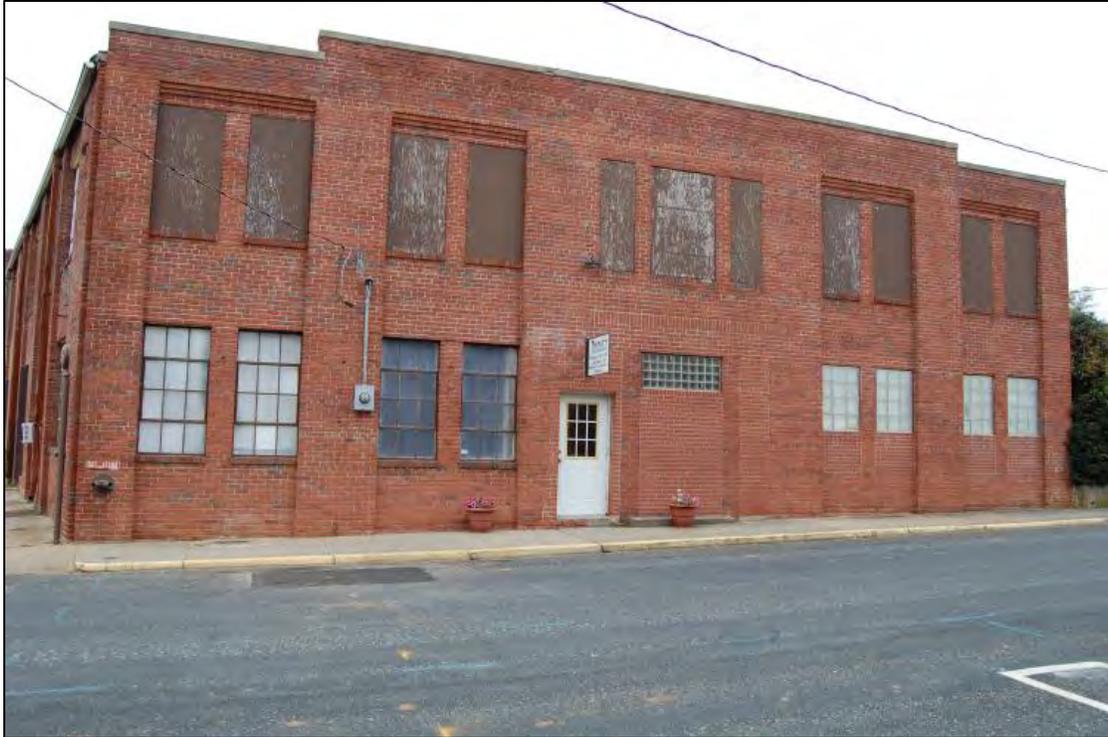
Figure 235: East front (East 2nd Avenue) and south side elevations of Lexington Shirt Corporation

The former Lexington Shirt Corporation building has no known historical or architectural significance. Its ca.1937 and 1950s-era blocks form a workmanlike industrial building that is not notable. Further, the building has been altered by the filling of numerous window bays and the addition of sliding garage doors. It is therefore not eligible for National Register listing under any of the Register's Criteria.

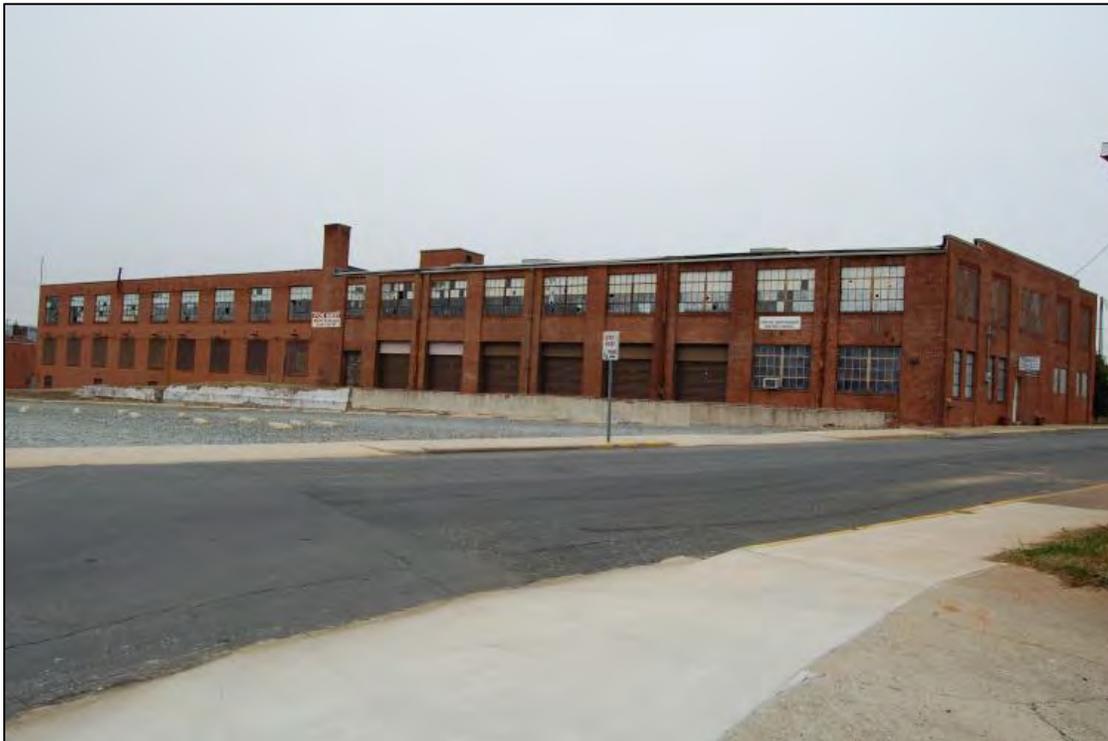
Figure 236: South side and east front elevations of Lexington Shirt Corporation

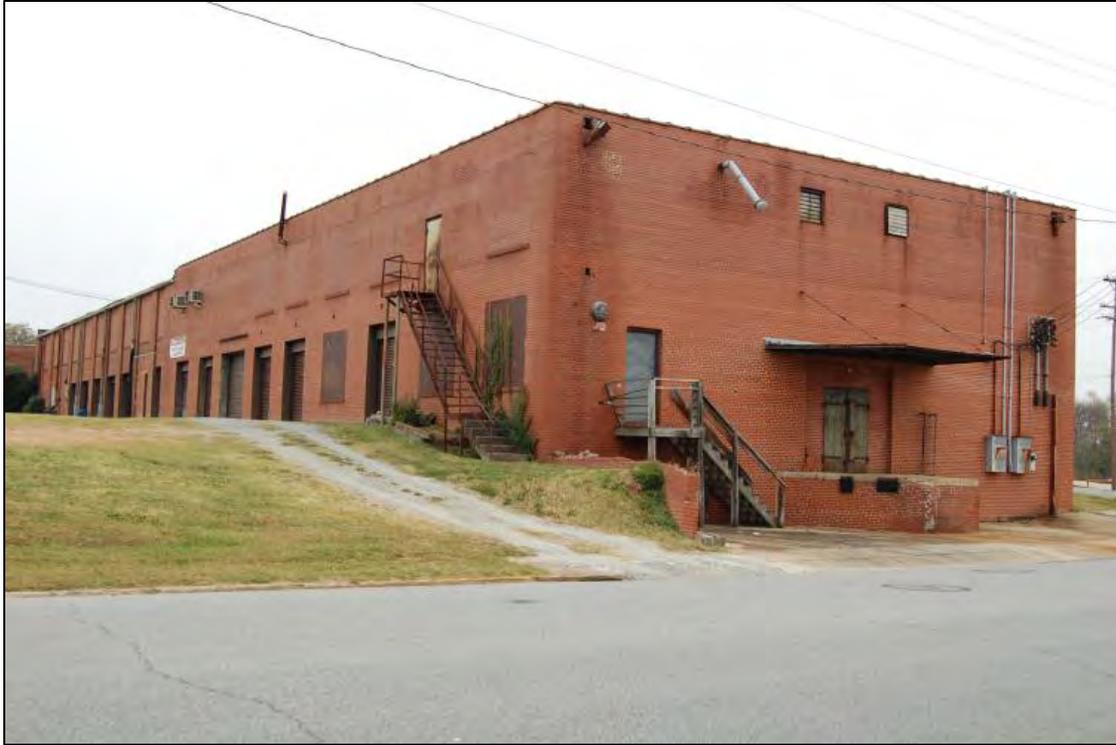
Figure 237: West rear (East 3rd Avenue) and north side elevations of Lexington Shirt Corporation

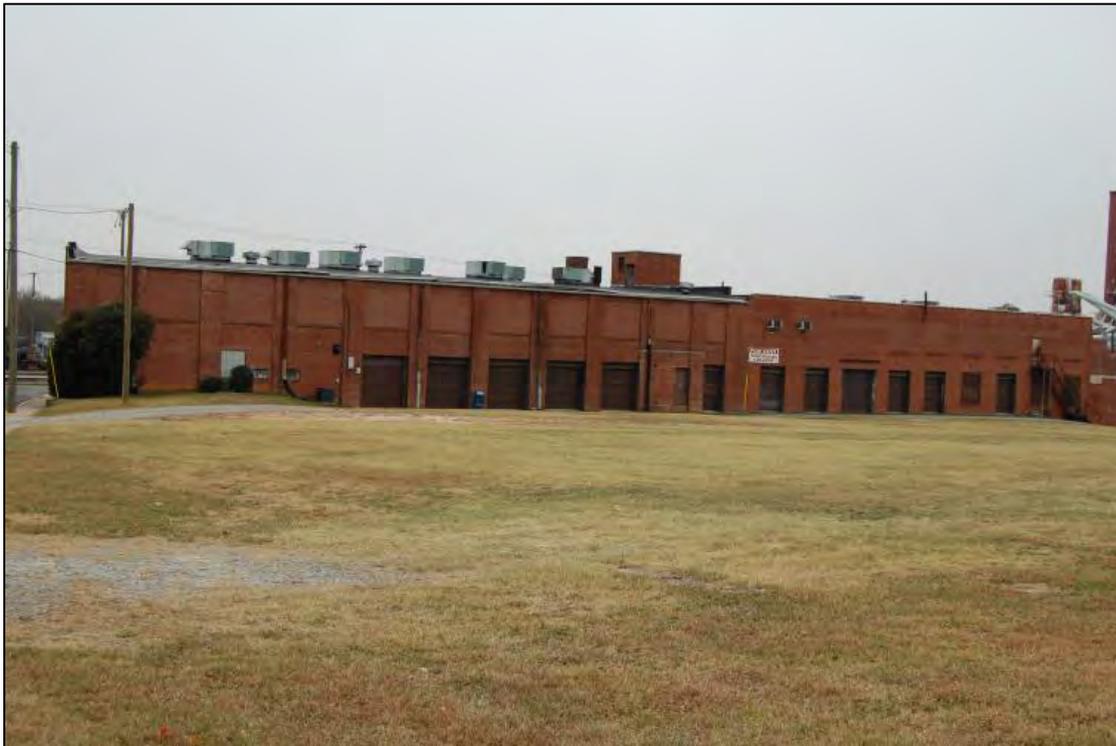
Figure 238: North side elevation of Lexington Shirt Corporation

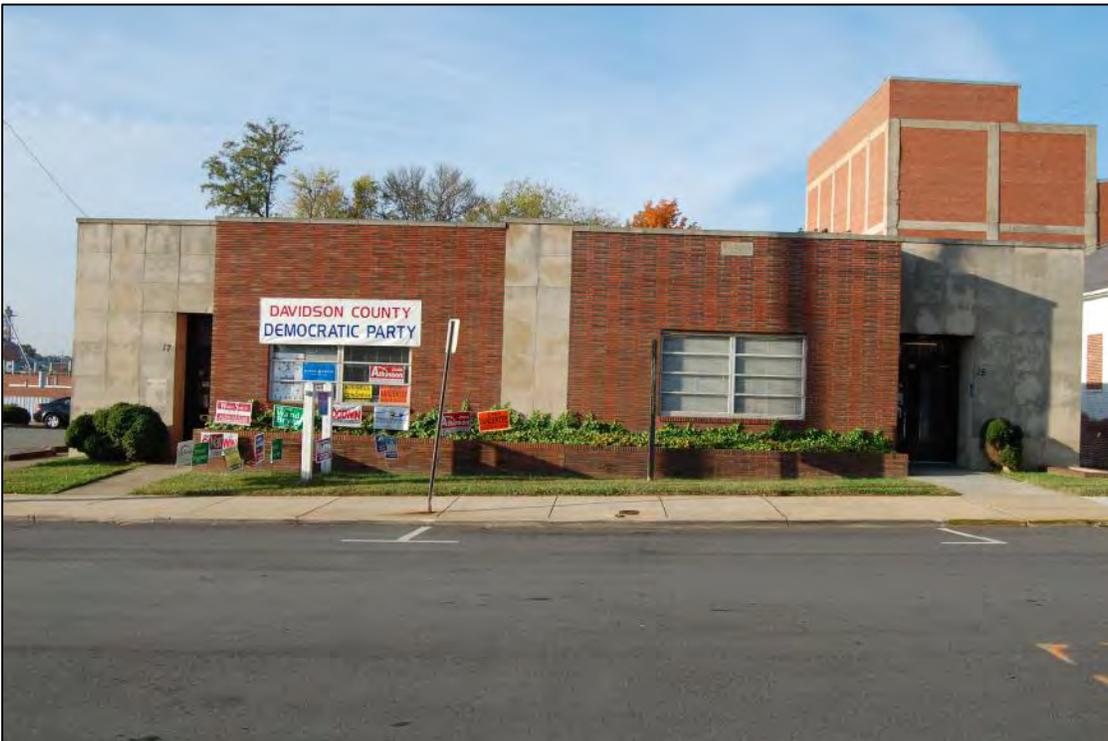
Figure 240: Wellborn Building, east front (2nd Avenue) elevation with 1951 block at right and 1958 block at left

The northern (1951) portion of the Wellborn Building is constructed of masonry clad in brick veneer and topped by a flat roof (Figure 240 - Figure 244). The front (east) elevation on 2nd Avenue is finished with Roman brick set in running bond with alternating darkened stretchers. A low matching wall with the same brickwork sets off landscaping in front of the facade. The elevation is also marked by limestone panels, which are arranged in an L-shape around the recessed off-center entry and as a pilaster at the former south end of the block. A single, large, metal casement window pierces the front elevation of the block. The name plaque is set above it beneath the concrete coping of the roof. The block’s north side and west rear elevations are plainly finished with standard brick veneer and metal casement windows. The southern portion of the building (1958) essentially mirrors the original block with the same brick-veneer, limestone panels, and wall at the front, and standard brick veneer at the north and west. It is smaller, however, extending back only about 50 feet rather than the approximately 75 feet of the original block.

The body of the entire building and its side and rear elevations exemplify standard commercial-type design and finish found at similar buildings erected from the mid-1940s through the 1960s. The Roman brick, limestone panels, and low wall, however, give the front elevation a minimal mid-century-modern-type design. The overall appearance of the building suggests the design hand of a contractor rather than an architect.

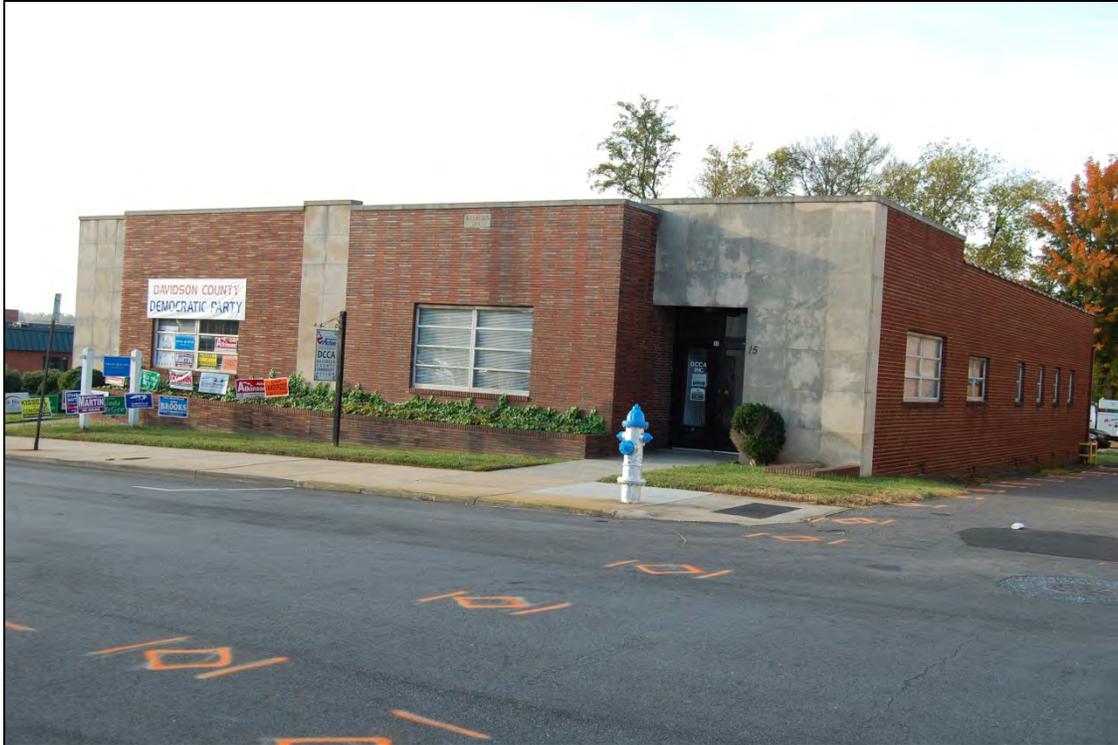
Figure 241: Wellborn Building, east front and north side elevations of 1951 block

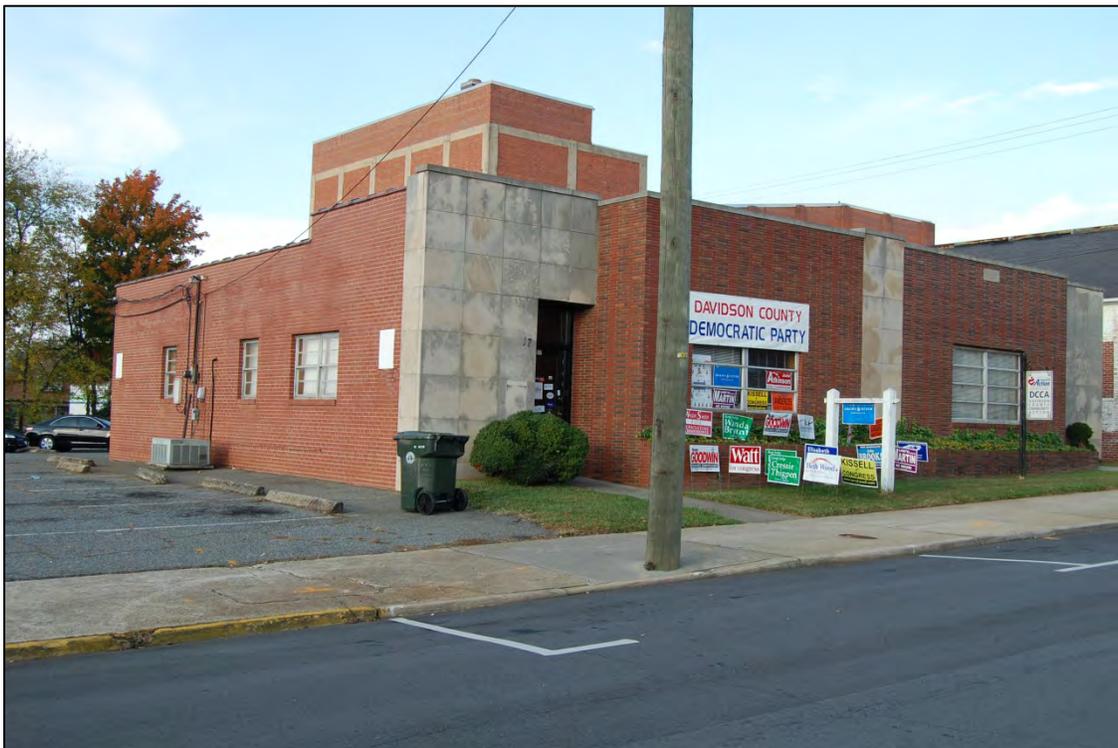
Figure 242: Wellborn Building, east front and south side elevations of 1958 block

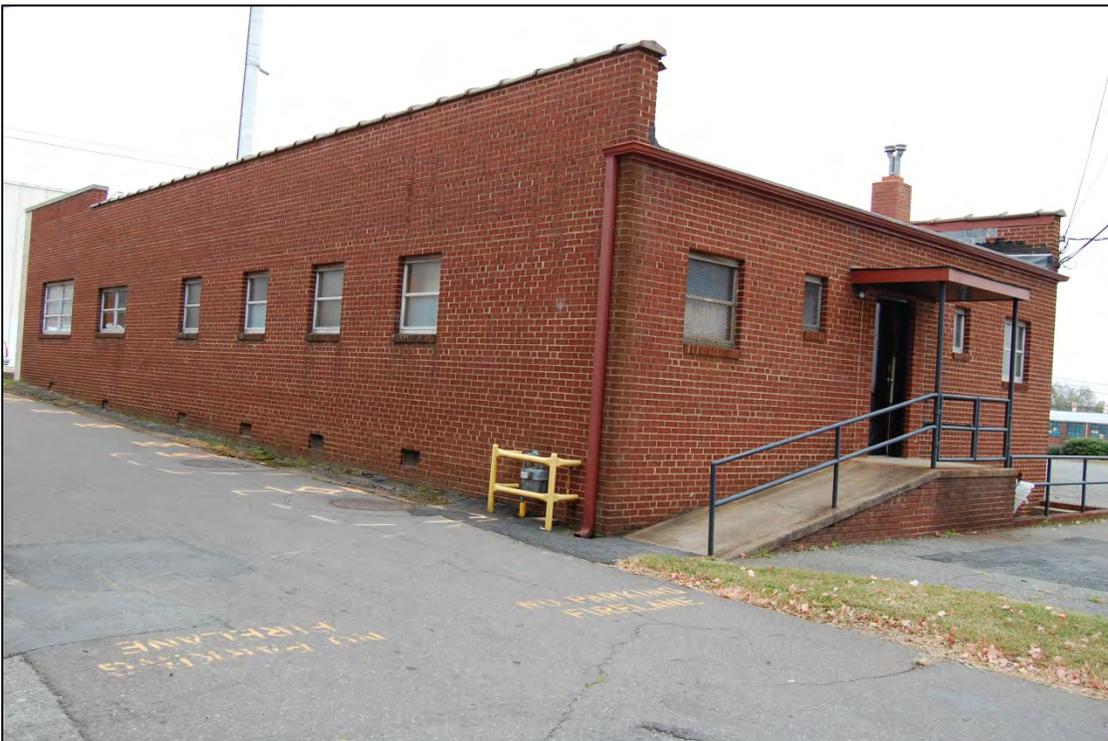
Figure 244: Wellborn Building, west rear and north side elevation of 1951 block

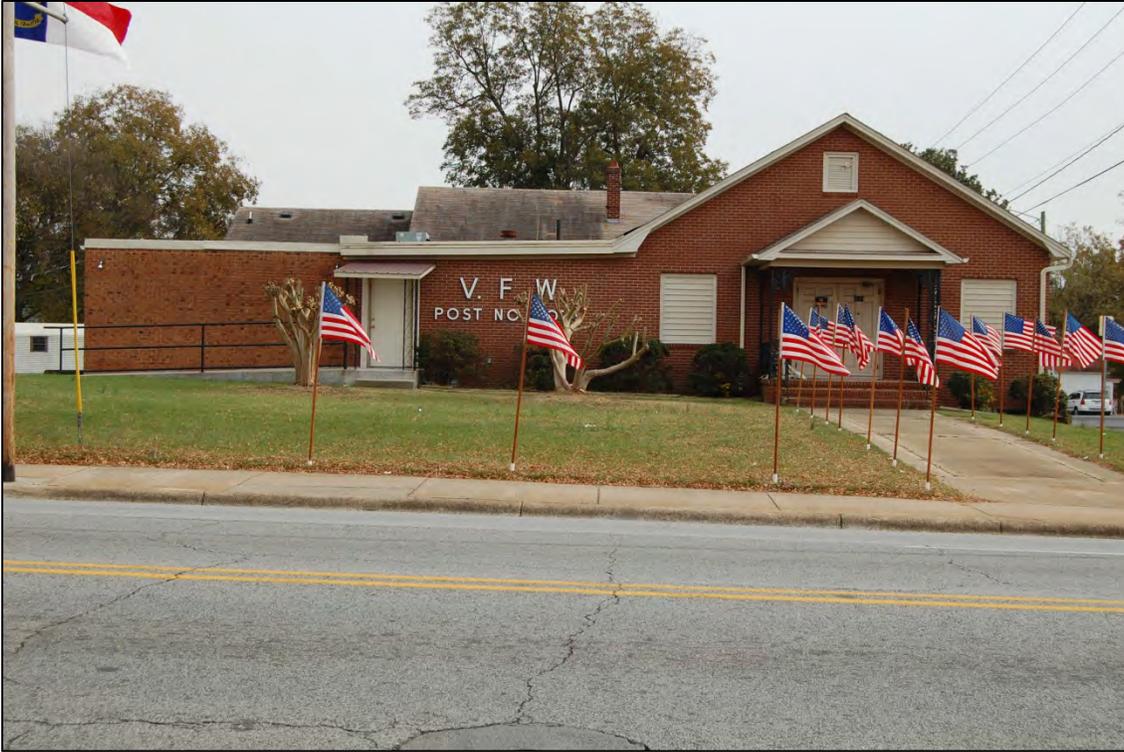
Figure 245: Floyd Lee Berrier VFW Post No. 3074, north front (Main Street) elevation

The VFW post building, or hut as it is called in city directories, is one-story tall and brick veneered (Figure 245 - Figure 248). If it started out as a single-pile, L-shaped residence, it soon acquired in the VFW's hands a gabled entry at the front and a small flat-roofed wing that now carries the name of the post. These portions of the building are clad in matching brick veneer. Rather than windows, the front (north) gable has a central entry flanked by metal ventilators. This appears to be a later alteration. A gable-end and flat-roofed wing were subsequently added across the rear (south) elevation and an even later flat-roofed wing, which is covered with orange-tinged brick veneer, extends to the east at the front elevation. Access could not be gained to the interior.

The Floyd Lee Berrier VFW Post No. 3074 building has no known historical or architectural significance and is therefore not eligible for National Register listing. It is not one of the original VFW posts, which were formed in Denver and Pittsburgh. Nor is it known to be a rarity in North Carolina: the VFW website identifies 173 posts in the state. No information could be found identifying Floyd Lee Berrier as a person significant in our history. And the building is not architecturally notable, but rather appears to be at heart an altered early twentieth-century dwelling.
