**HEDRICK BLOCK (URS survey #18A)
211-215 South Main Street**

Recommendation and Boundaries

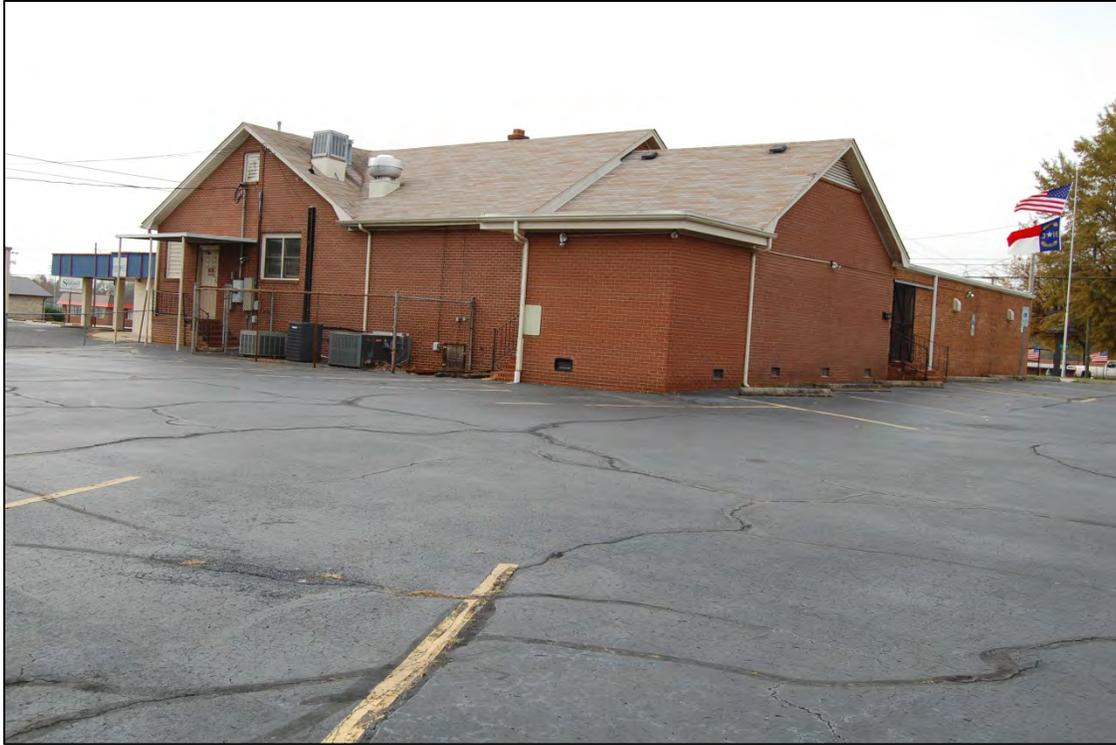
Figure 247: Floyd Lee Berrier VFW Post No. 3074, east side and south rear elevations

The VFW post building, or hut as it is called in city directories, is one-story tall and brick veneered (Figure 245 - Figure 248). If it started out as a single-pile, L-shaped residence, it soon acquired in the VFW's hands a gabled entry at the front and a small flat-roofed wing that now carries the name of the post. These portions of the building are clad in matching brick veneer. Rather than windows, the front (north) gable has a central entry flanked by metal ventilators. This appears to be a later alteration. A gable-end and flat-roofed wing were subsequently added across the rear (south) elevation and an even later flat-roofed wing, which is covered with orange-tinged brick veneer, extends to the east at the front elevation. Access could not be gained to the interior.

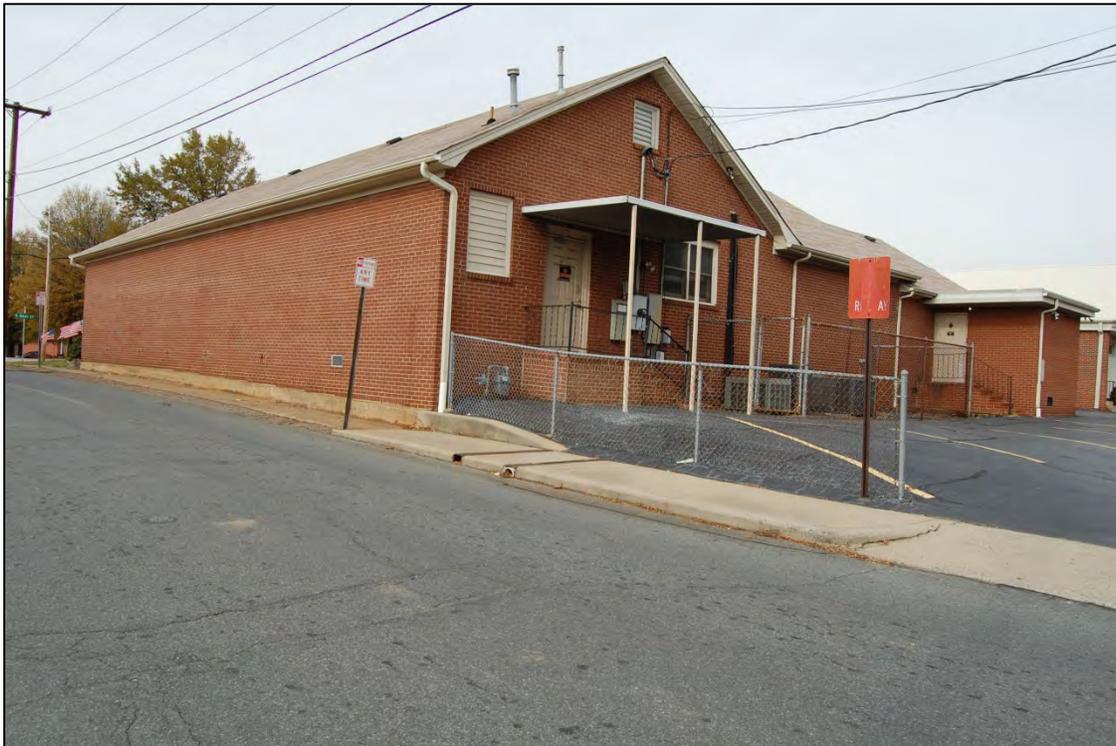
Figure 248: Floyd Lee Berrier VFW Post No. 3074, south rear and west side (7th Avenue) elevations
