Above the Flood: Elevating Your Floodprone House

FEMA 347/ May 2000

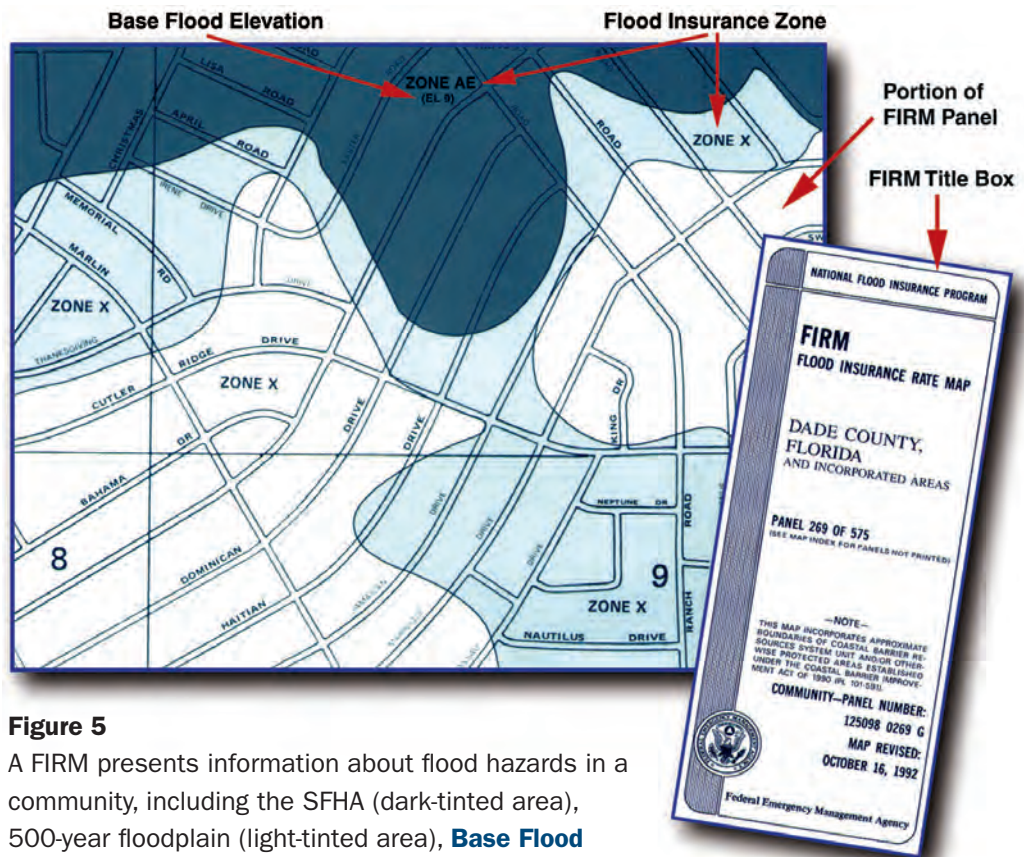
Figure 5
A FIRM presents information about flood hazards in a community, including the SFHA (dark-tinted area), 500-year floodplain (light-tinted area), **Base Flood Elevations**, (BFEs) (number in parentheses), and flood insurance zones (AE and X in this example).

Note that the SFHA in the example in Figure 5 is designated Zone AE. This zone is only one of several applied to SFHAs under the NFIP, including V, VE, V1-V30, A, AE, A1-A30, AO, and AH. These zones indicate differences in the types and severity of flood hazards in SFHAs. For the purposes of this publication, it is sufficient to focus on the basic differences between the two main types of SFHA zones—V zones and A zones. The distinction is important because regulatory requirements associated with V zones and A zones differ significantly. As explained later in this chapter, these requirements affect the types of building elevation techniques that may be used under the NFIP.

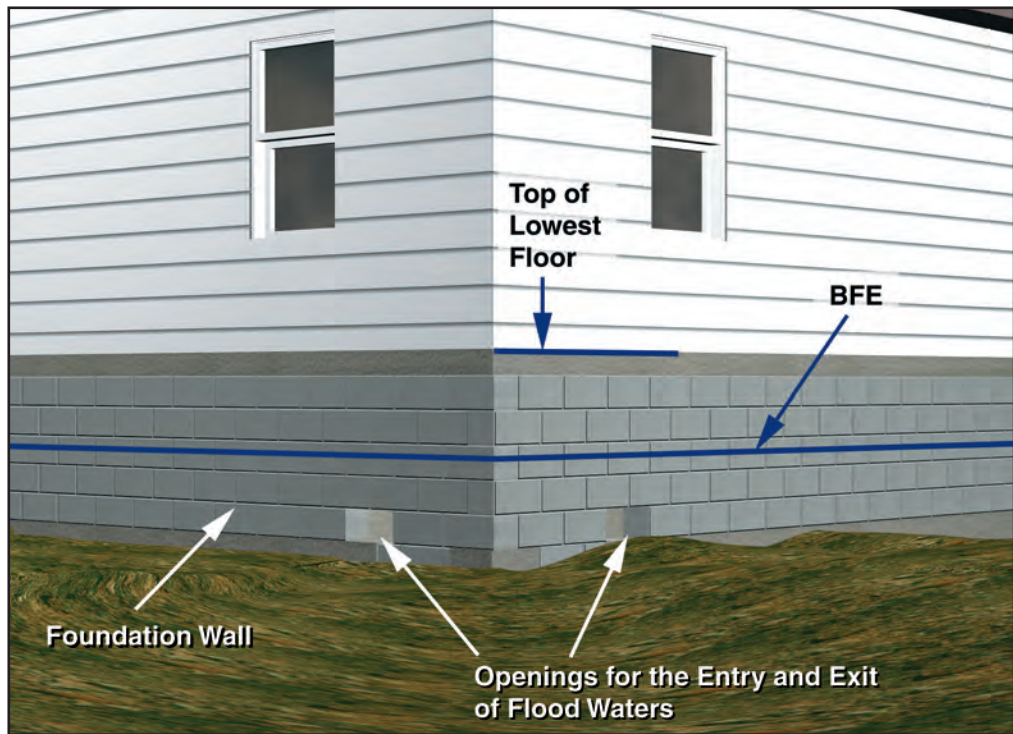
Figure 6

In a new, substantially improved, or substantially damaged building in an A zone, the elevation of the lowest floor must be at or above the BFE.

In A zones, where flood hazards are less severe, buildings may be elevated either on an open foundation or on continuous foundation walls below the BFE (Figure 6). Regardless of the type of foundation used, A-zone buildings must be elevated so that the **lowest floor** is at or above the BFE, as shown in Figure 6. If continuous walls are used below the BFE, they must be equipped with openings that allow flood waters to flow into and out of the area enclosed by the walls (Figure 6). Allowing the entry and exit of flood waters ensures that water pressures will be the same on both sides of the walls and reduces the likelihood that water pressure will cause the walls to fail.

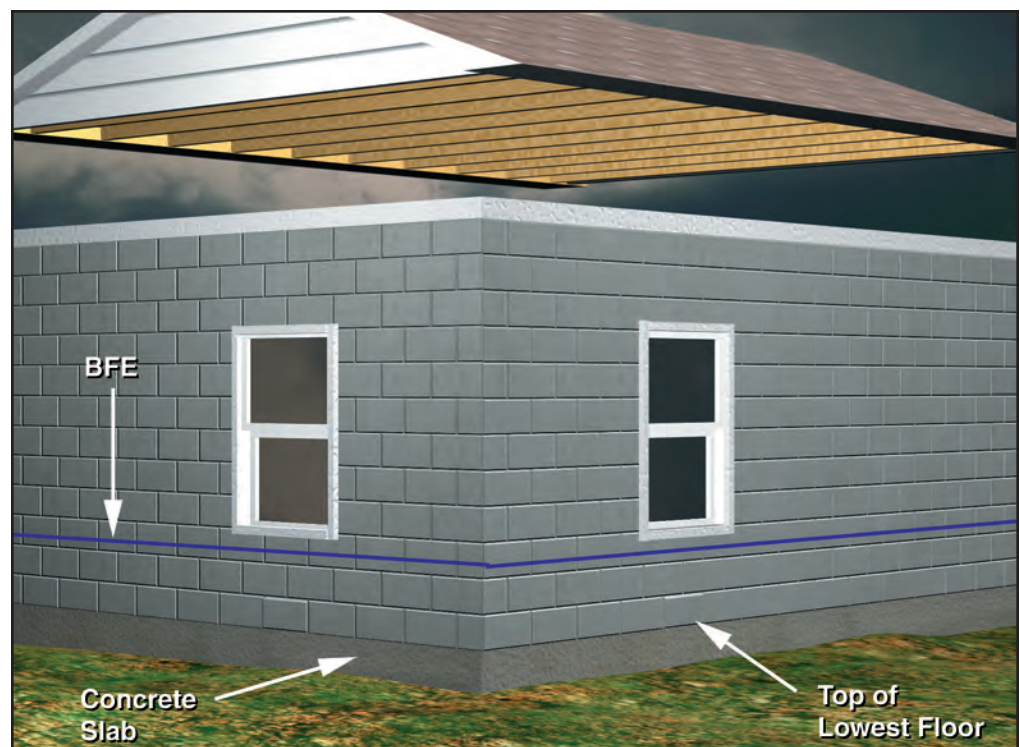
Figure 10
The first step in Technique 1 is removing the roof.

Technique 1 is appropriate for houses with concrete or masonry walls, but not for houses with other types of walls, such as those framed with wood studs, which would be more vulnerable to flood damage. This technique is usually appropriate when the depth of the base flood at the house is no more than 4 or 5 feet above grade. The elevation process begins with the temporary removal of the roof and roof framing, in a single piece if possible (Figure 10). This is commonly done with a crane. The roof is then stored on site so that it can be reinstalled later. The next step is to remove the windows and doors.

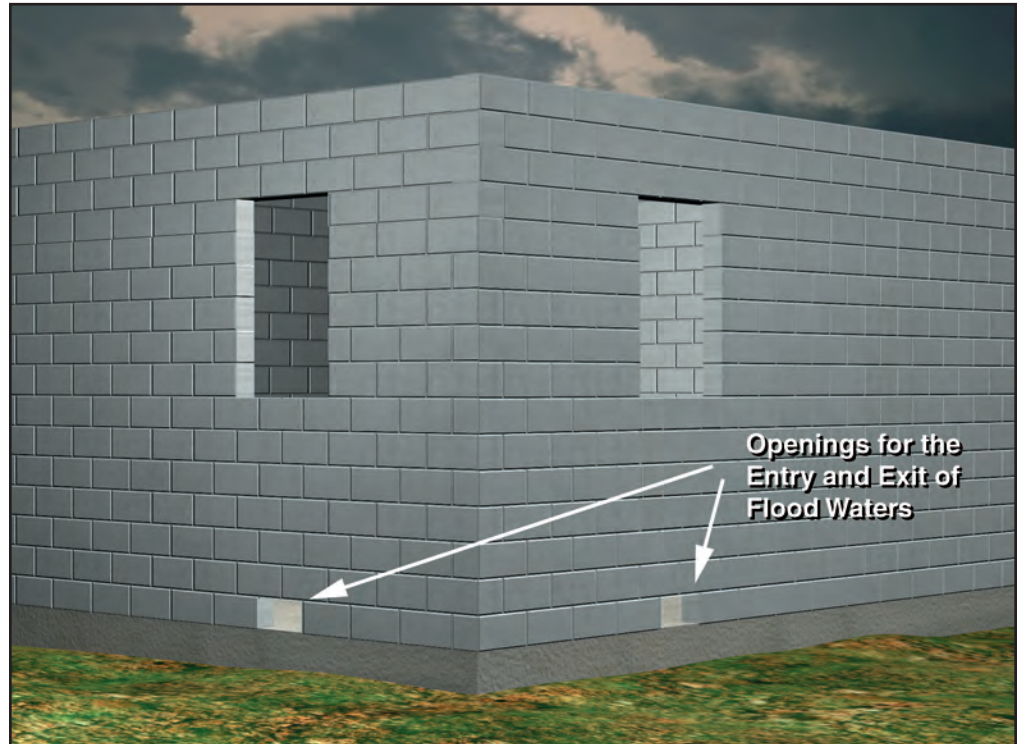
Figure 12
Openings are created in the walls near the ground.

Blocks are removed from the walls of the house at selected locations within 1 foot of the ground (Figure 12). The resulting openings will allow flood waters to flow into and out of the lower area of the house so that the water pressures on both sides of the walls will remain the same. The roof and windows are then replaced, and a new wood-frame floor is constructed above the flood level (Figure 13).

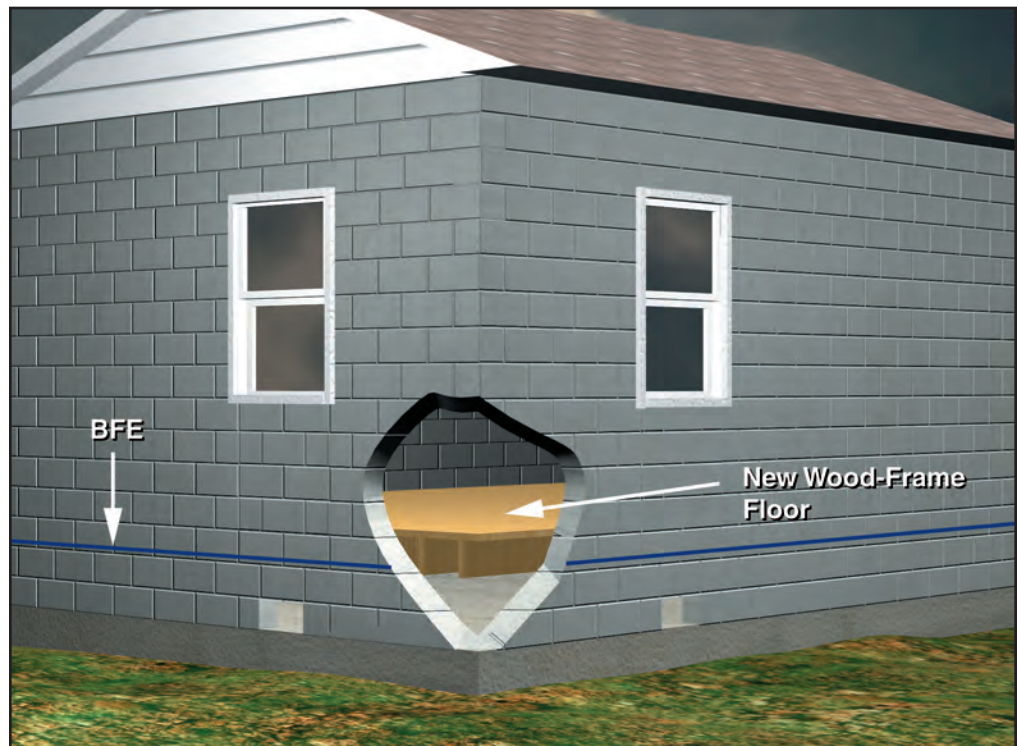
Figure 13
A new wood-frame lowest floor is constructed above the flood level, and the roof, windows, and doors are reinstalled.

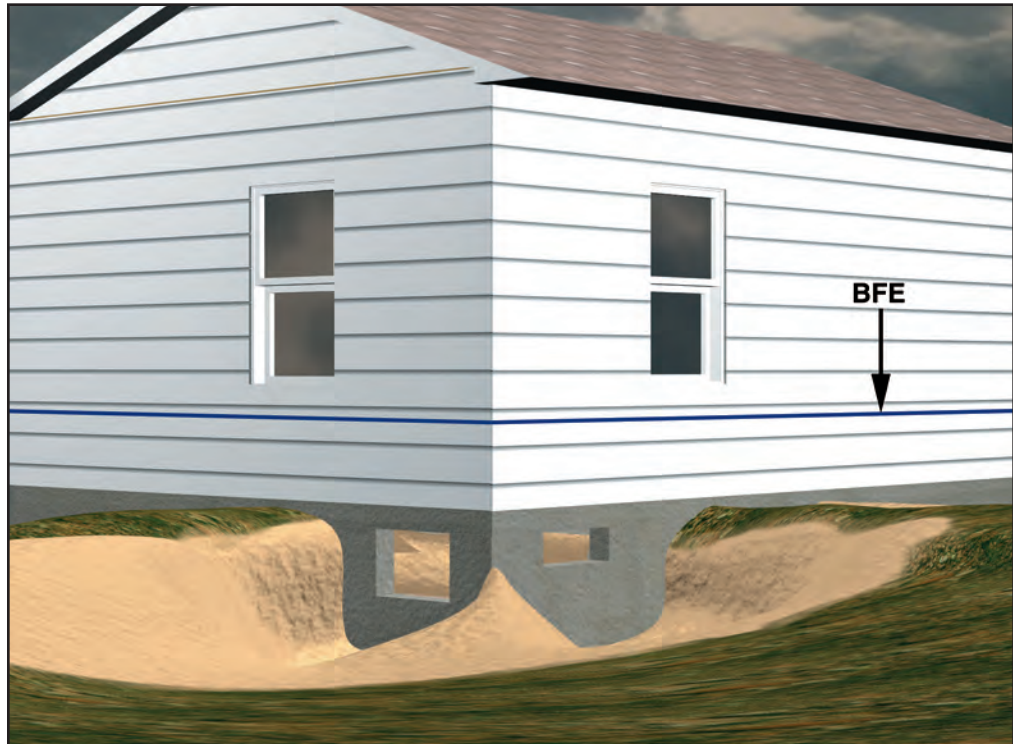
Figure 17
Trenches and tunnels under the slab provide access for the jacks and I-beams that will lift the house.

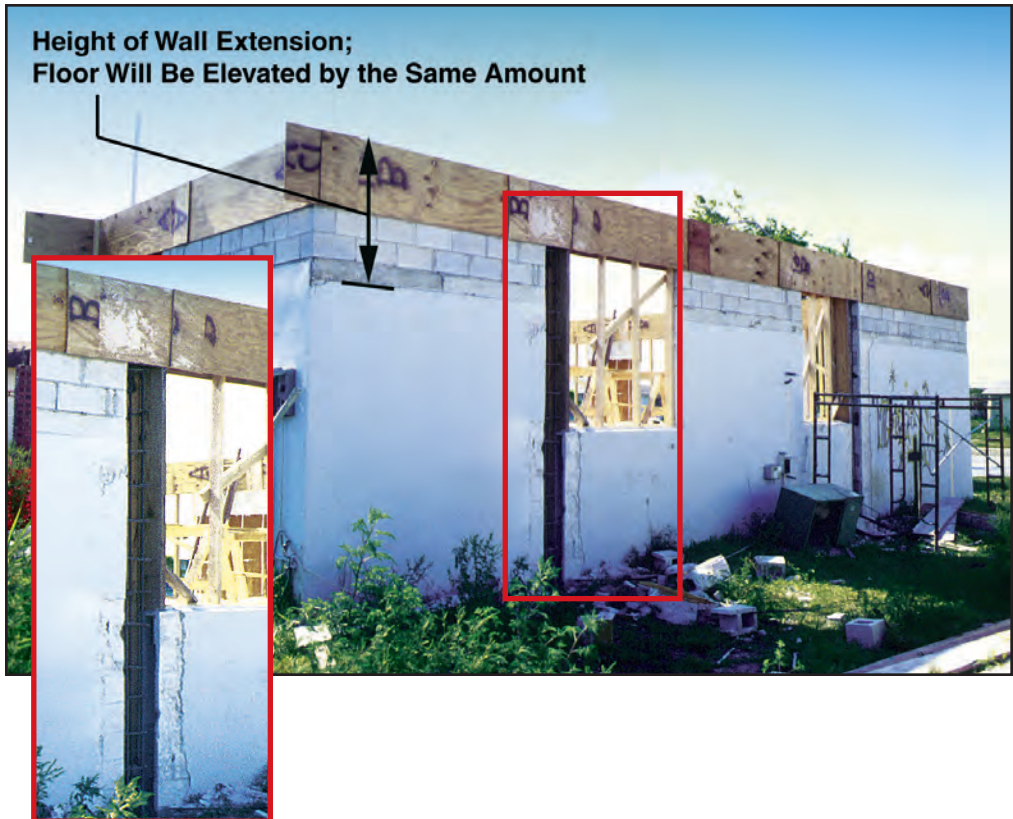
Figure 23
View from the back of the house. The walls have been extended upward with concrete blocks. The plywood visible at the tops of the walls is used to form cast-in-place concrete bond beams that will strengthen the extended walls. The roof trusses shown in the foreground were salvaged for reinstallation. The owner of this house decided to replace the original roof sheathing and shingles with new materials.

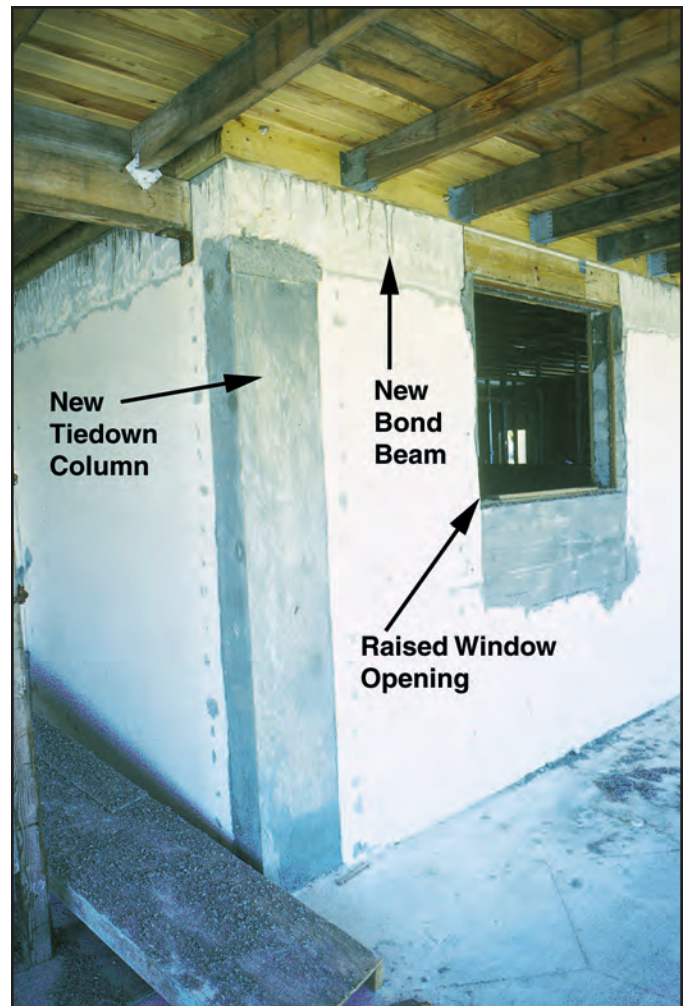
**Figure 41**

Note the new bond beam at the top of the extended wall, the new concrete tiedown column at the corner, and the raised window opening.

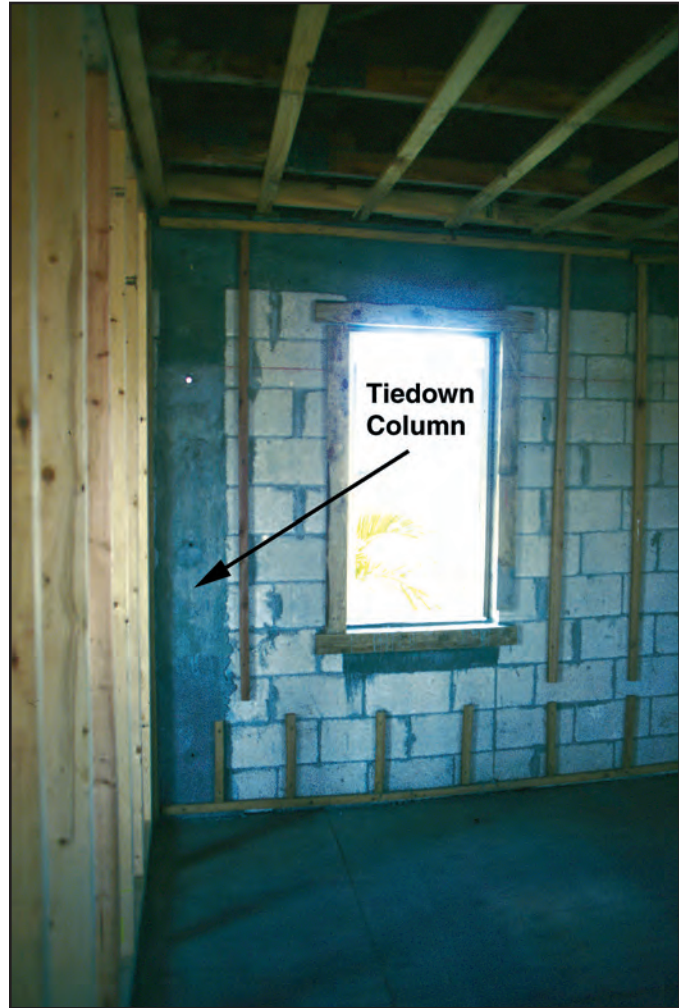
Figure 46
Concrete tiedown columns, such as the one to the left of the window in this photograph, were also used in this house.

Concrete bond beams similar to those shown earlier were used in this house, but here they were installed on the tops of both the original first-story walls and the new reinforced concrete block second-story walls.

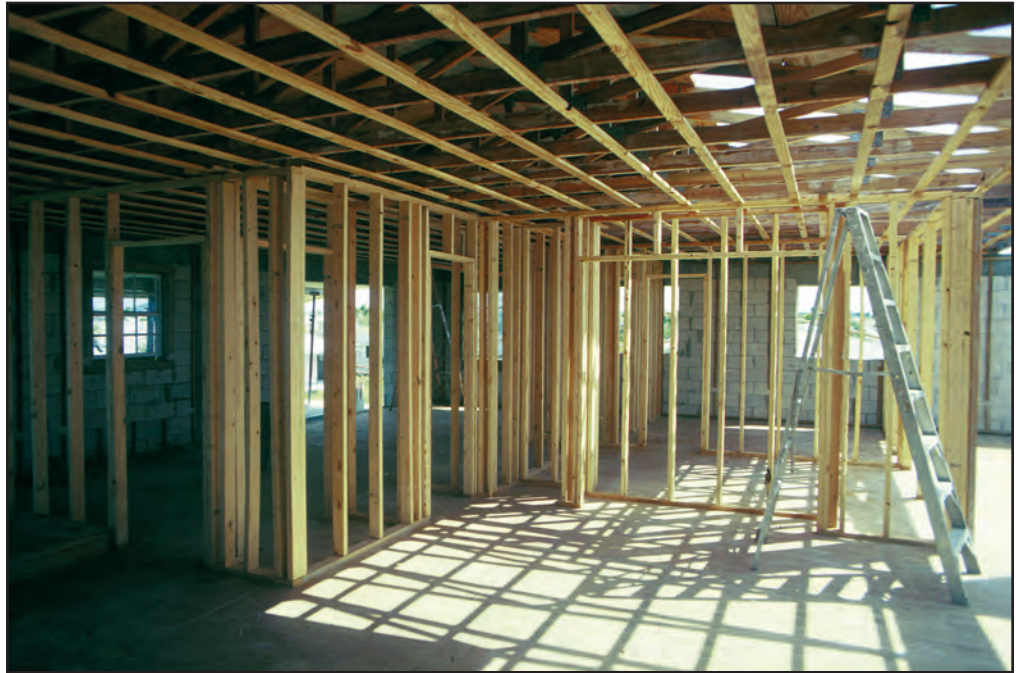
Figure 48
Wood 2 by 4 studs
were used to frame
the interior walls of
the second story.
